# NEW BUILD SNAGGING SURVEY

25/01/24

Example Survey  
3 bedroom house

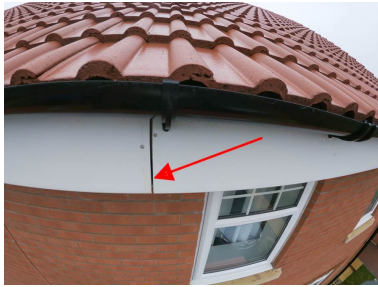
r1

There is trim missing to the soffits/fascias

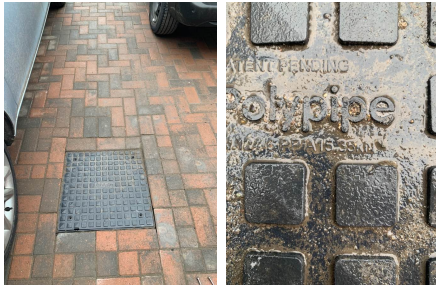
g1

Developer to confirm classification of inspection chamber is correct rating as per BS EN 124 ⚠ Significant issue

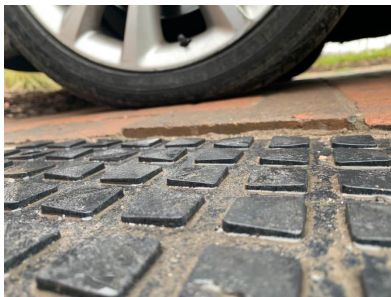
g3

Chamber cover lower than ground level

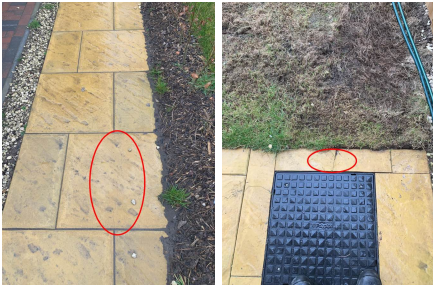
g5

The flagstone is chipped / cracked

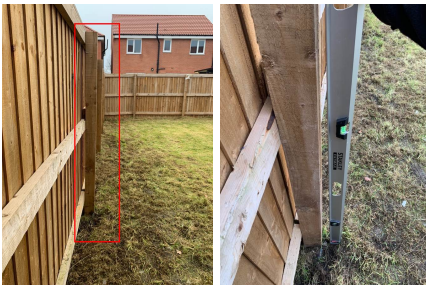
g7

Fence not plumb

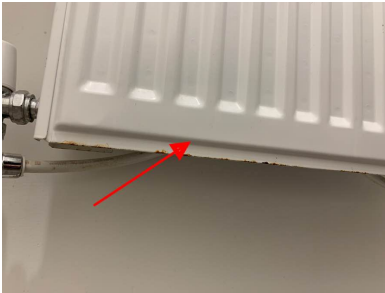
wc2

Radiator is corroded

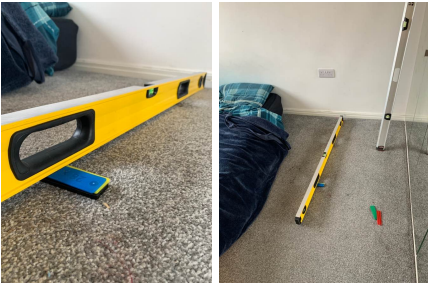
b1.1

12mm

A straight edge level was used and found the floor to be un-level and out of tolerance to NHBC 9.1.5 ⚠ Significant issue

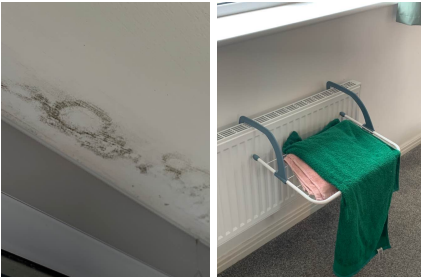
b1.2

Mould at window reveal - likely condensation

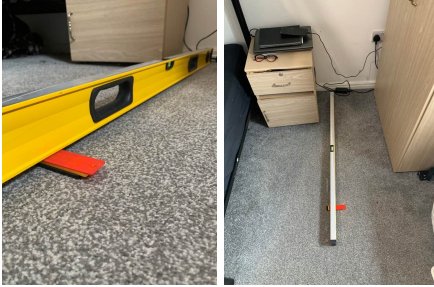
be2.1

13mm

A straight edge level was used and found the floor to be un-level and out of tolerance to NHBC 9.1.5 ⚠ Significant issue

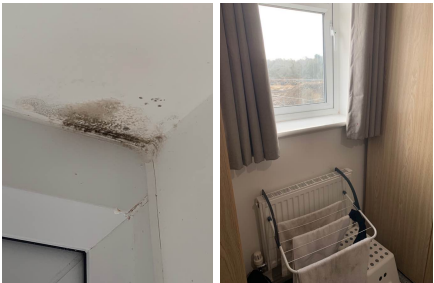
be2.2

Mould at window reveal - likely condensation

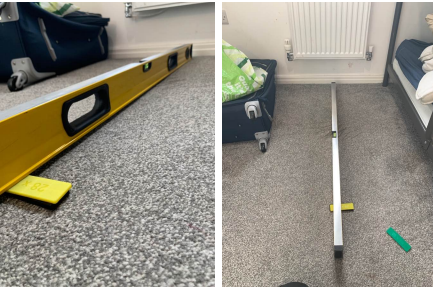
be3.1

10mm

A straight edge level was used and found the floor to be un-level and out of tolerance to NHBC 9.1.5 ⚠ Significant issue

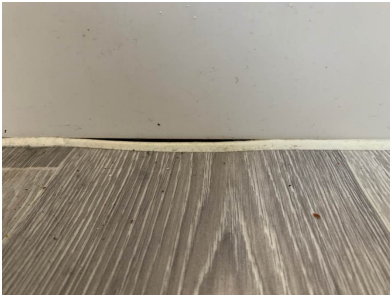
ba1.5

The sealant is splitting. Mastic trade to attend and redo section[s]
