SNAG LIST

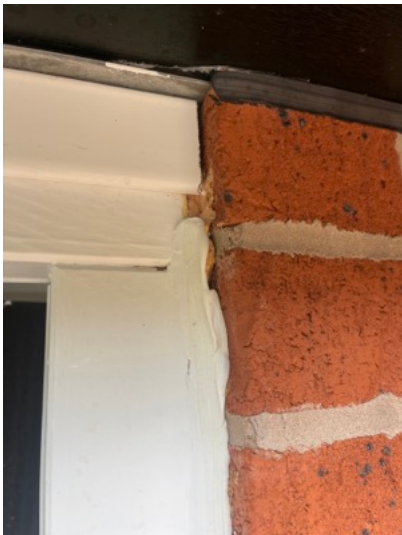
7

Poor finish around front door where the foam hasn't been cut before applying mastic

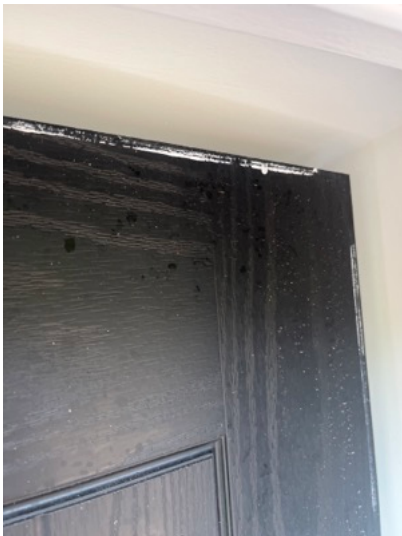
8

Frame paint has stuck to the door

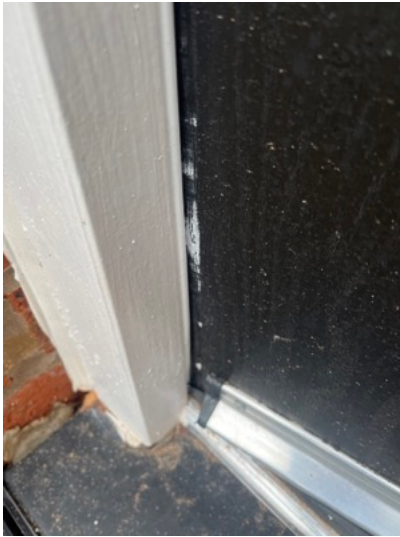
9

External Front
Assigned To
Another example

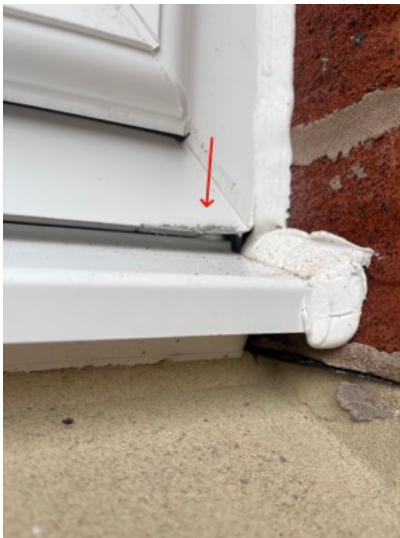
10

External Front
Assigned To Glazing
WC Window tarnished

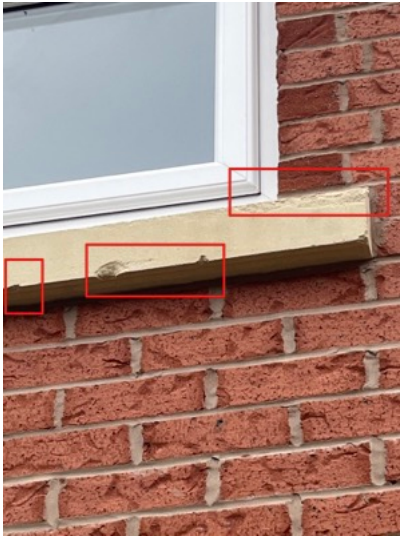
12

Cast stone to front bedroom badly damaged - I believe it better to replace rather than attempt repair

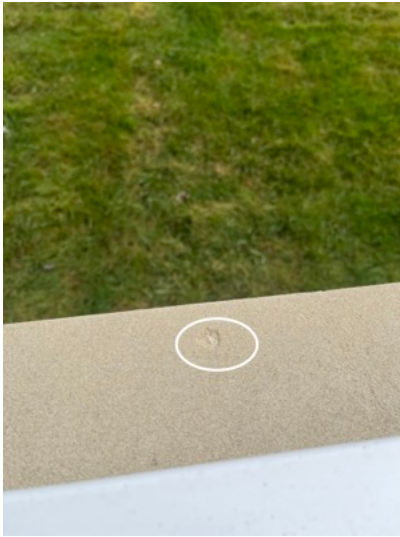
15

Assigned To Plastic Surgeon
Dented sill - lounge window

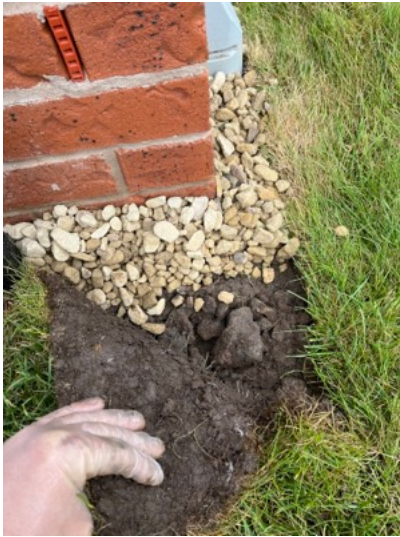
18

External Front
Assigned To Landscaping
Another example

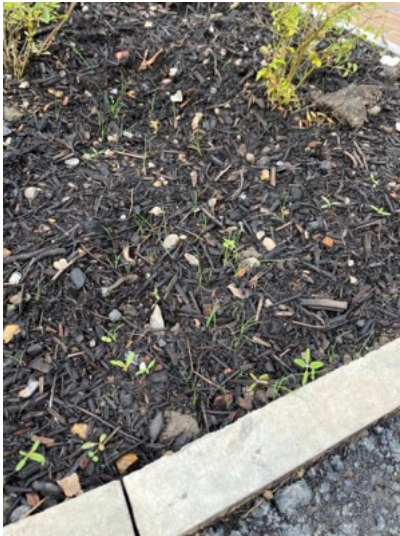
19

External Front
Assigned To Landscaper
Front garden showing weeds
There will be missing membrane causing
this

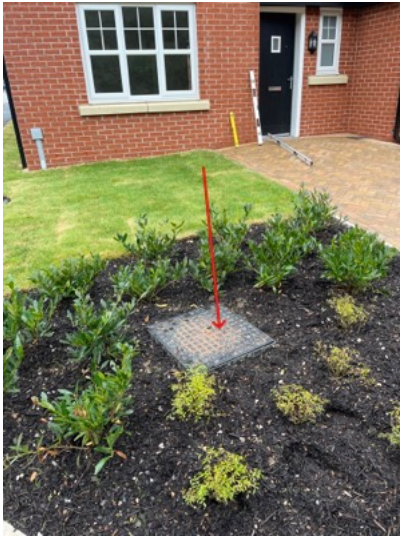
21

External Front
Assigned To
As above - reference

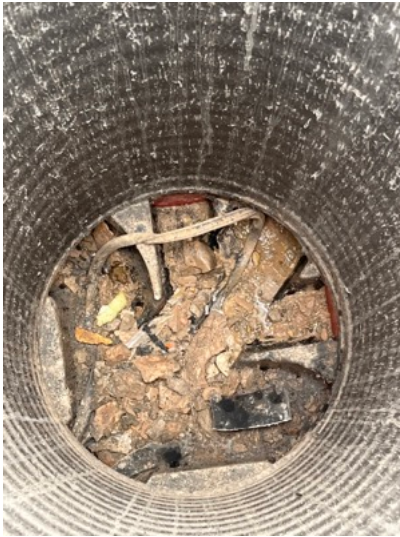
24

Chamber fully blocked including rubber seal

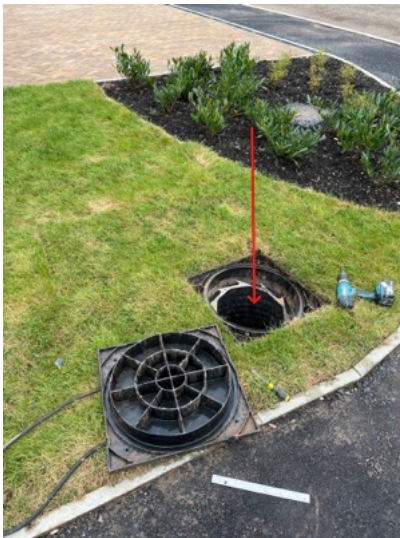
25

As above - reference

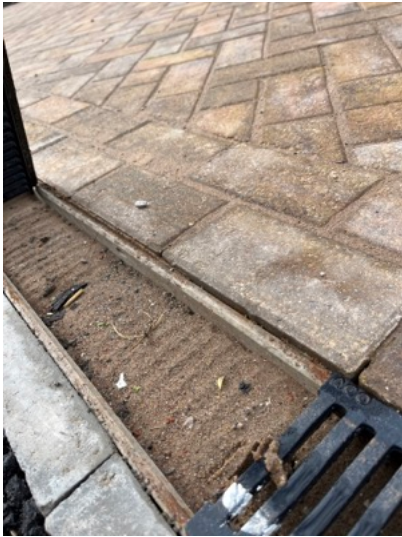
40

Assigned To Groundwork
ACO full

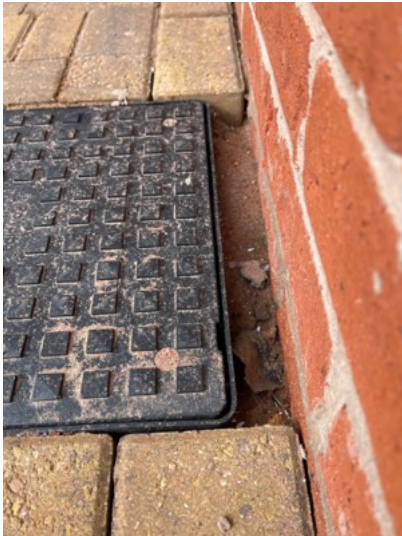
41

Assigned To Groundwork
Gap next to chamber (next to door)

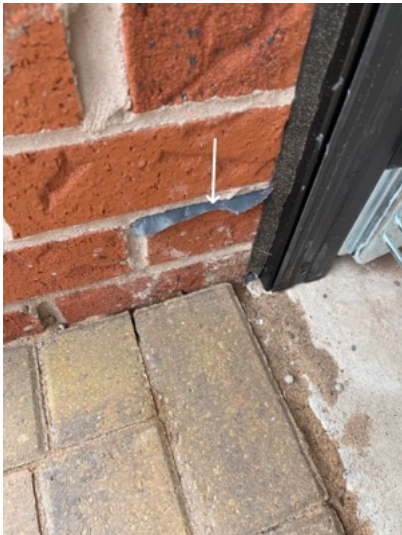
42

Assigned To Brickwork
Trim membrane

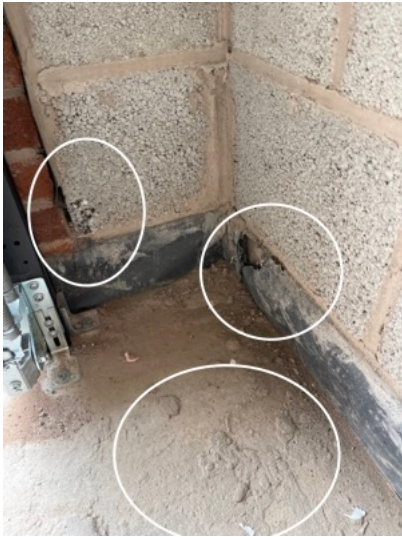
43

Poor finish around the perimeter

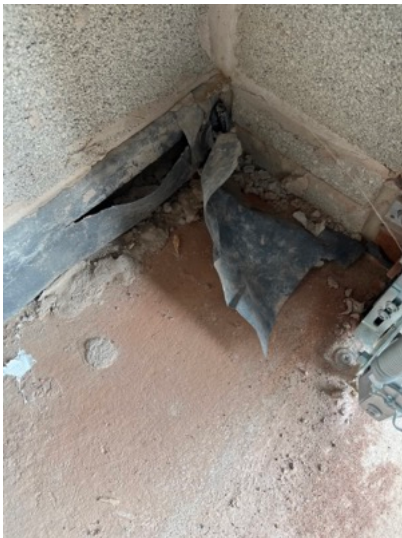
44

Both sides need making good

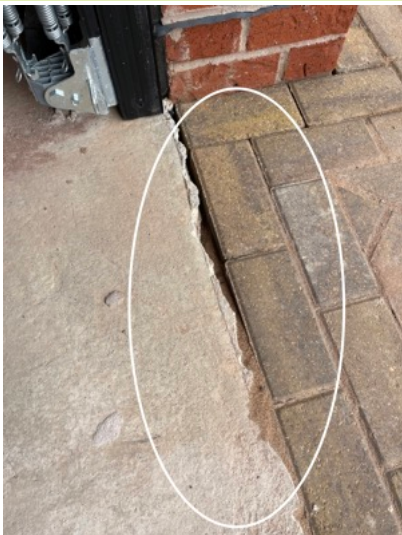
45

Screed threshold rough finish

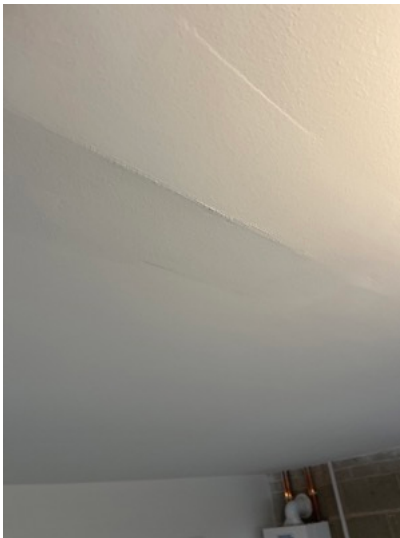
50

Garage
Assigned To Plasterer
Ceiling finish poor
Scrim tape and board lines visible

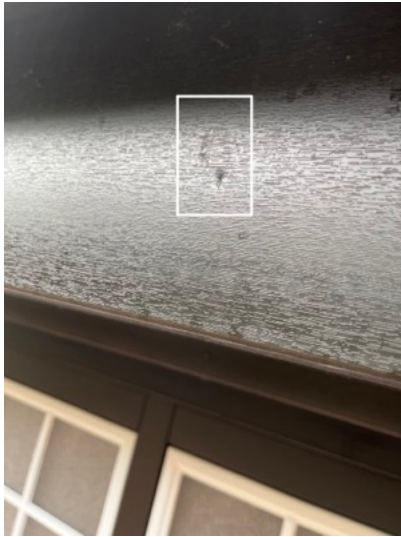
Garage fascia dented

Plastic surgeon to repair fascia

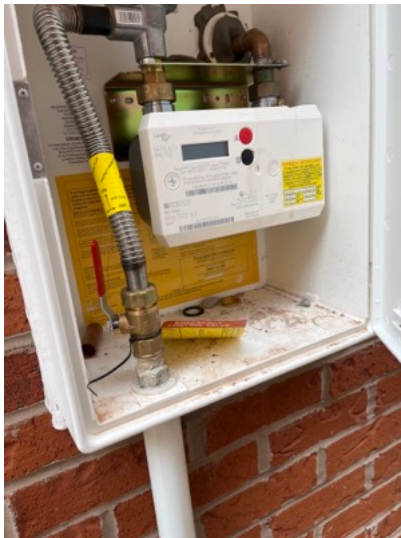
55

No earth visible - confirm if pipe running in the ground is PE (Polyethylene) or copper

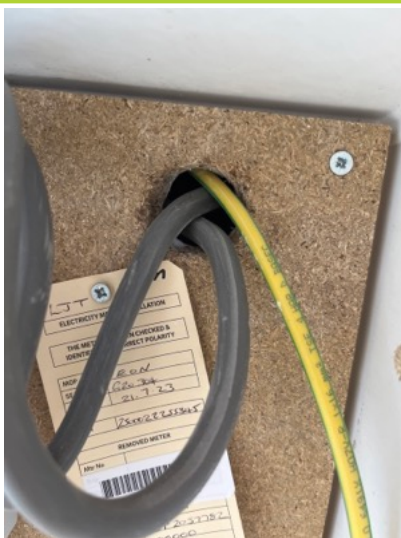
57

Elec meter needs sealing

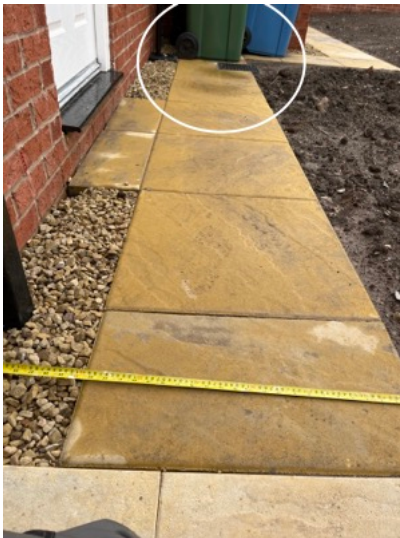
64

The path width is less than 750mm which is out of tolerance for refuge removal

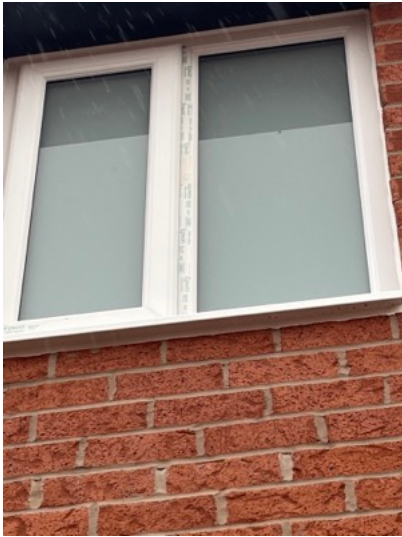
69

External Rear
Assigned To Glazing
Remove wrappers

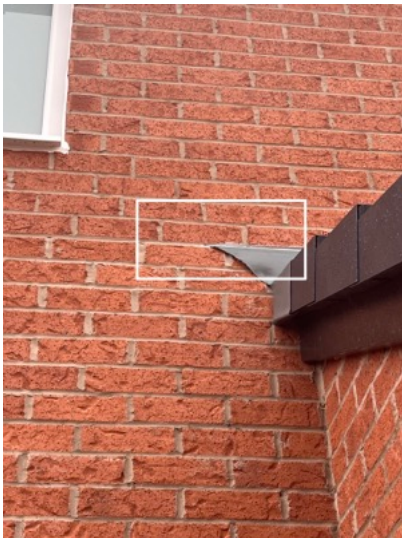
70

Weep vent missing to end of the assumed cavity tray

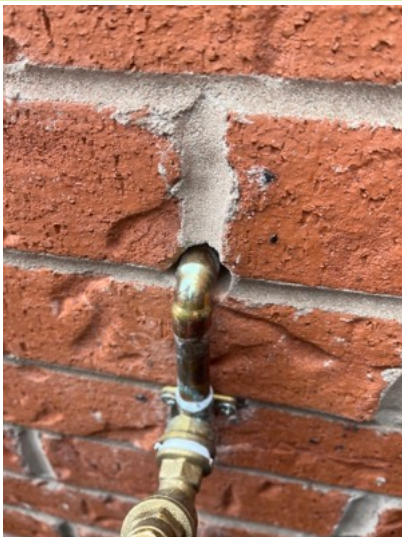
71

External Rear
Assigned To Mastic
Seal gap around tap

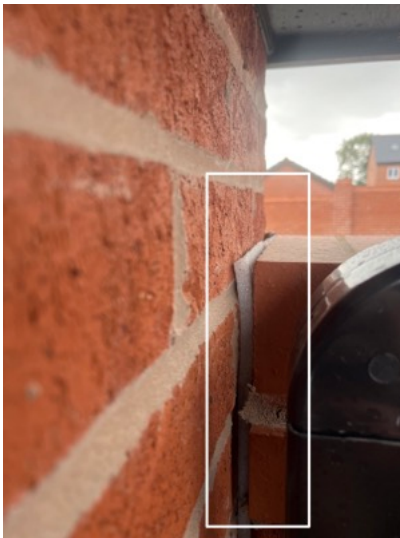
73

External Rear
Assigned To Mastic
The expansion joint at house / boundary
wall has foam fill
Hasn't been sealed & will need to remove
rwdp to do

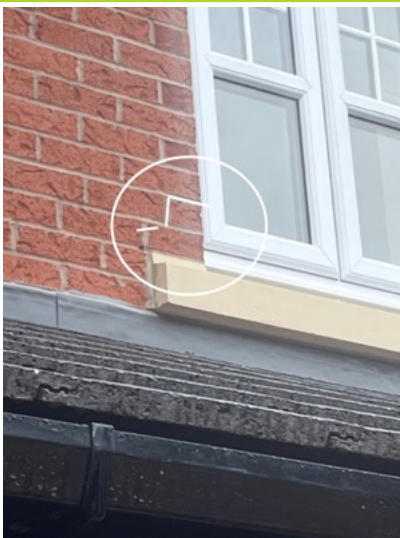
85

Cracking to mortar front bed window

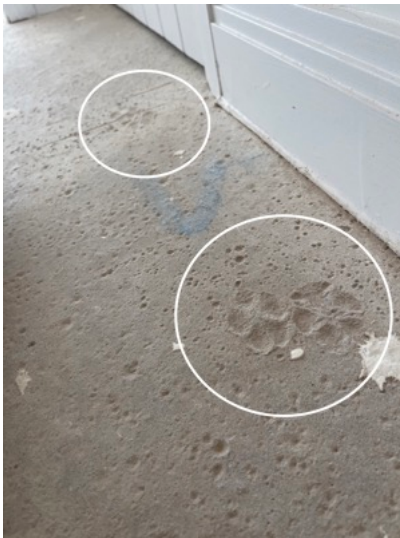
98

Screed has snots, Dents and animal paw prints

Should have a self level screed to allow hard surface flooring

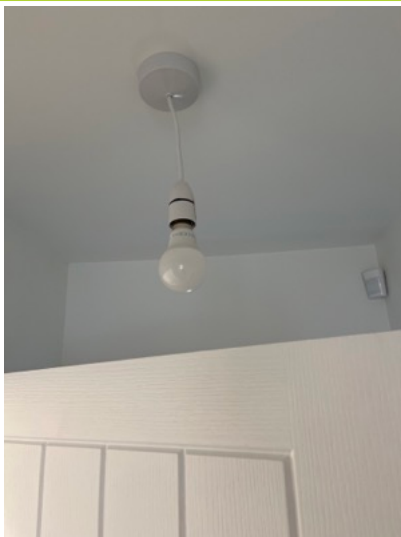
101

Some light pendants positioned above doors - will prevent any shades being hung

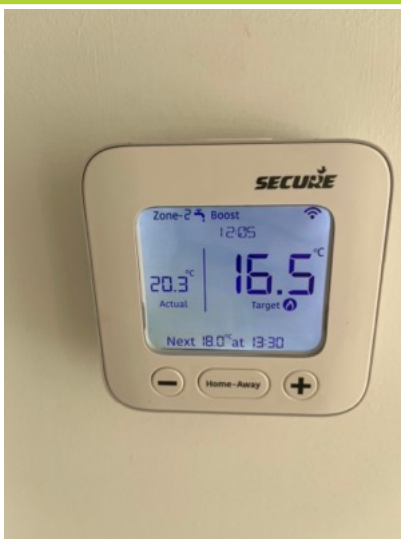
102

I have concerns that the heating system isn't set up correctly. I tested one zone at a time and some rads came on that were on the other zone, some rads didn't come on at all (some raised in this report). Heating engineer to test it thoroughly ensuring zones are correct and all rads working

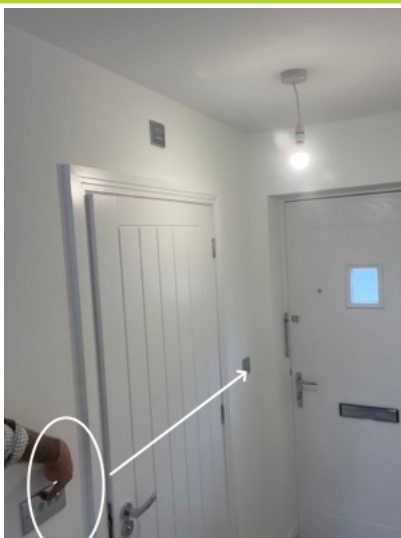
103

The entry light switch is not by the front door which is poor design. Re wire required, chasing out etc but worth addressing as it makes no sense in its current position

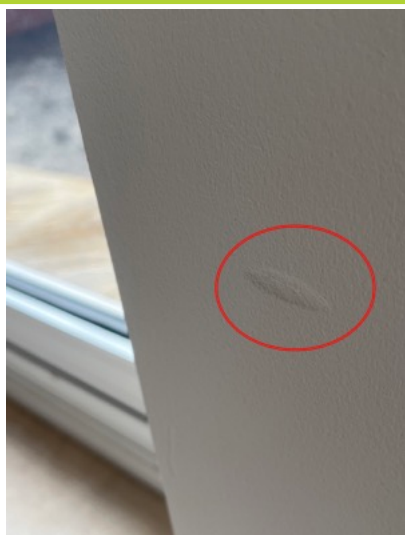
113

Example dent in Dining room

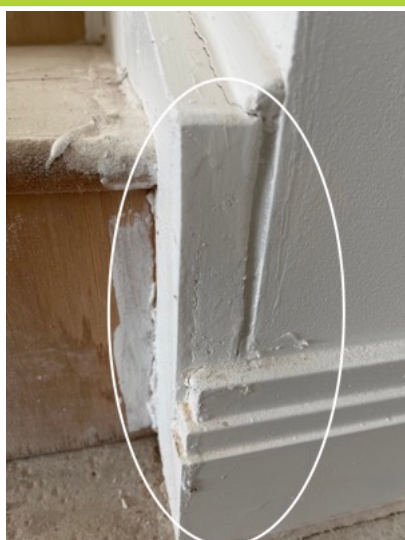
114

Rough finish around staircase

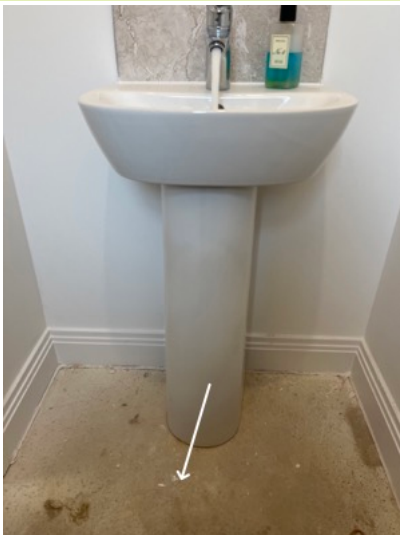
120

Assigned To Plumber
The pedestal is loose

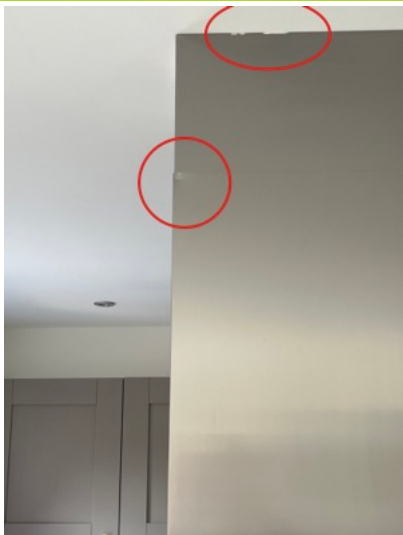
133

Hood dented

Out of tolerance (visible from 0.5m+)

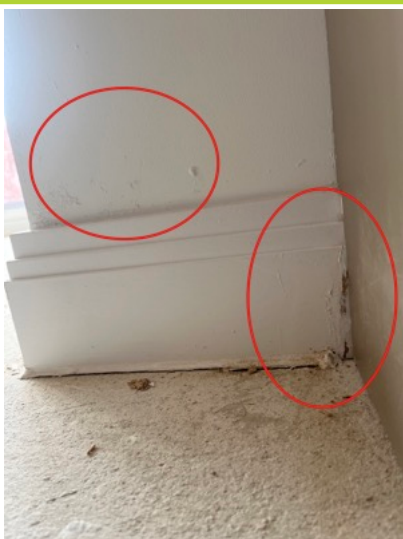
134

Rough finish under breakfast bar

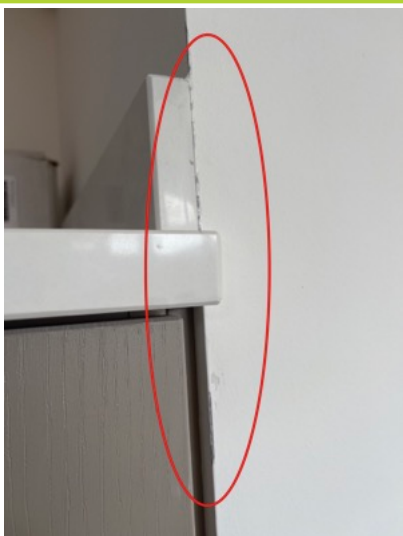
135

Rough finish down the side of the unit edge

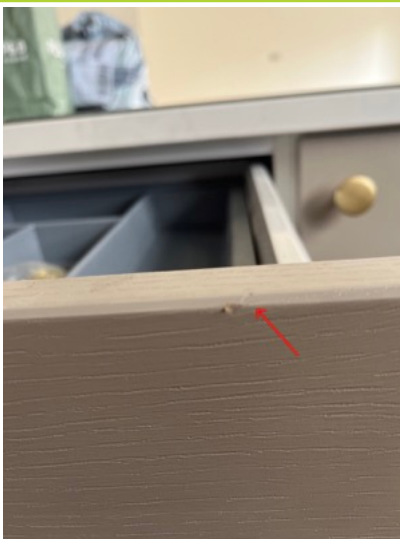
141

Repair drawer

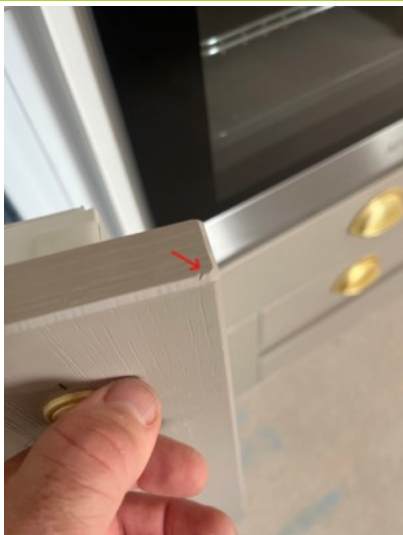
142

Also door near oven

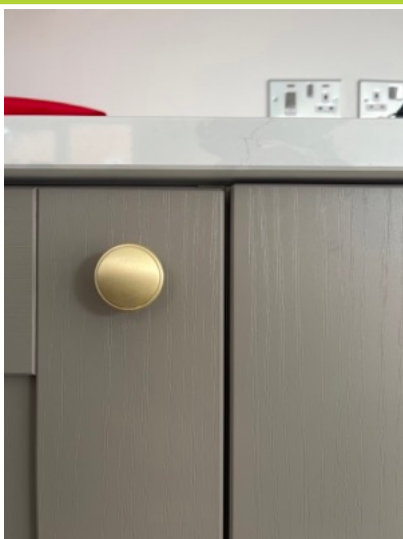
143

Doors aren't aligned

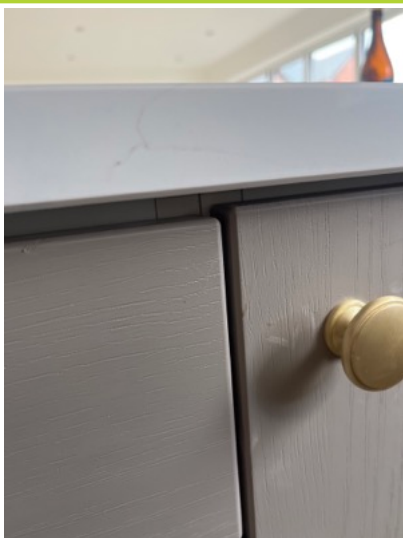
144

Align doors

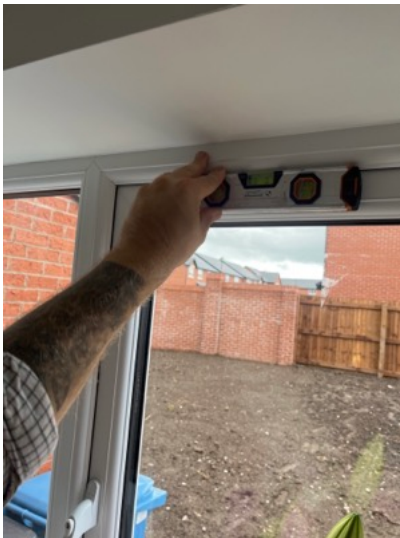
146

The window frame isn't level and it's obvious by eye

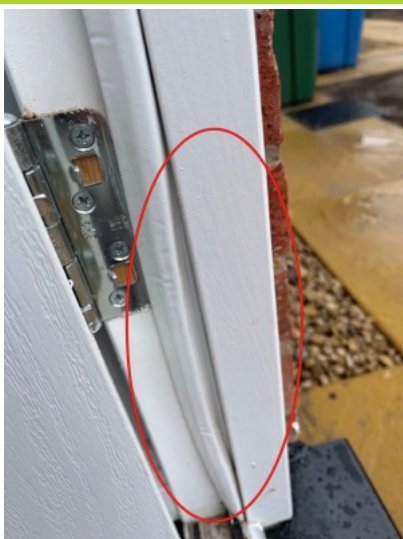
___/___

Seal not secured

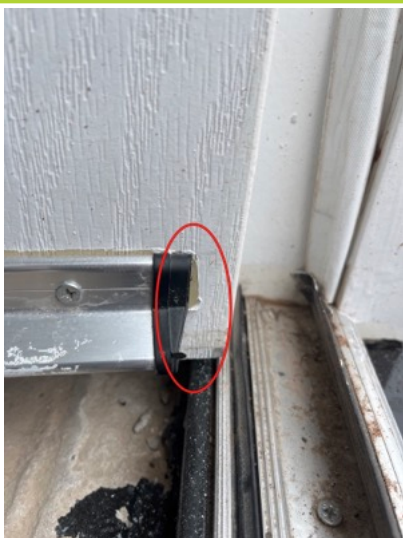
151

Also finish next to weather bar needs tidying

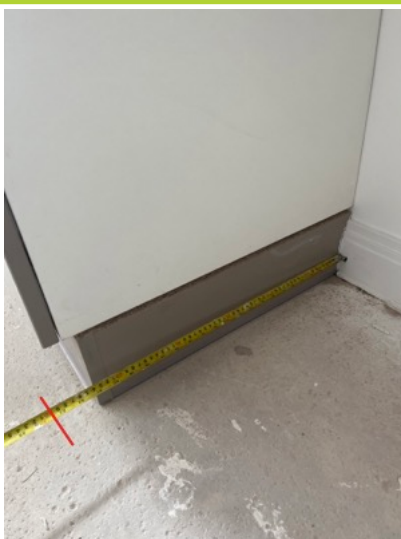
155

Appliances likely to protrude out
Consider removing skirting

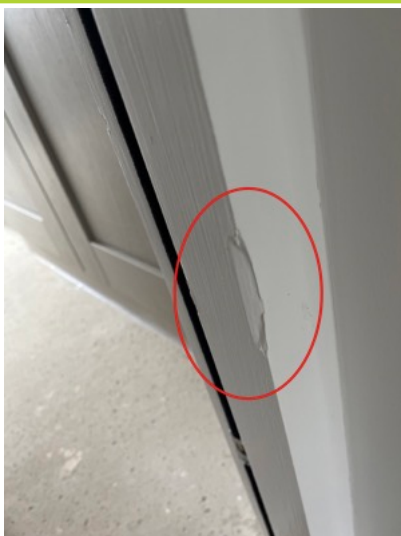
156

Garage door frame tarnished

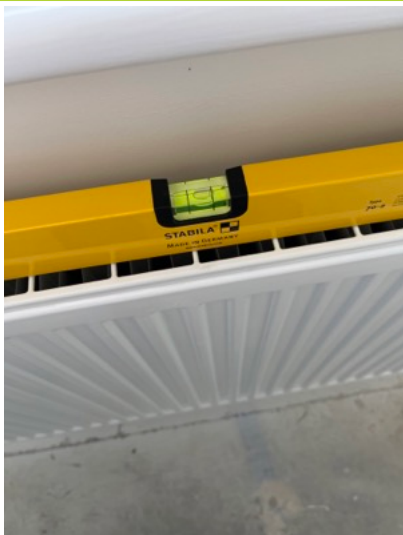
186

Master Bed
Assigned To Plumber
Rad isn't level

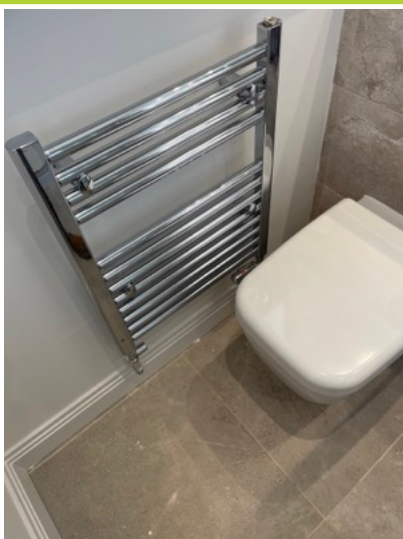
187

Assigned To Plumber
Poor design - the towel rad is too close to the toilet

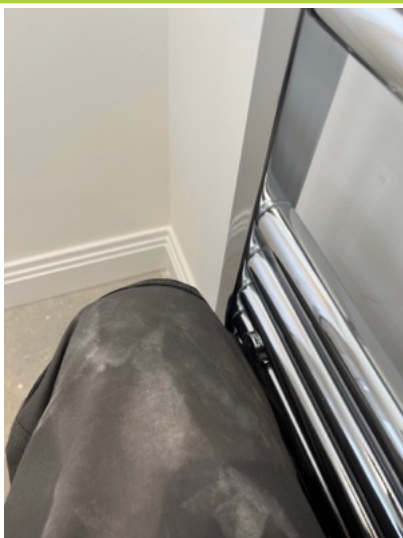
188

Master En-suite
Assigned To
As above

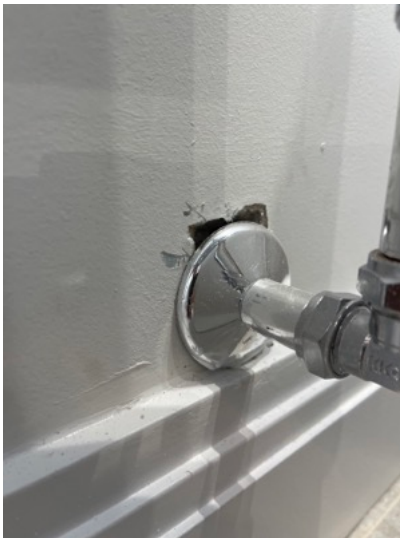
190

Master En-suite
Assigned To Plasterer
Poor finish not hidden by pipe collar

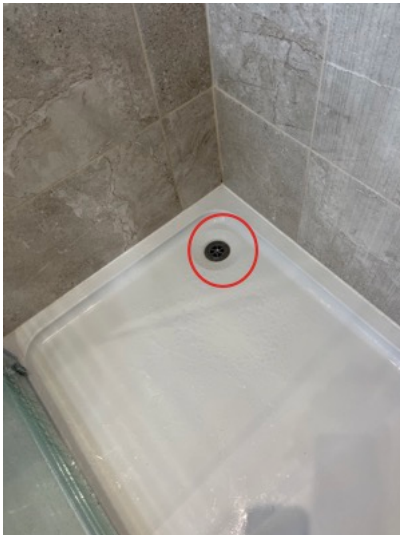
191

Master En-suite
Assigned To Plumber
Missing cap to drain

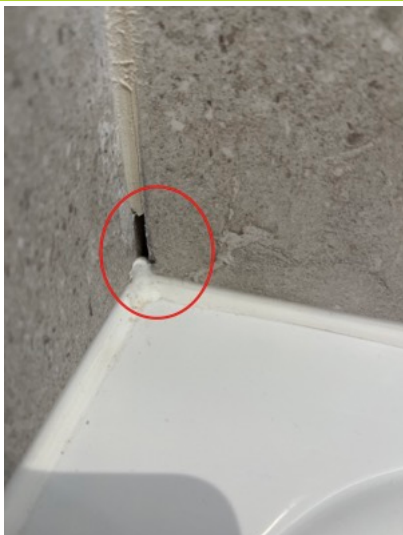
192

Missing grout in shower enclosure

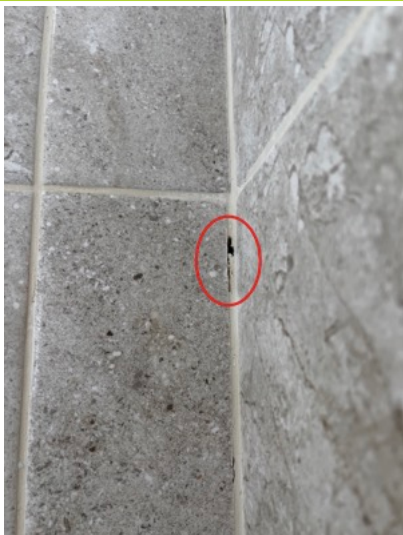
209

Bathroom
Assigned To Tiler
Another example

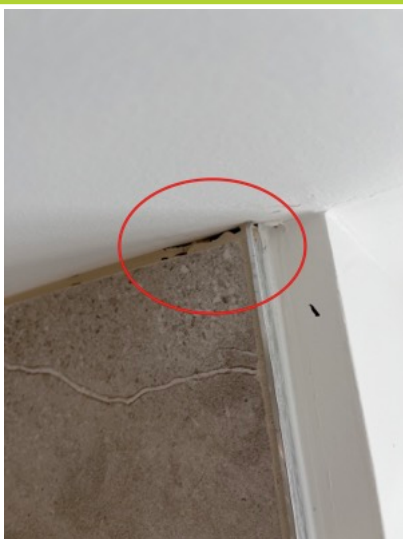
210

Bathroom
Assigned To Tiler
Another example

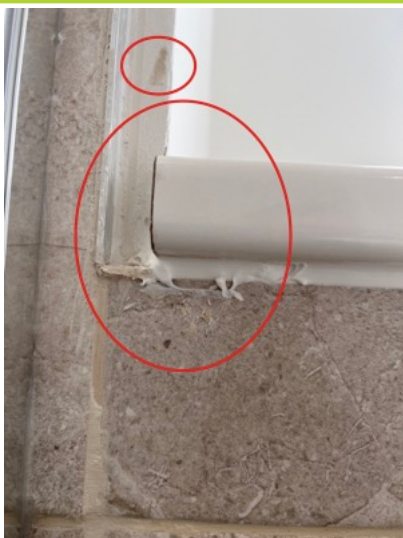
211

Bathroom
Assigned To Mastic
Finish is poor around shelf
