SNAGGING

NEW - BUILDS

A HOMEOWNER'S GUIDE

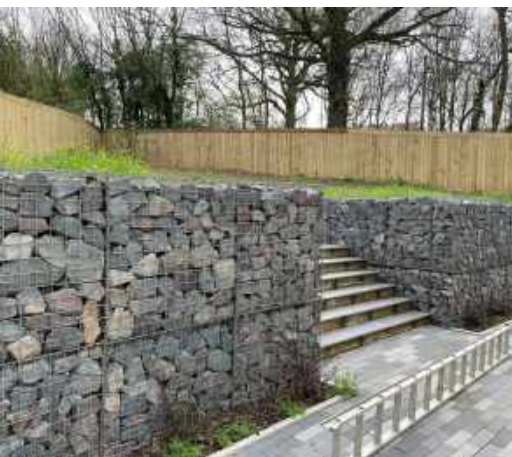
Where ground levels are raised, there should be no fall higher than 600mm without guarding (pic 1).

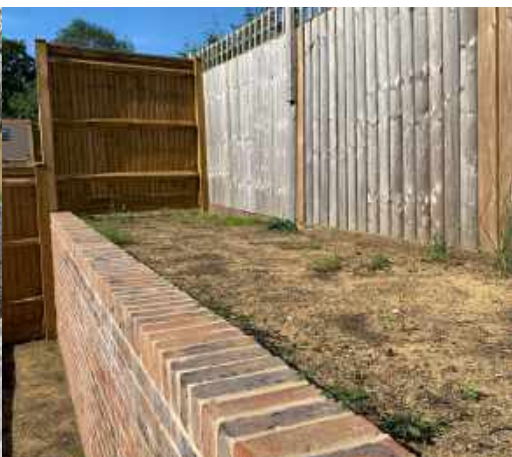
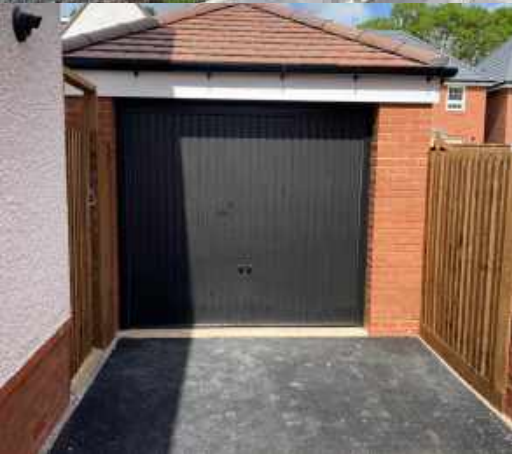
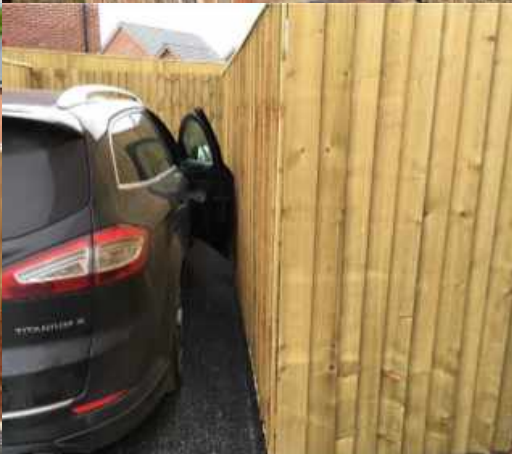
If you have a narrow strip down the side of the house that has been turfed, it will not survive so it should have gravel or paving. Also if you have very narrow, steep banks or raised areas (pic 2), think of how they will be maintained with a lawn mower.

Picture 3 shows a garage that hasn't been installed central to the drive. Also check that paths are wide enough for wheelie bins and you actually have enough room to park (pic 4).

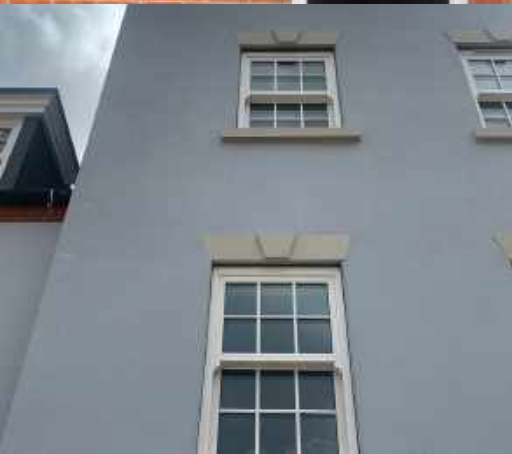
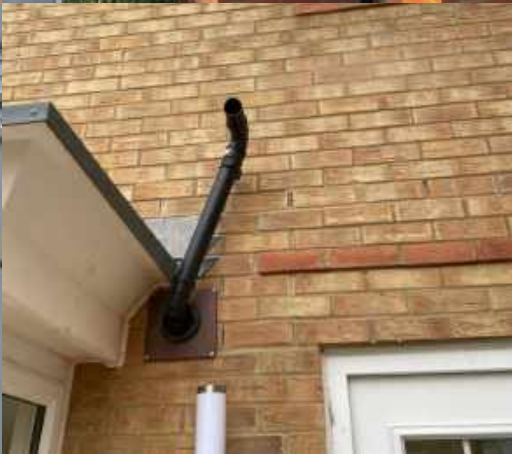
The 3rd picture below shows an example of misalignment of windows. A more common issue with smaller builders is they don't consider privacy in bathrooms, as they should have frosted glass.

If something looks like the trades have had to rectify incorrect detail (such as wrong position of the boiler flue as per pic 4), try to visit other houses of the same house type on site or show home to compare it.

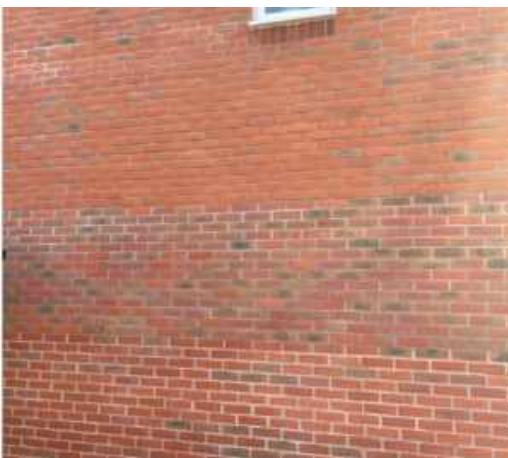
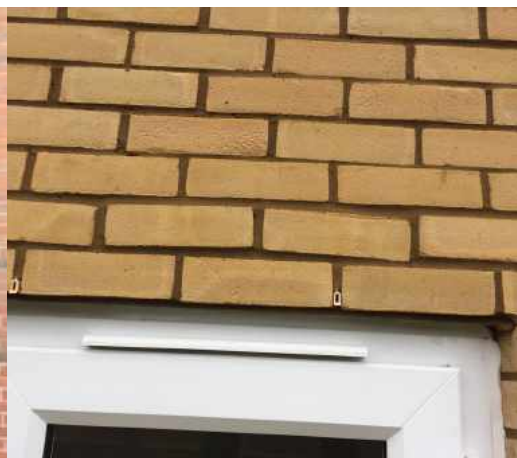
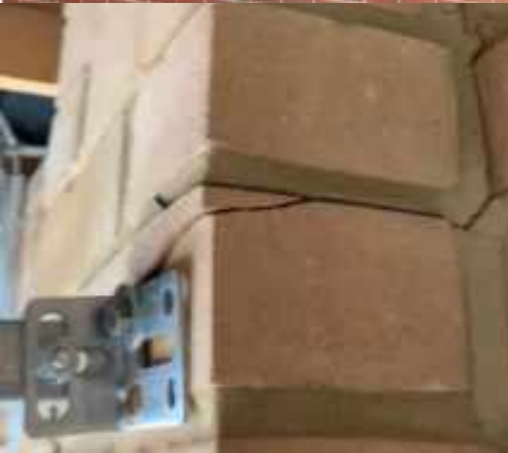
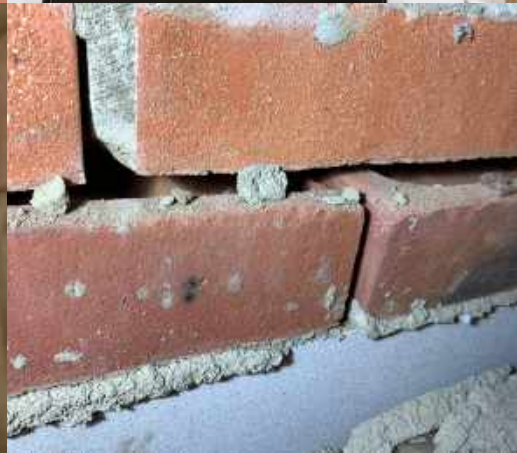
- **banding** (where bricks batches are not mixed or otherwise entirely different bricks used at different storeys as shown below)
- **uneven bricks** which is a sign of rushed or just poor workmanship
- **damaged bricks**
- **repointing** of mortar

Another sign of poor workmanship is unequal perpends, which is the thickness of mortar at the sides of bricks. They should be 10-15mm wide

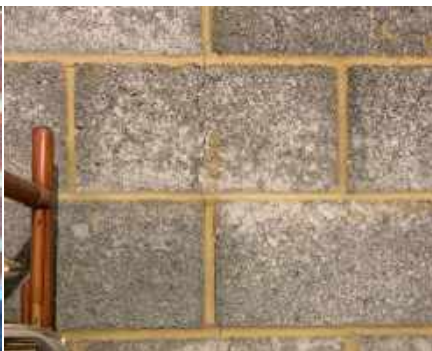
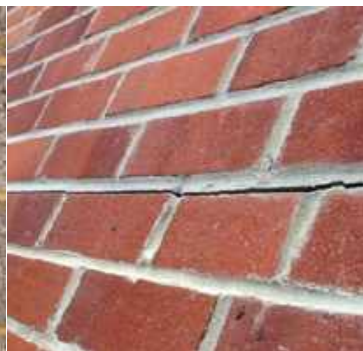
As shown in the first image this is commonly caused by subsidence or heave. Heave is typically caused by an upward movement in the ground due to factors such as the expansion of soil or the presence of water beneath the surface, while subsidence occurs when the ground sinks or settles. Two factors that commonly cause this are when trees are cut down or drainage fails (pipes moving or leaking).

An example is shown on the second picture which is caused by thermal expansion and contraction where expansion joints haven't been provisioned.

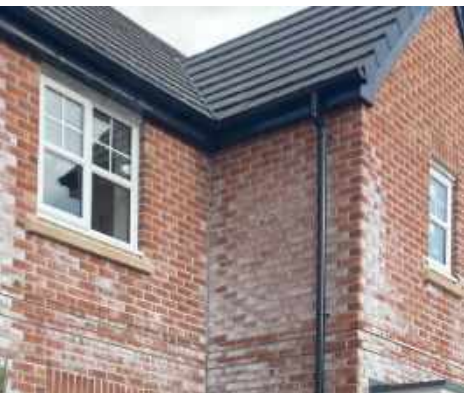
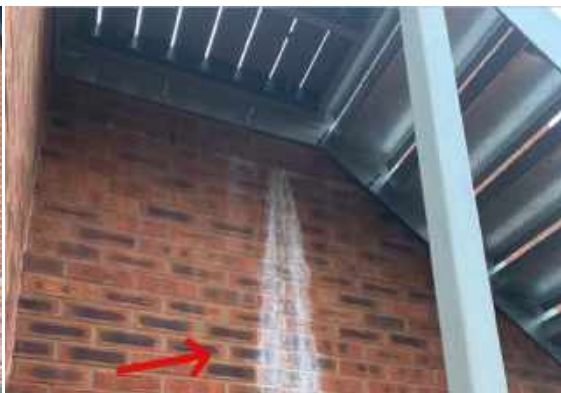
The second photograph shows that it can be a 'warning sign' of isolated saturation such as a leak from gutters onto brickwork or from particular weep vents (explained in a chapter shortly) suggesting excess water in the cavity.

As a rule of thumb in our opinion, if efflorescence is isolated to just a couple of small areas it is not a concern. If it is widespread all around the the house or it suggests constant saturation to a specific area then it should be investigated / rectified by the builder.

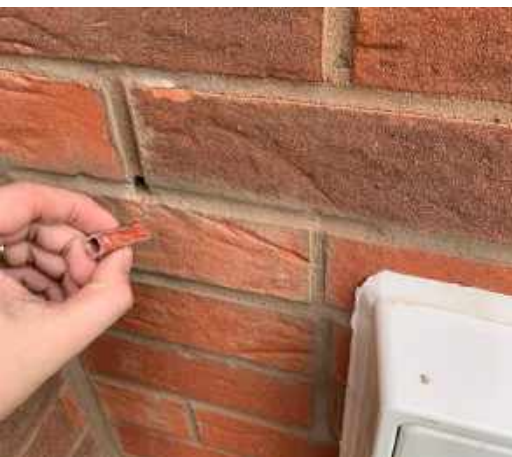
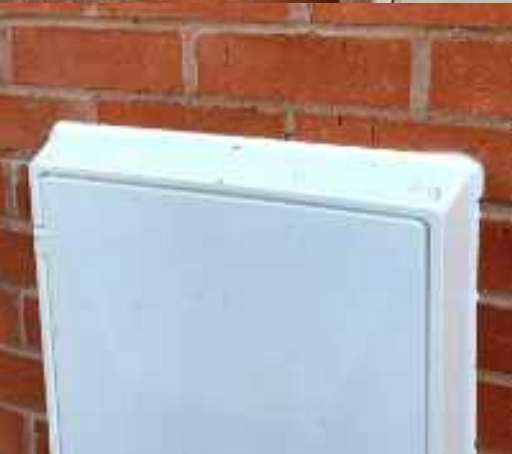
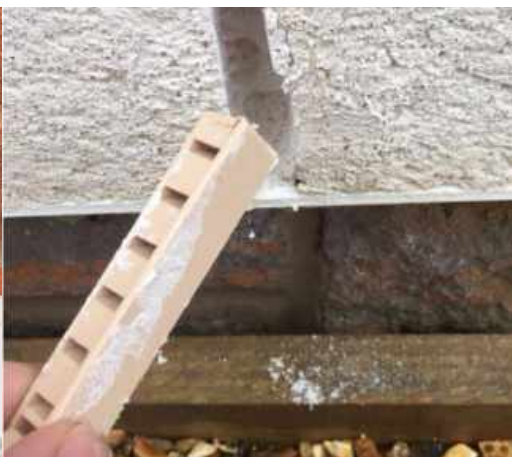
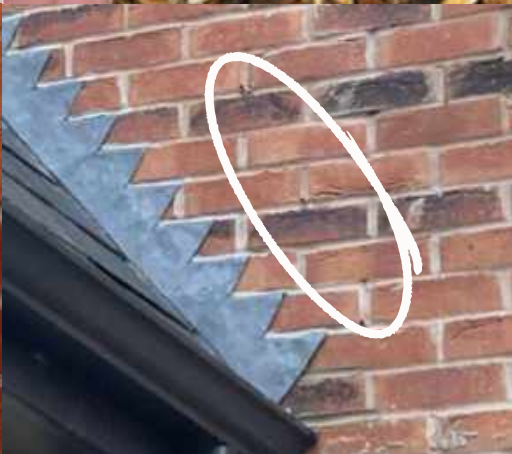
They are located above 'openings' such as external windows, doors, bay or extensions. They should also be above meter boxes (see pic 1 where the weep vents are fake and pic 3 where missing).

Finally, as shown in the last picture it is important that the weep vents are at the correct height to flashings. Lead flashings will be above front door canopies, bay windows and stepped in line with (adjoined) garage roofs etc. Often the weep vents are too high to the flashing suggesting the flashing and cavity tray are misaligned.

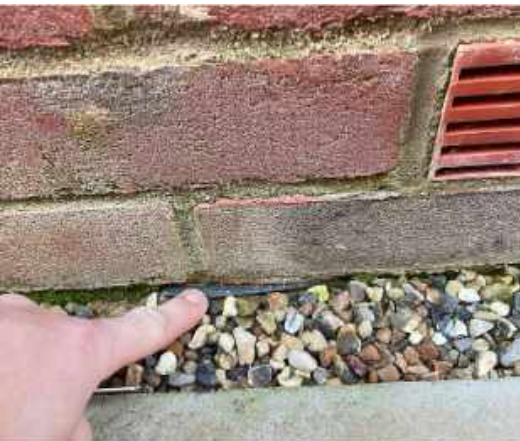
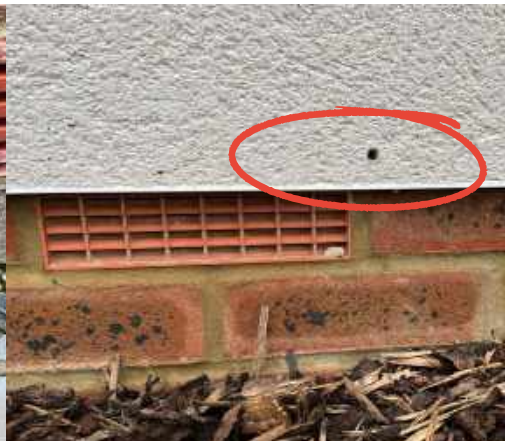
The second photo below shows how the builder have bridged the DPC. This means that the render is lower than the DPC, and so any moisture is able to rise above it.

They have had to retrospectively drill and insert weep vents in the render due to the error, but the issue of rising damp is a possibility regardless.

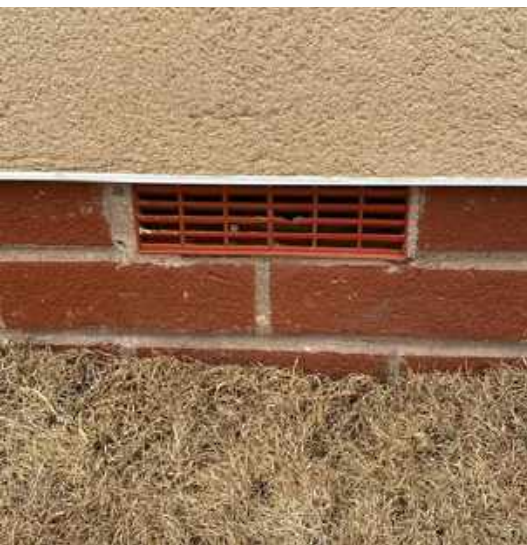
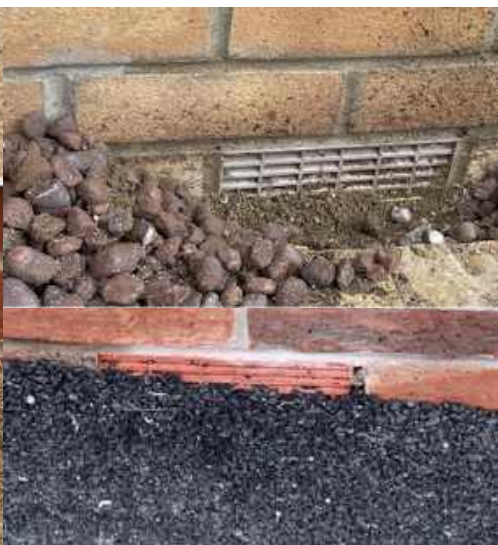
Air bricks are vents that are installed at low levels in the walls of a building to allow for air flow and ventilation with houses with suspended floors. In new build properties, air bricks are an important feature that helps to prevent damp and moisture buildup inside the sub-floor.

It is particularly important to identify air bricks that too low and next to hard surfaces such as tarmac driveways, as rainwater is likely to easily enter and cause issues in the long run (see last image).

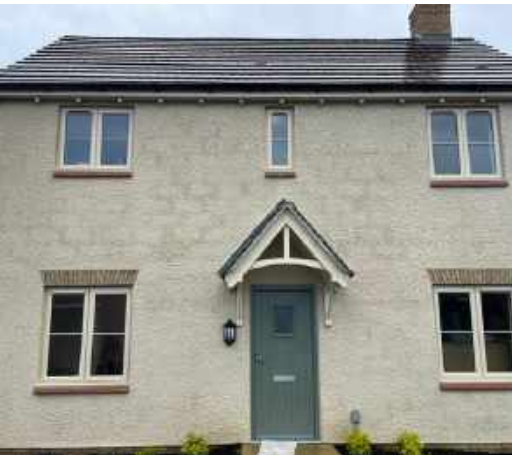
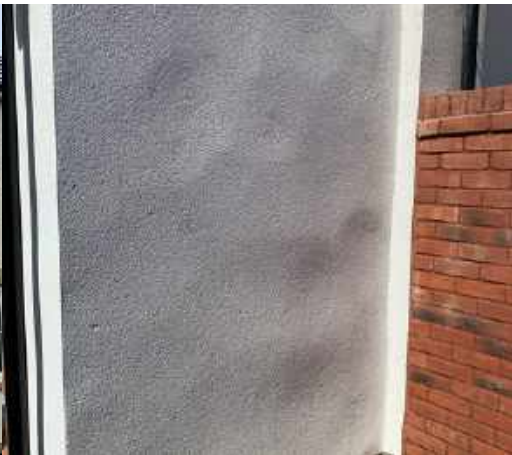
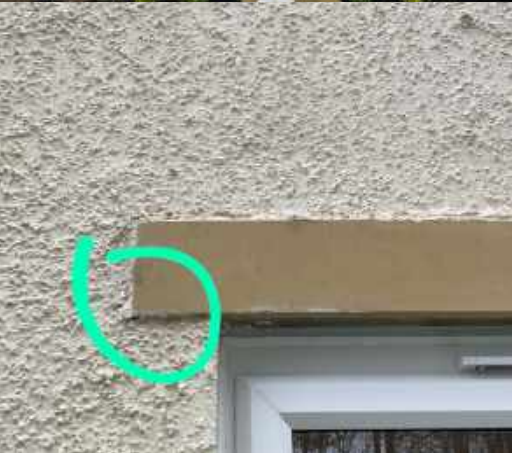
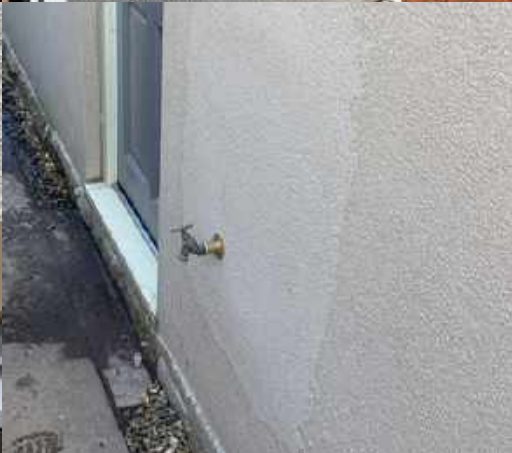
Other than poor application or repairs, render can experience ghosting and crazing. Ghosting, a form of efflorescence, is where the blocks become visible (see pic 1). Crazing, on the other hand, appears as a network of fine cracks on the surface of the render, and is often caused by a lack of curing time or over-troweling. Most houses will have expansion joints to prevent vertical cracks from thermal expansion so check this is installed if you have a large or adjoined house.

The most common issues we find are when the finish is uneven (pic 2), the weep vents have been entirely covered (pic 3) or repairs aren't flattering (pic 4).

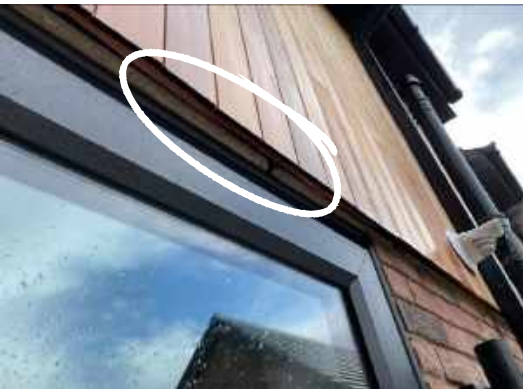
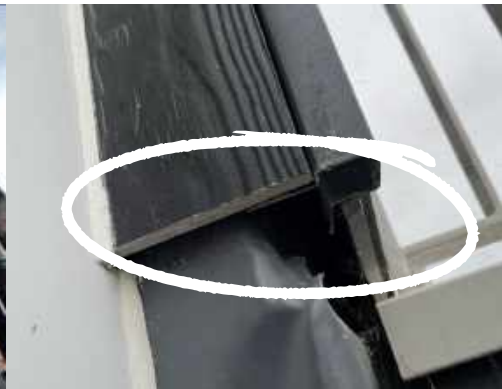
- missing trim
- excessive gaps

These issues make it susceptible to insect and birds entering and potentially causing damage.

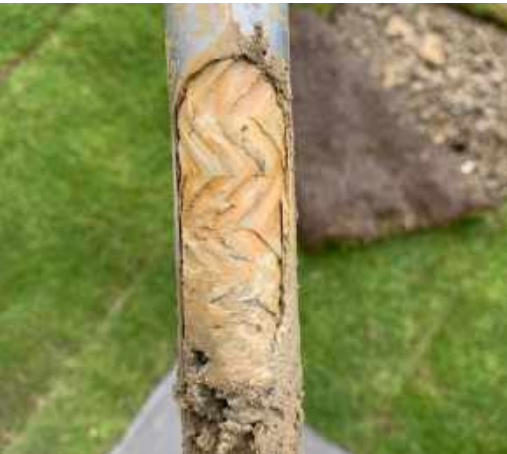
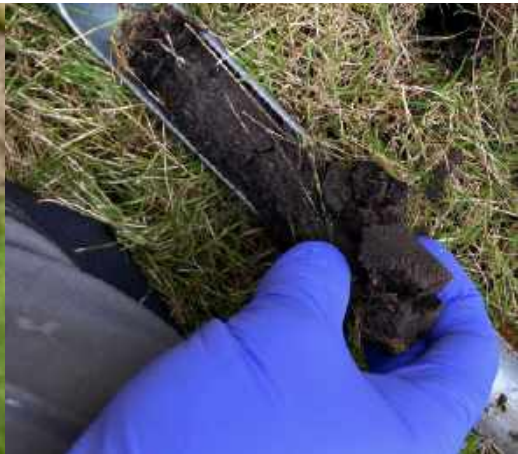
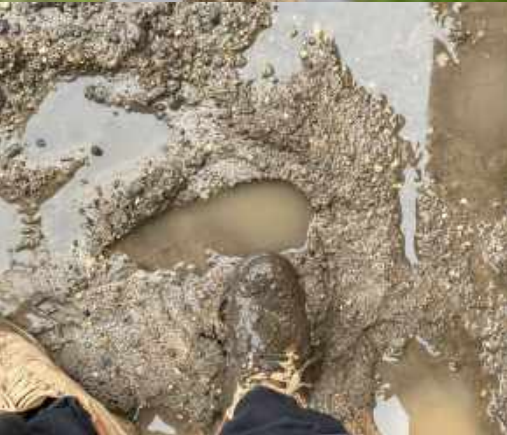
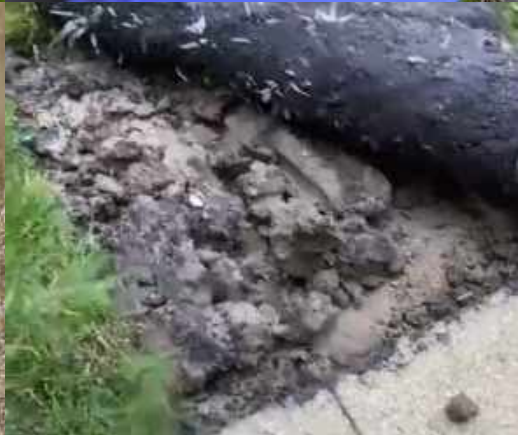
This is the uppermost layer of soil, which contains most of the nutrients required for healthy turf. We use a soil probe to check the consistency; see Pic 1, which has a heavy clay consistency in the layer that is meant to be topsoil. You can use a garden trowel or small spade to check the clay consistency quite easily: dig and remove a small section about 10cm deep and inspect the soil by pressing your thumb into it. It should crumble as shown in the 2nd picture, but if your thumb imprints into it (i.e. feels like plasticine) then it is heavy in clay; a cause of boggy lawns.

Boggy conditions tend to only be noticeable during the Autumn and Winter months due to the higher levels of rainfall. A boggy lawn is a sign of either inadequate drainage being provisioned if the topography requires it, or soil heavy in clay consistency. We suggest first checking the turf for clay, and then consider inadequate drainage as the cause when approaching the builder.

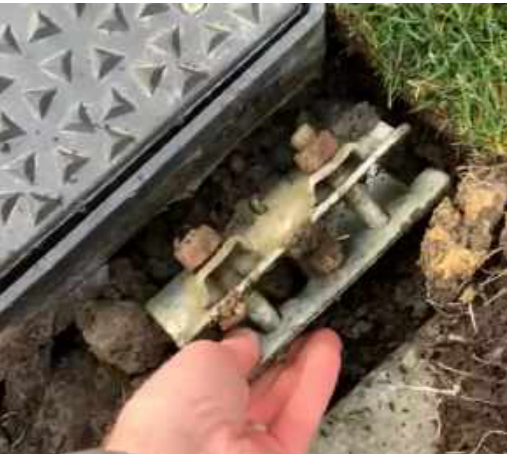
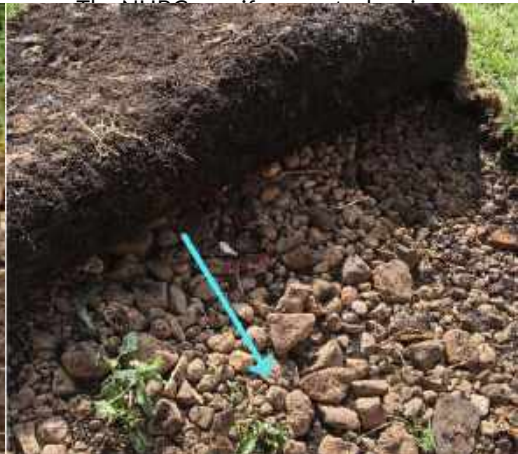
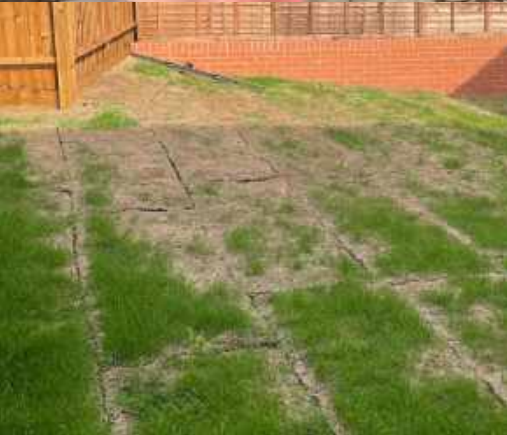
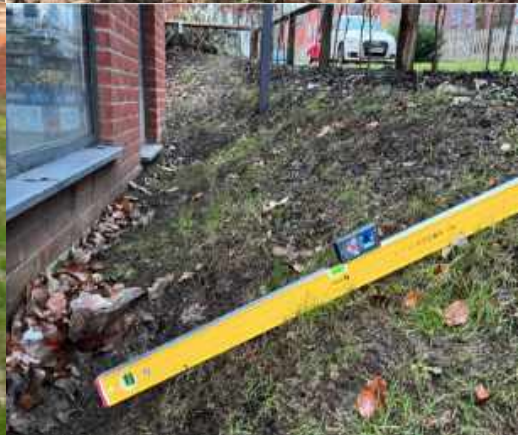
Any stones or debris can create an uneven surface but also it will mean the turf will not thrive. Common areas for stones and debris to be found is next to paths, inspection chambers and fencing. Stones are the most common culprit but we have found an array of items as seen in picture 1. If you have newly laid lawn by the developer, try not to walk on it to avoid imprints so either spot-check where you can reach from the path or wait a few weeks, as any areas that doesn't thrive will turn yellow.

Steep gradients towards the house (such as pic 3) are also more likely to encounter pooling rainwater. It can look poor and unlikely to be enjoyed recreationally (see pic 3). In this instance it is recommended to install retaining walls that will allow for flatter lawns. The NHBC state that the gradient should not exceed 1:6, and the way in which we check this on our surveys (as shown in the 4th picture) is to use a level with a 'disto' laser measure placed on top which detects gradients.

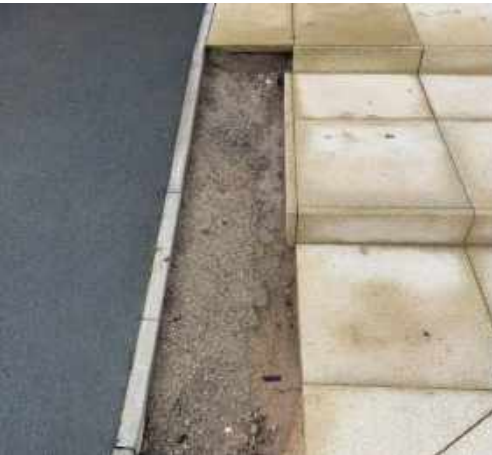
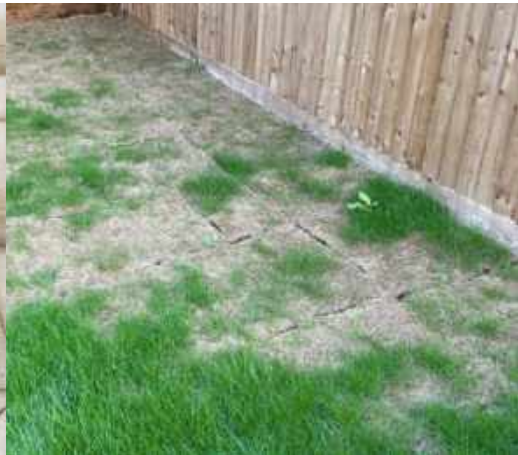
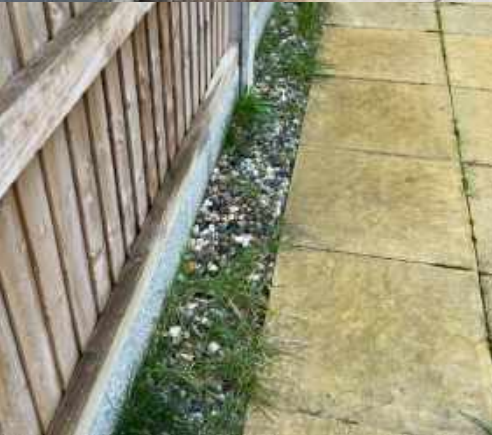
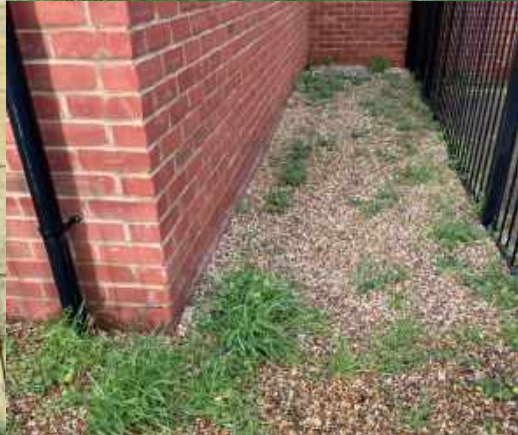
A steep lawn will be impractical to mow as well as hazardous to walk over and you want to ensure that the inspection chambers are at ground level to the lawn to ensure the blade of the lawn mower does not catch it. For any narrow sections (e.g. pic 1), ideally it should either have weed membrane laid and stone or bark added rather than adding turf, as it isn't practical to maintain. If you have moved in to a property in summer with newly laid turf, it is important to water regularly to prevent it drying out (see pic 2).

Where there is mulch / bark chippings, these areas are often not properly prepared as seen in pictures 3 & 4. They should have weed membranes before the decorative layer is poured on, so if you have any areas like this we recommend scooping some away to check if it is laid underneath.

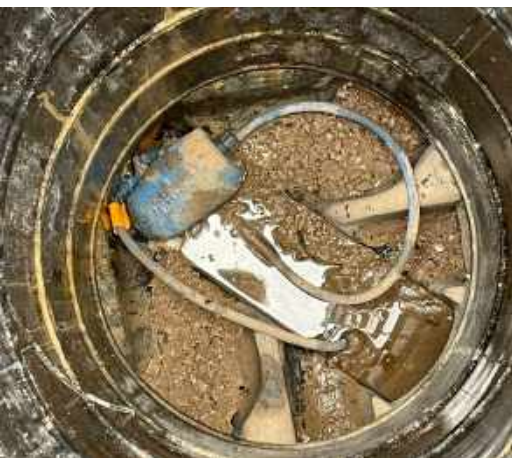
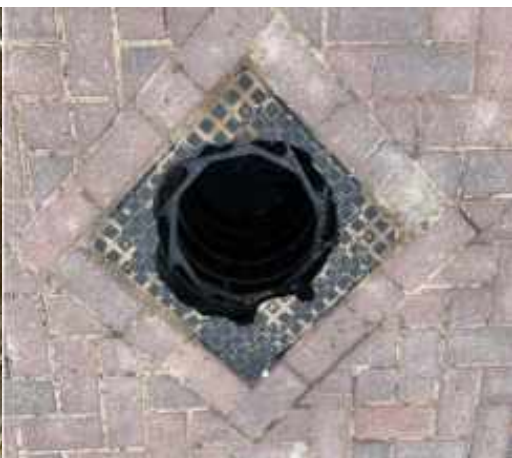
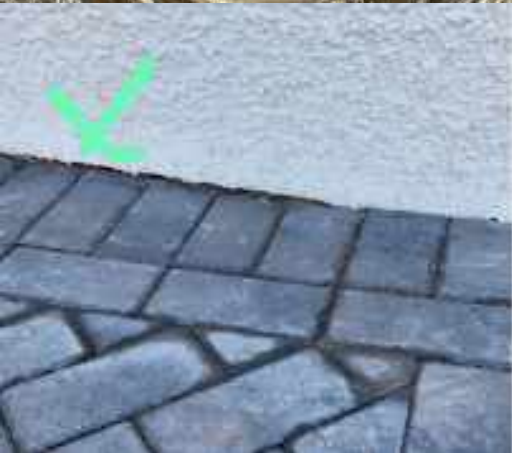
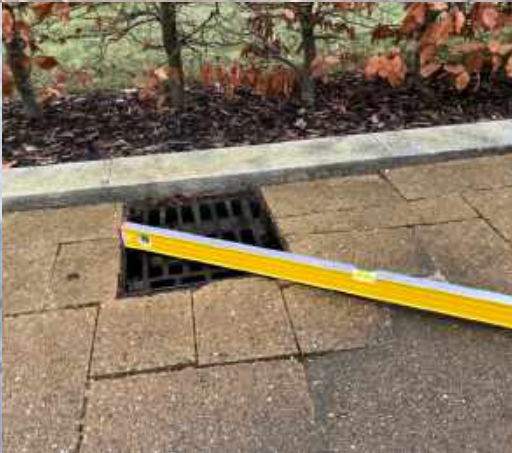
These are access points to check junctions of drainage pipes, and to allow them to be rodded if blocked. An example of a blocked drain is shown below (pic 1) which is very common. Waste pipes should have a 1:60 fall which is shallow enough for toilet paper and solids to run with the water rather than be left behind. The chambers should also be level with the surrounding grounds. We recommend removing the chambers to inspect if safe to do so (caution advised as some can be heavy-duty).

Ground levels can be too high (pic 3, and also refer to brickwork DPC), and uneven grounds will see rainwater pooling and not drain away (pic 4 showing the rainwater drain is high)

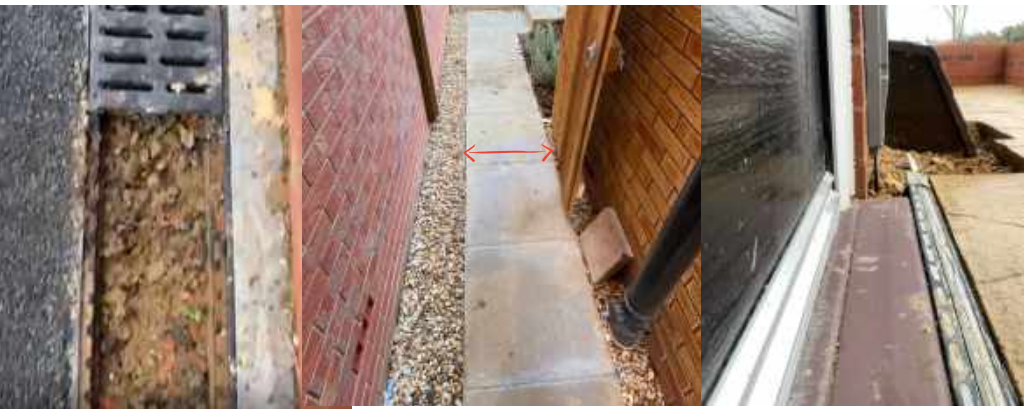
It is important to consider how excess rainwater will cope around the front and back door thresholds which have a level access (ie. are the same height as the ground rather than stepped up). At the least, there should be a slight gap between the paving slabs abutting the threshold to allow rainwater to drain, or ideally install a brickslot. These are a smaller version of an Aco drain but the main difference is that a brickslot does not need to be connected to the drains; it just needs to divert water away from the door.

Paving abutting aco or drainslot channel drains should be 5mm above, as does the threshold the other side of it. The second picture provided below shows a brickslot which still has its protective wrapper on, but the issue is that the threshold is leaning in to the door, so rainwater that lands between the door and brickslot will likely pool and find its way in the property.

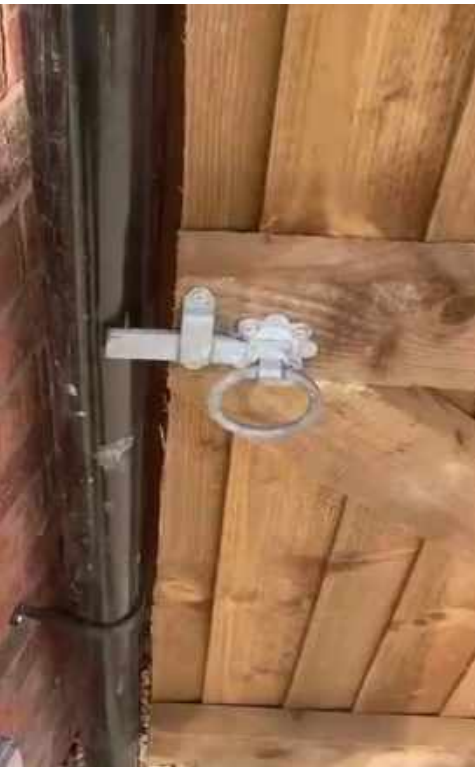
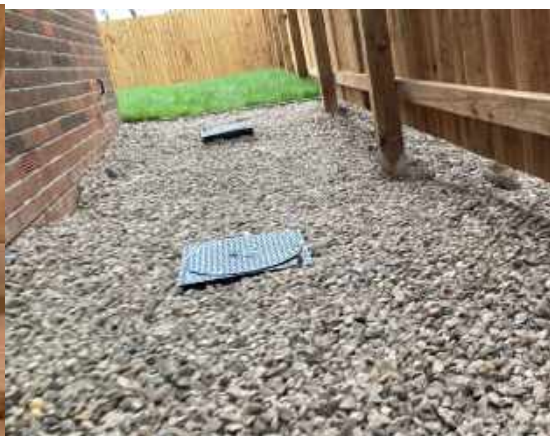
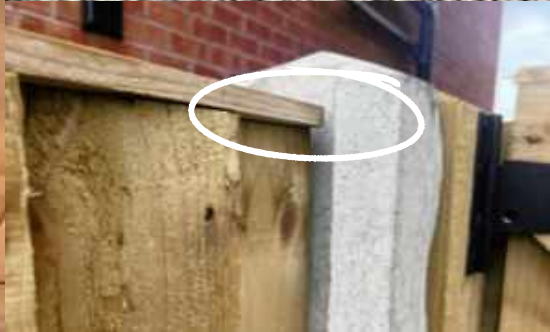
You'd think the basic function of being able to close and lock a gate are taken as granted, however most of the time we find an issue. Often the gate posts aren't aligned plumb so there is an unequal gap which causes the gate to be twisted. Other common issues include the gate coming in contact with objects (pic 1), the latch bending or coming off due to wind smashing the gate, the bolt not aligning or large gaps underneath as shown in pic 2.

The posts should be plumb and secure so spend 1 minute walking around applying slight pressure to the posts to ensure they will cope under heavy wind conditions. If you have concrete posts, a common issue is for the fence panels not fitting flush so they rattle loudly in the wind (see last picture below for an example of this).

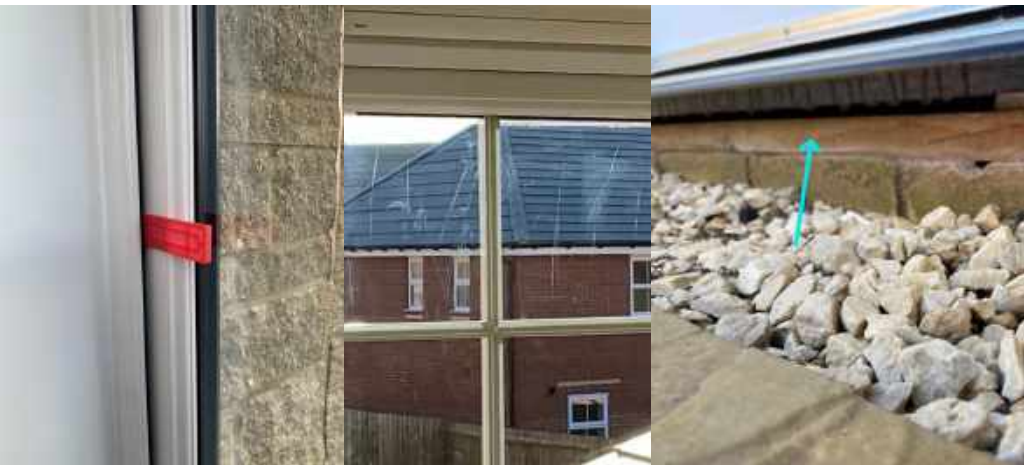
Whilst checking they operate, check for any cracks or scratches in the glass and frame. Unfortunately there is no way to easily repair glass, so any scratches longer than 25mm is considered out of NHBC tolerance so will require the glass pane replacing. It is best to inspect glass when the sun is out as it will highlight any scratches (see pic 2).

It is common for sealant around windows to be untidy and particularly common for mastic to be missing entirely underneath external door thresholds as shown in the third picture below.

Occasionally the sections of windows (known as the mullion, transom and glazing bars) are not straight or level. Also the edges of the glass will have plastic trim that is often not cut to size so there are sharp edges at the mitre join or they bend out.

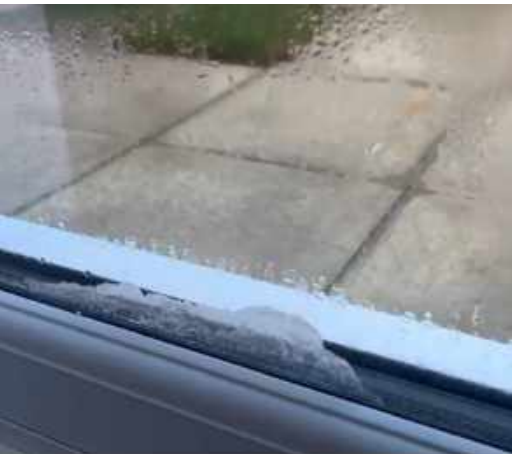
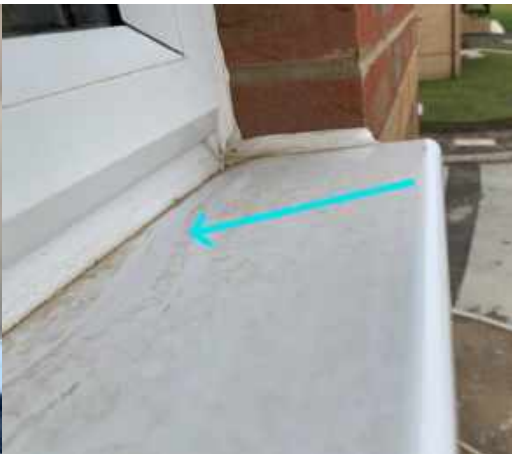
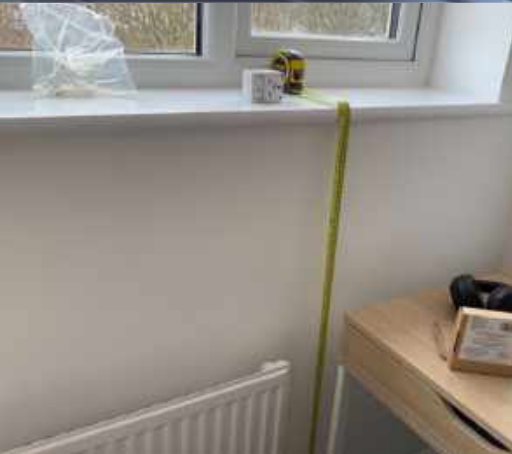
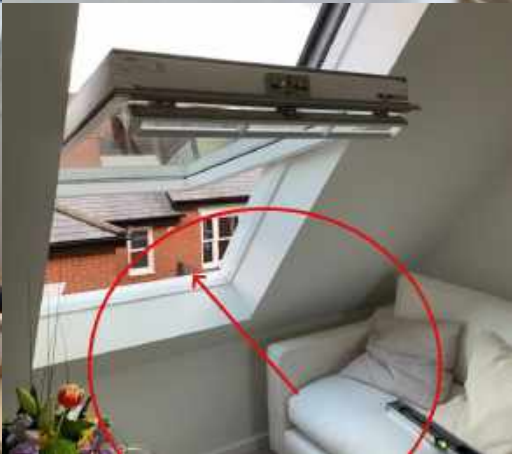
- privacy: is the glass in bathrooms and WC's frosted?
- blown inside the double glazing: the beads or moisture may be visible as shown in the first photograph
- the window sill leans in rather than out to prevent rainwater potentially seeping to the reveal inside (second picture below).
- The height of windows being too low or too high

The height of windows in a 2 storey home should be no less than 800mm but not higher than 1100mm (see picture 3 below). In a 3 storey homes and apartments the windows should have restrictors as the exit in a fire is from the staircase and not the windows. Picture 4 shows a concern of a child being able to climb and fall from a low-level velux window on a 3 storey house. This should not be able to open more than 100mm wide.

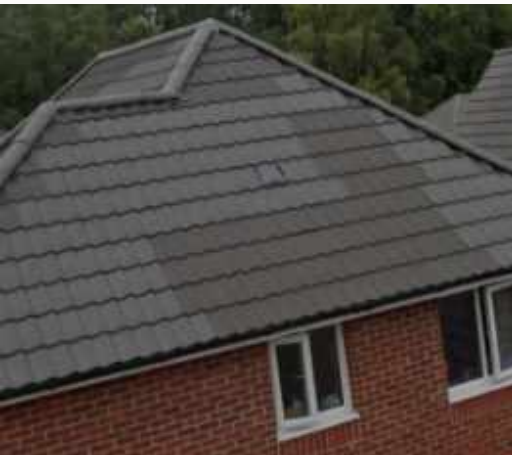
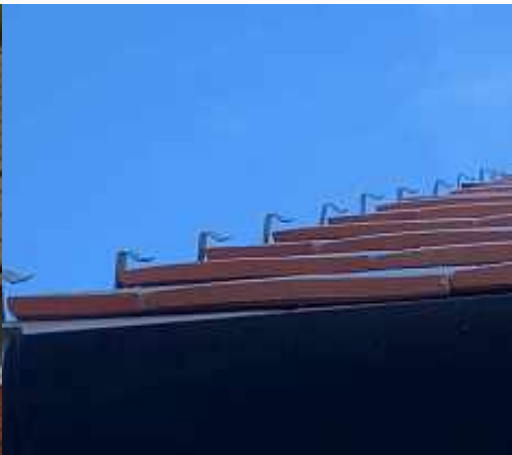
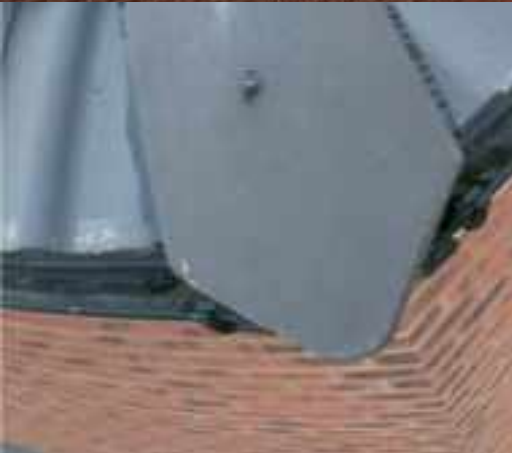
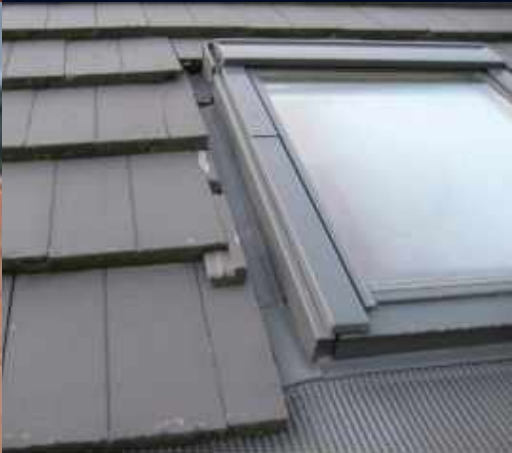
- Different batches of tiles (pic 1)
- Verge clips not in contact with tiles (pic 2)
- Dry verges (plastic caps) not secured
- Gaps to soffits, fascias and bargeboards more than 10mm
- Hip tiles over projecting (pic 3)
- Ridge or Hip tiles not screwed in.

Also on roofs with velux windows, often there are narrow tiles which come away (see pic 4). To avoid this the roofer should use 1 and a half tiles that are cut to size.

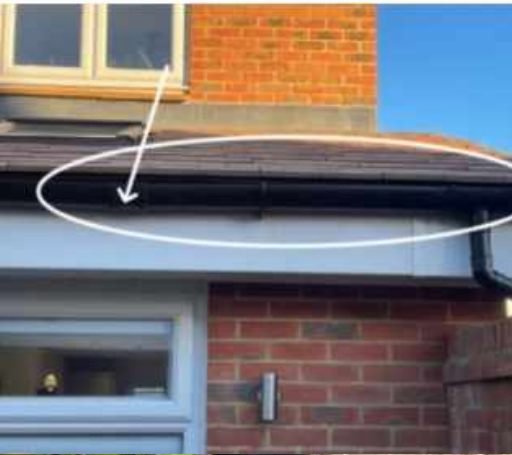
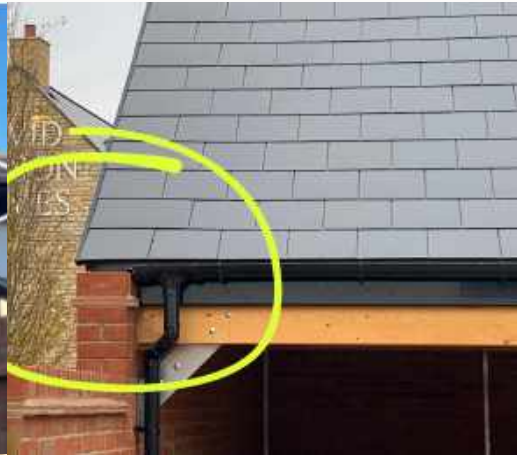
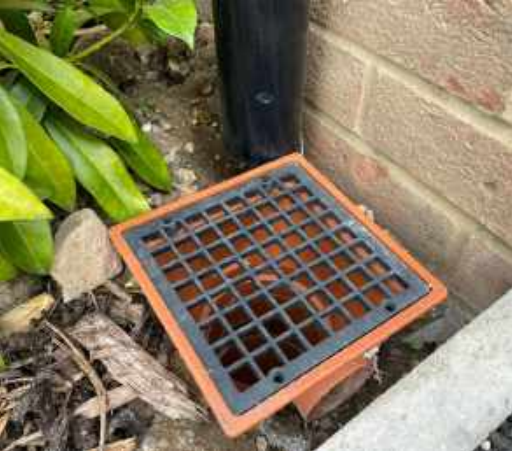
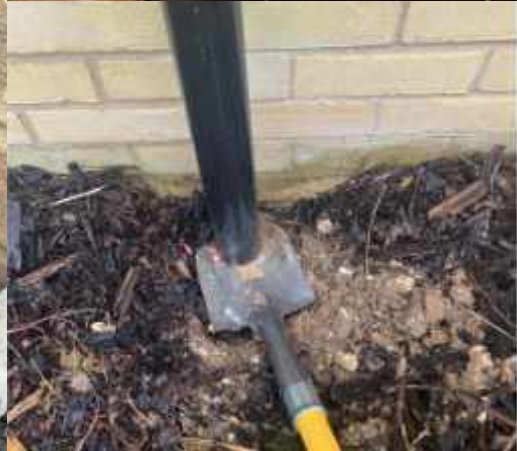
It is best to try and inspect how the gutters and downpipes react by inspecting in heavy rainfall, although signs of blocked gutters can be apparent by isolated pools of water the morning after. Reasons for gutters leaking include: having leaves or debris in them, the tiles do not overhang into the gutter properly (they should project 50mm into the gutter), there is a gap, or the gutter tilts / is twisted. It is also important that they have a steady gradient toward the nearest downpipe and don't have dips. Picture 1 shows this issue.

Sometimes as shown in the second picture, the gutter doesn't even extend out far enough. It is also surprising the amount of times that we find that rainwater downpipes are not connected to the drain, as shown in the third and fourth picture below. The volume of water from the roof will cause saturated grounds and potentially cause structural issues.

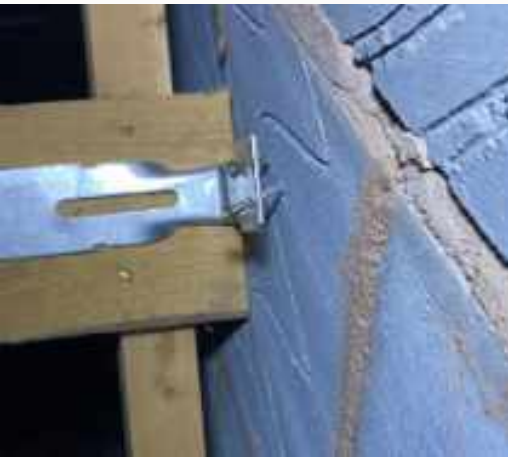
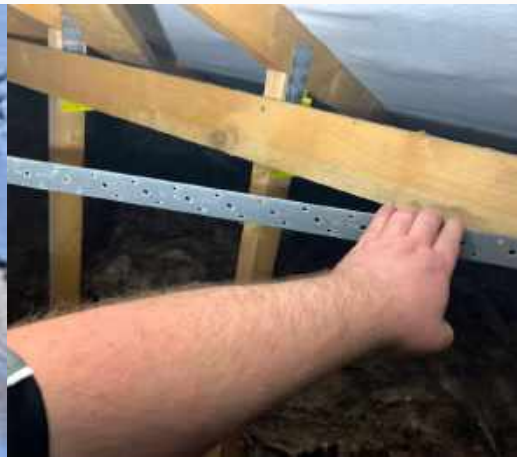
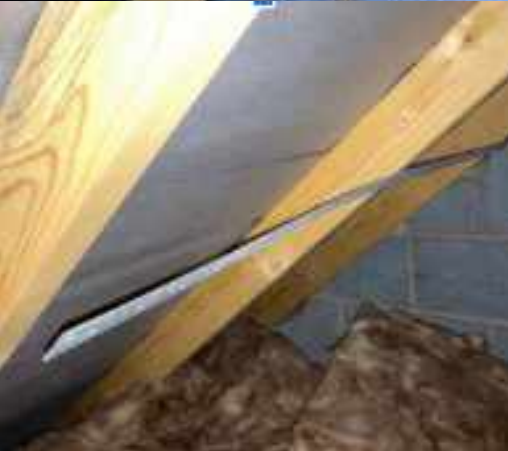
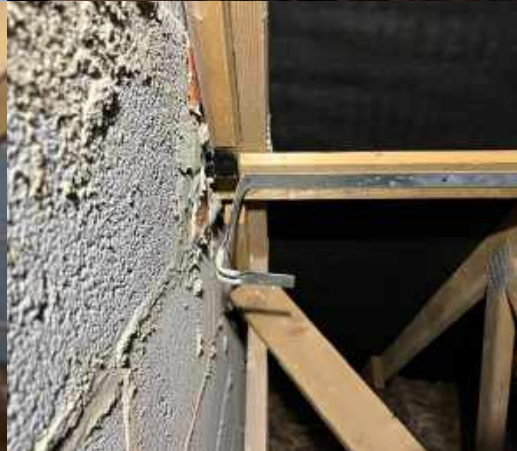
These provide stability to the gable walls and they should be connected to the 'inner side' of the block in the cavity. So with this in mind, you should not see the strap's right angle as it should be the other side of the block. The first picture shows the strap's right angle is on the wrong side of the block and of course it has been poorly secured.

The way the strap is attached is also often incorrectly installed. Sometimes it is only fixed directly to the trusses (pic 3) rather than to timber bracing or noggings. The most common approach is attaching it to 'bracing' [a stretch of timber running horizontally as shown on the other pictures]. It should have 8 nails fixing it to this bracing which is often not done as seen in the second photo below.

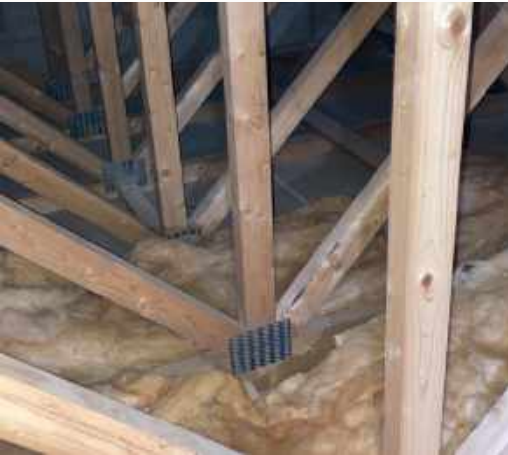
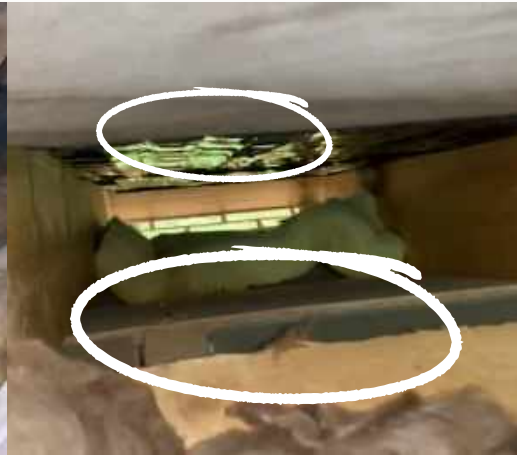
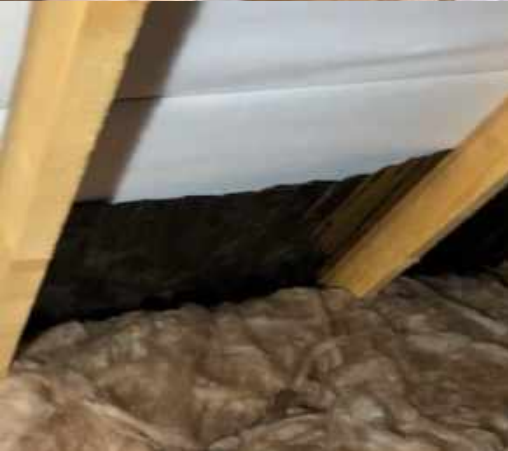
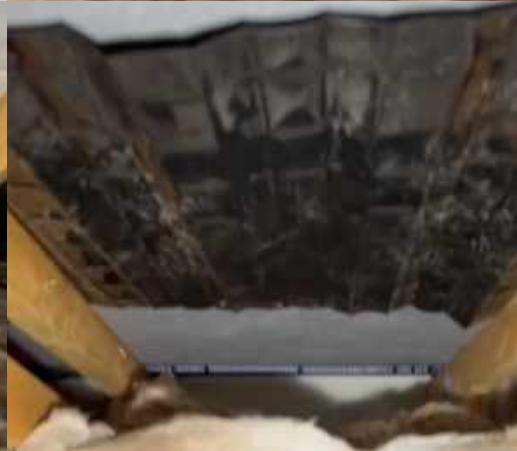
Vent trays

The purpose of these is to allow air flow from the eaves up into the loftspace which is vital to prevent excessive condensation issues (discussed in more detail shortly). They allow for the insulation to be butted up against them, but are often pulled tight (see pics 2 and 3) or at the wrong height (pic 4).

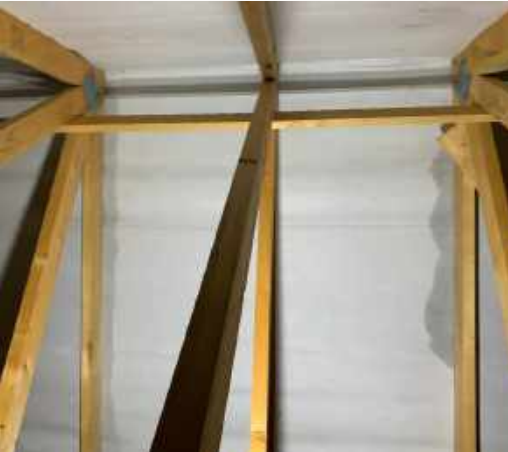
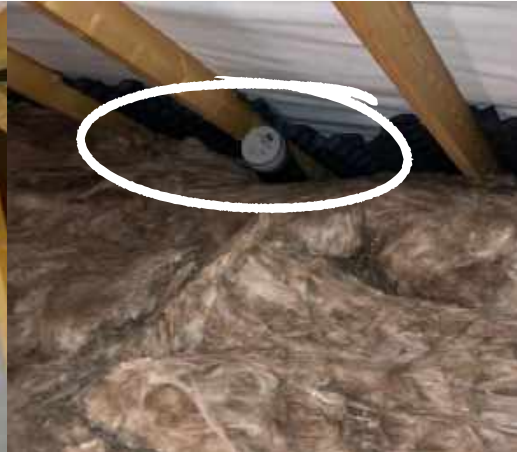
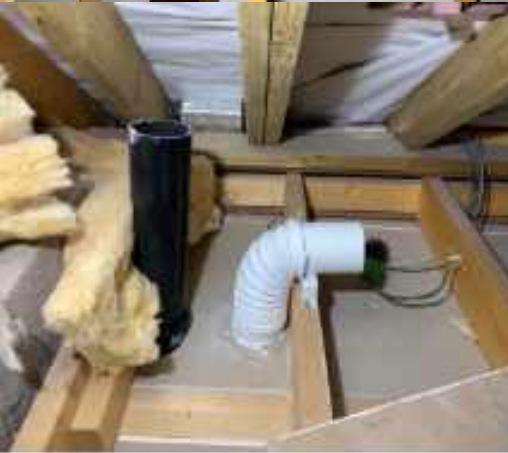
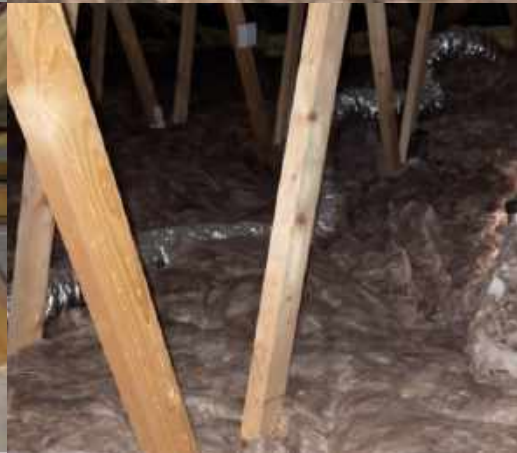
Check in bathrooms whether the extraction vents are connected to the ceiling, and if so make a note of where they are so you can check in the loft. The vent ducts in the loft need to vent externally through the roof tiles, and they need to be:

- insulated
- connected properly
- as short as possible, with no dips where condensation can pool. Pic 4 shows an excessively long duct.

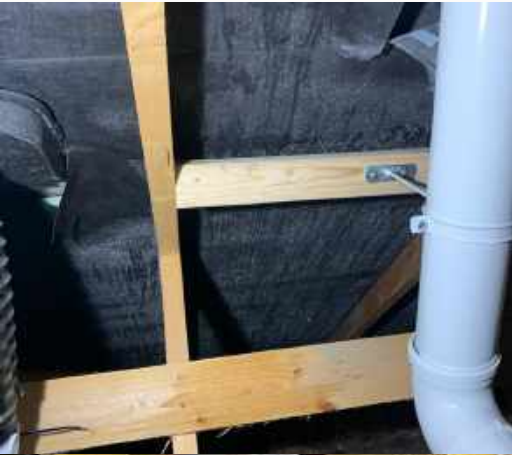
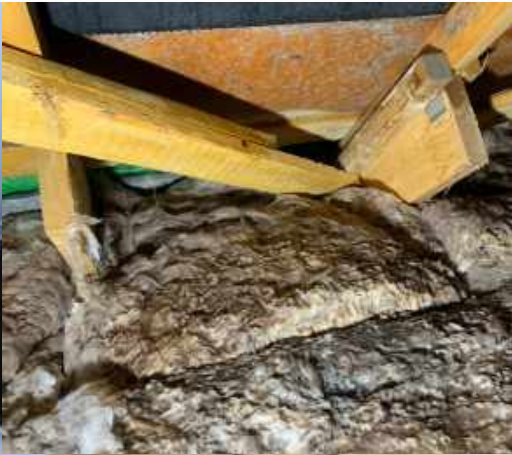
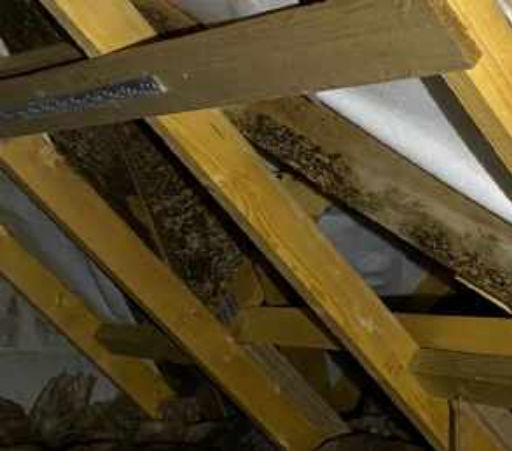
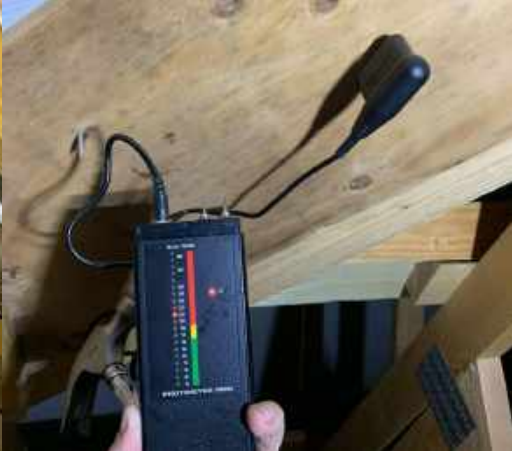
Condensation issues

It is common for winter months to experience condensation in the loft. The cause of this is either poor ventilation or poorly laid insulation where heat from the bedrooms are causing excess moisture to form. Often in situations where there is excessive amounts of condensation in lofts, it is a combination of both. Therefore check for adequate ventilation at eaves / the ridge and for any gaps in the insulation. The 2nd picture shows how the condensation in the loft is dripping down and causing the mineral wool insulation to be saturated due to the eaves being packed with insulation and having no ventilation.

Where moisture from condensation saturates timber for long periods of time, it is a concern as it could effect the integrity of the roof. When the moisture content of timber is in the region of 18-20%, it makes untreated timber susceptible to such damp issues. This will often appear as black, green or white mould as seen in picture 3. The way to check for the moisture content of timber is use a moisture meter as shown in the 4th picture below. However, these are expensive so if you have concerns, your money may be better spent on a surveyor attending.
