SNAGGING

NEW - BUILDS

A HOMEOWNER'S GUIDE

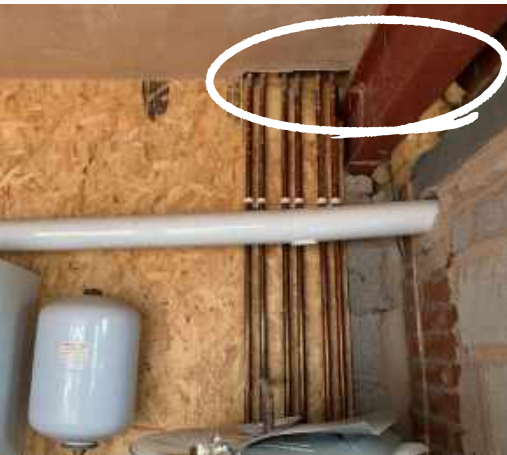
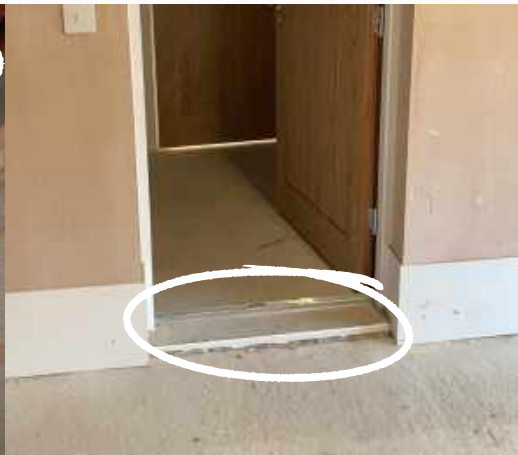
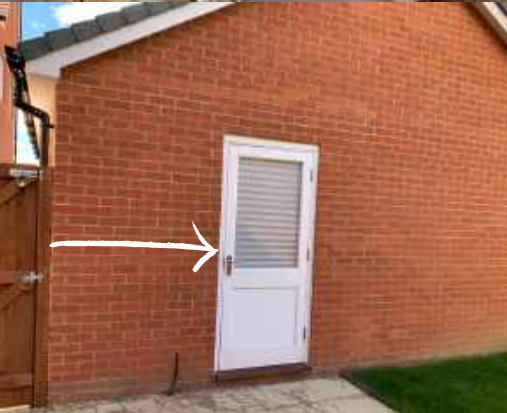
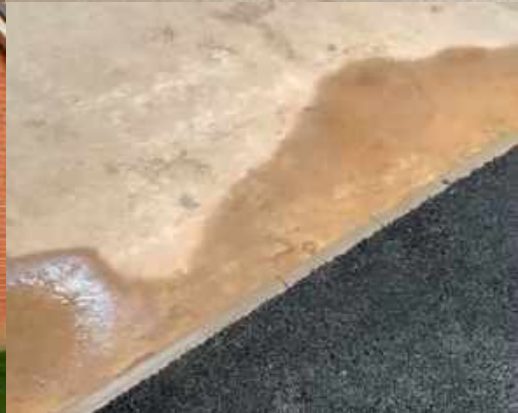
Typically the garage should have an aco (channel drain) at the foot of the opening, or again by having a slope or a 'lip' at the entry.

The last picture below shows where neither have been installed, and the added issue in this photo was the slope of the drive was toward the garage which made matters worse.

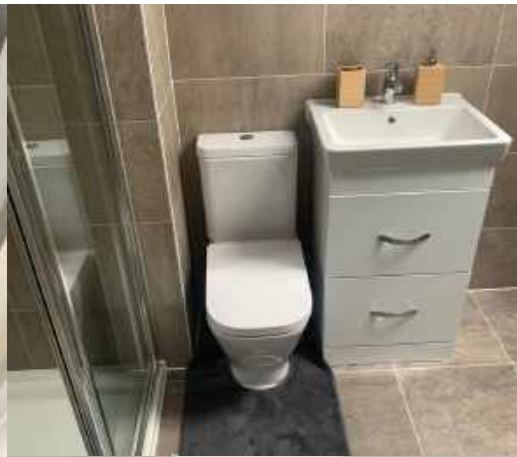
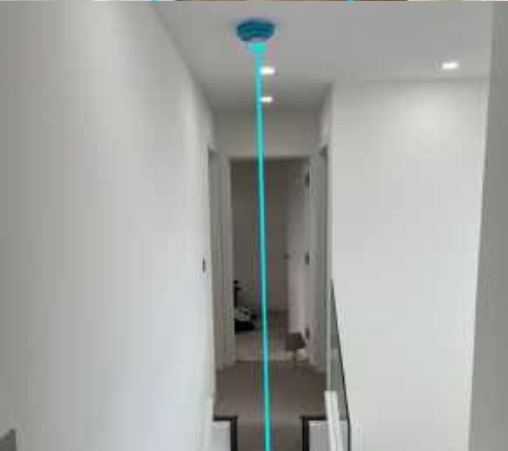
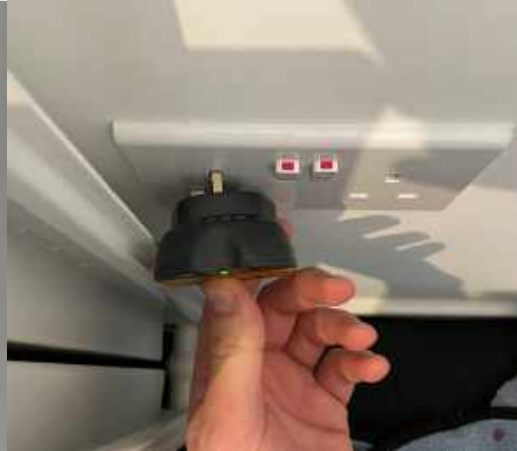
Functionality:

- Generally open and close all doors to check they do not hit the wall or radiators (etc). They should have door-stops when it is likely to impact in daily use.
- Also check all kitchen cupboards: example issues include the dishwasher door catching due to plinth not cut underneath and doors hitting handles of nearby doors.
- Check that sockets work and can actually be accessed (pic 4).

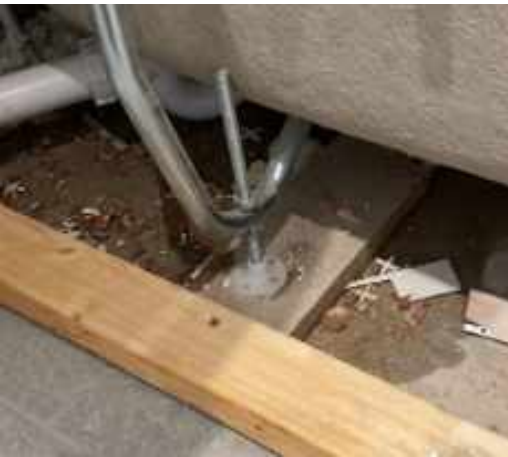
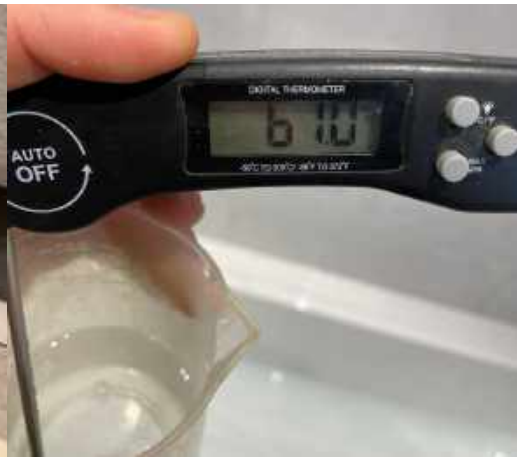
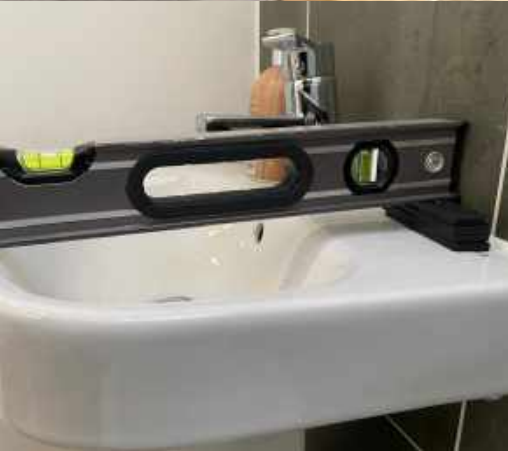
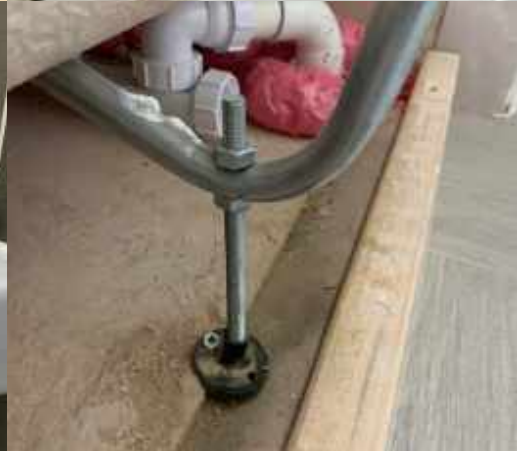
Check all sinks and showers to ensure:-

- the hot and cold water are correctly connected
- the pressure isn't too low
- the taps etc are sturdy
- the sinks and toilets are level
- there are no blockages
- bath feet are level (see last picture)

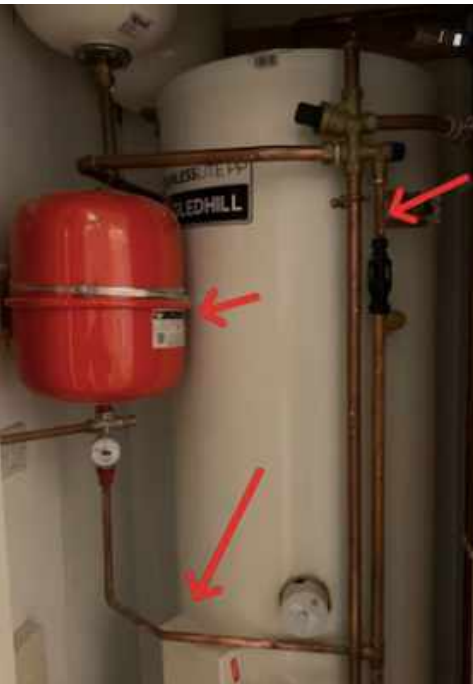
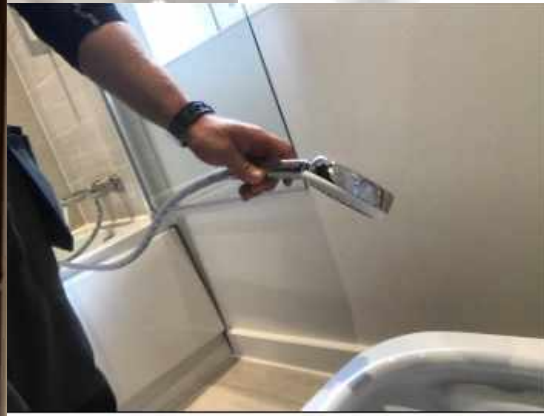
Sometimes water backs-up in the shower when the sink or bath empties (pic 2) or the sinks make a loud "glug" noise draining. These noises suggest there is a vacuum in the system, created by a potential blockage or failing air admittance valve (AAV) [see loft section for more info]. One way to assist in balancing out vacuums if drains aren't blocked is to replace the standard u-bend traps under the sink with anti-vac traps (see pic 3 below).

The last image presents a potential back flow issue, where there is the chance for dirty water to enter the fresh water supply. If your shower hose is able to reach the toilet like this, it needs a clip or shortening.

As described. in the section regarding plumbing, if you pull the plug to empty water or use the toilet shower etc and you experience a loud "glugging" type sound then this will be a vacuum often created by either the air admittance valve not working at the top of the soil stack or a blockage. If the blockage cannot be found then the remedy is to install anti-vac traps to the sink.

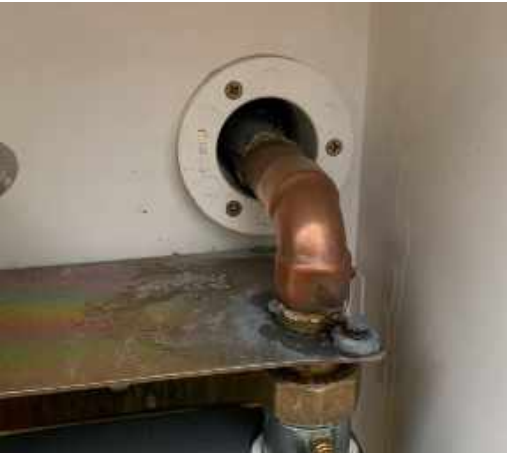
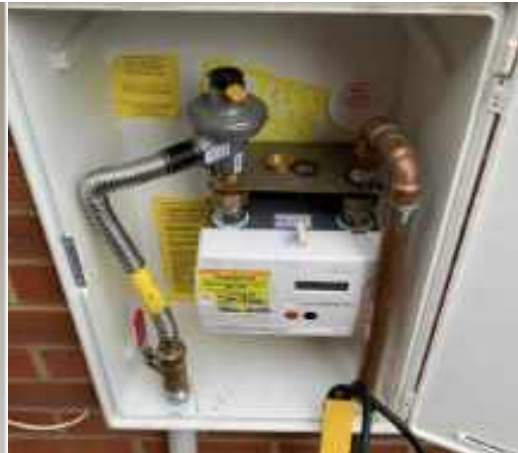
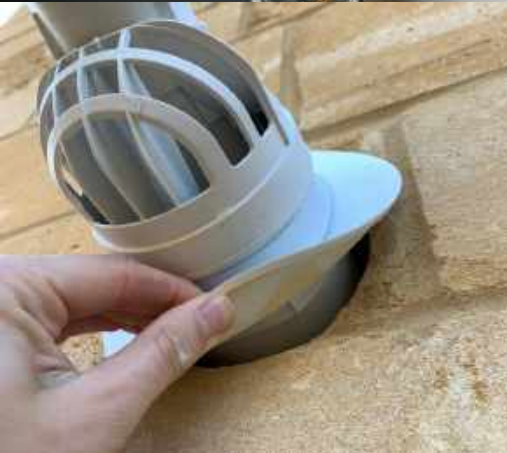
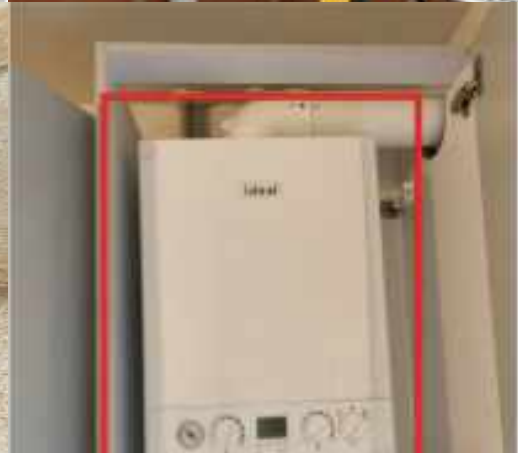
Gas Meter

Open the gas meter box, and there should be intumescent putty where the pipes enter the property (see picture 1 where it is missing).

Also the pipework should be earthed which is identified by a green and yellow wire (pic 2 shows it missing).

Check the flue is sealed (pic 3) and the flue is directed toward the boiler slightly, so any hot moisture does not drip from the flue outside; rather returns to the boiler (pic 4).

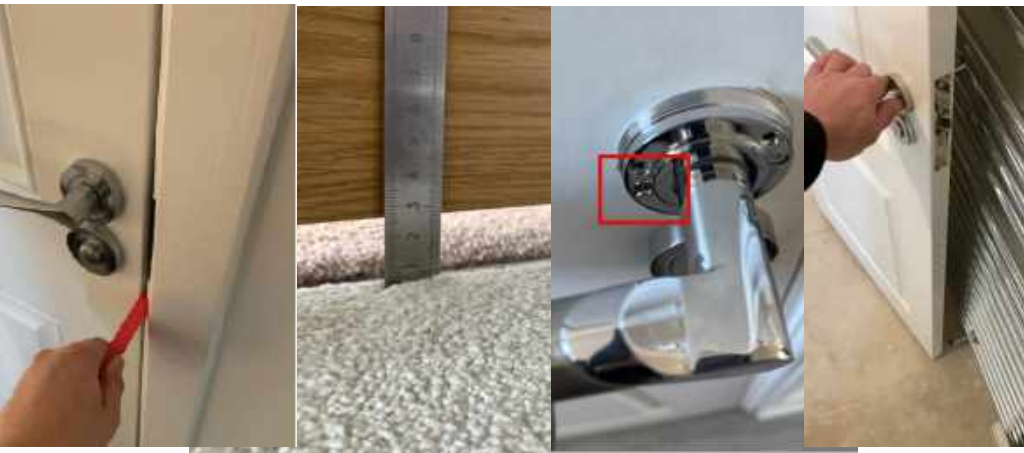
As mentioned in the section regarding design flaws, check for doors that may cause damage to fixtures such as radiators and wardrobes. The exception is when there is a wide arc where the door is unlikely to be contacting the wall or fixture. Even when there are door stops we sometimes find the fixing is hit before the stopper (picture 4).

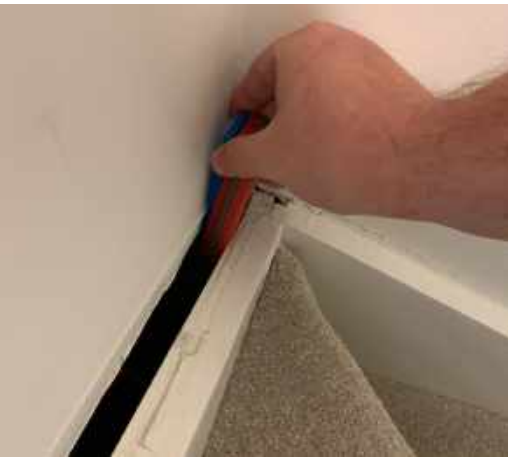
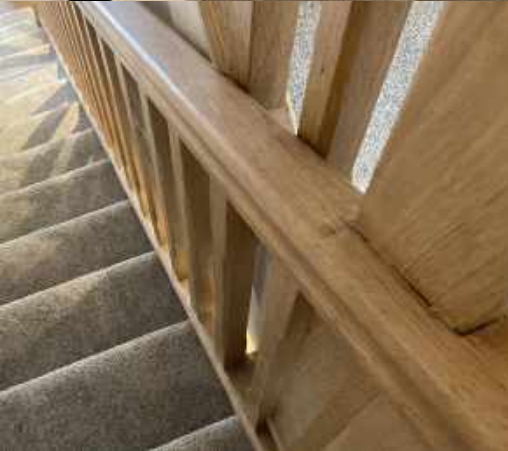
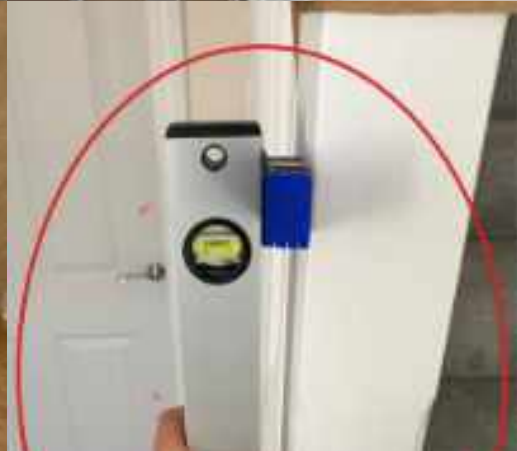
Handrails at the top of the stairs should be returned into the wall to prevent clothes getting caught (2nd photo).

If the staircase returns back on itself or is wide (a reach greater than 1100mm from one side to the other) then there may be the need for a second handrail (i.e. on both sides). Handrails should be uninterrupted with 25mm gap for your fingers (see pic 3 showing this issue). Newel caps should be securely fixed, and the posts should be straight (pic 4).

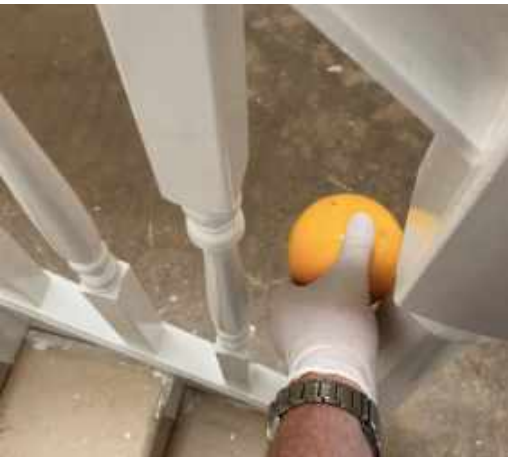
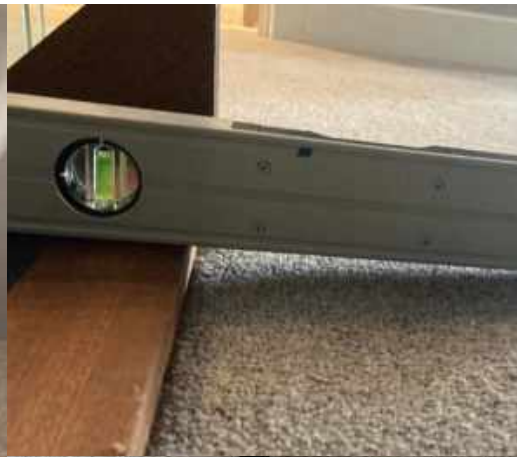
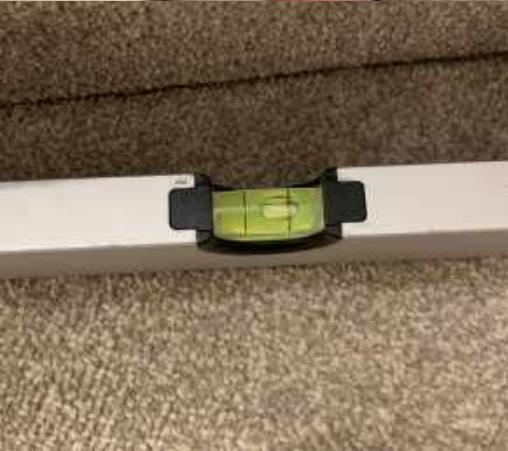
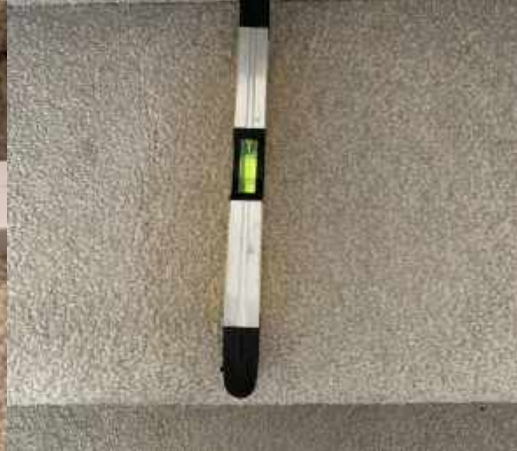
Pictures 3 and 4 show that the treads should be level in both width and depth. The homeowner of the house in the 4th photo had actually fallen down the stairs due to this issue.

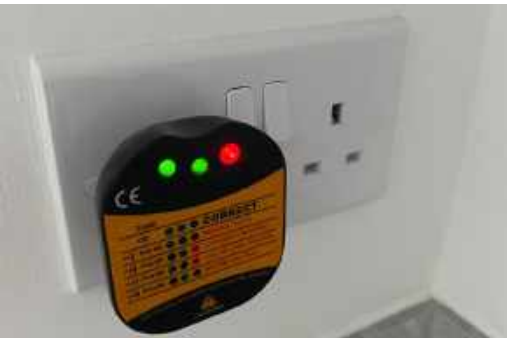
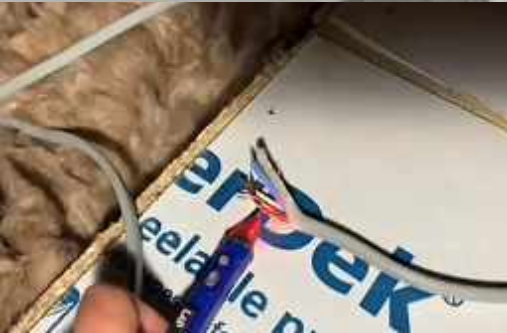
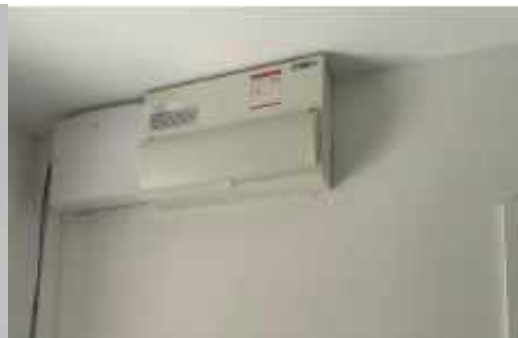
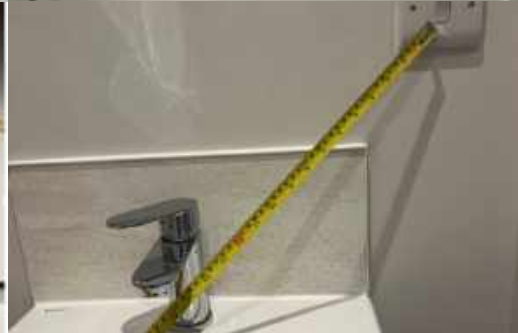
The most common area we find live wires are in the kitchen around cupboard lighting and in the loft as shown below (pic 3). If you spot any exposed wires we recommend to stay clear and wait for an electrician to make safe.

It is allowed for switches to be in bathrooms and WC's, but they should be 60cm away from sinks. In kitchens, switches and sockets should be more than 100mm away from the hob and 300mm away from the sink.

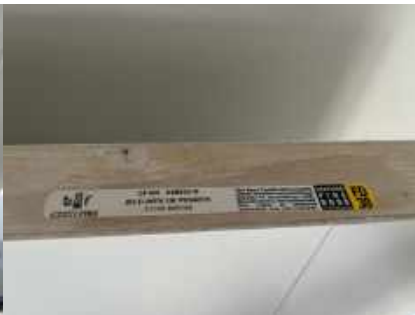
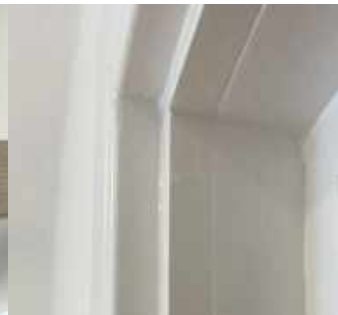
When your property is 3 storeys (or an apartment) the windows are not to be considered a point of egress, so they should always be restricted. Instead the staircase should be protected to ensure safe passage walking down and straight out. Protecting a staircase involves having fire doors which should have a FD30 label as shown below. It should also have intumescent seals to the door frames which have the appearance of narrow plastic strips. Check all 3 sides of the frame have them in place.

The purpose of them is to swell under heat, so it is important to check the gap between the door and frame does not exceed 4mm. We use a fire door wedge to check this. The only doors that do not need intumescent seals are those that aren't deemed habitable, such as bathrooms. A common issue we find with intumescent seals is when they have been painted over: see last picture below of an example.

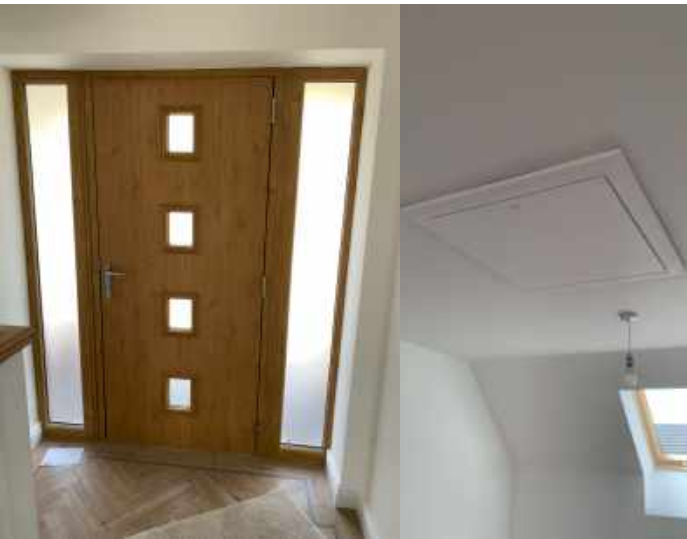
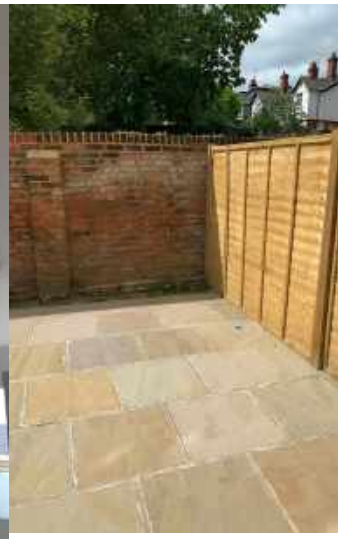
If you are concerned about the security of this (i.e. being more easily broken into), you can install protective plates that prevent it being turned via the letterbox. You should have a door chain but otherwise should not have more than one mechanism to operate to get out.

One of the lesser-found issues but one important to consider if you have a 3 storey home is the size of enclosed yard / garden if that is where you exit in an emergency. Refer to part B of the Building regulations for variations such as if there is an extension, but otherwise the size of the enclosure should be no less than the height of the building. The 2nd picture below is of a yard that did not meet building regulations as it was half the size required, with no means of getting out of the yard.

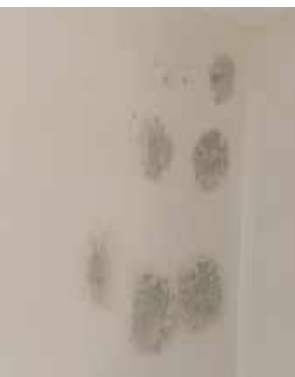
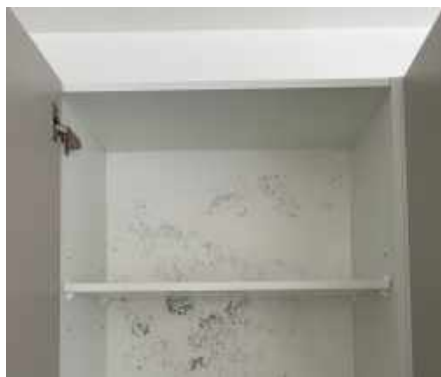
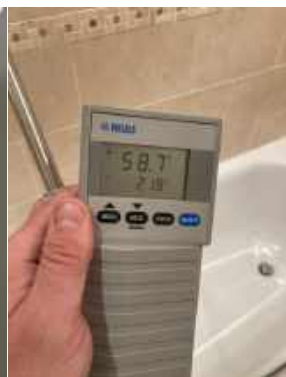
Other than bathrooms, it is common for mould to occur inside areas such as wall mounted cupboards, as shown in the example picture below. In the case of wall mounted cupboards where the unit has been attached to plastered walls, it can be due to the moisture in the plaster being trapped before it has dried out. In areas such as cupboards under the stairs or wardrobes, it is simply the case there is not enough ventilation.

If you feel as though you are ventilating your property adequately and there is reoccurring condensation then we recommend instructing a surveyor that is experienced with causes of damp. As shown on the last photo, specialist equipment will be able to check for relative humidity readings which will determine whether it is interstitial condensation or other potential causes (e.g. internal or external leaks or insulation issues).

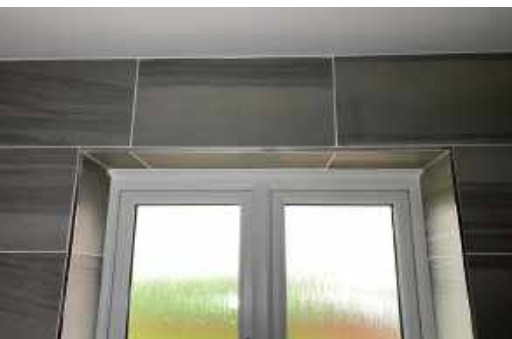
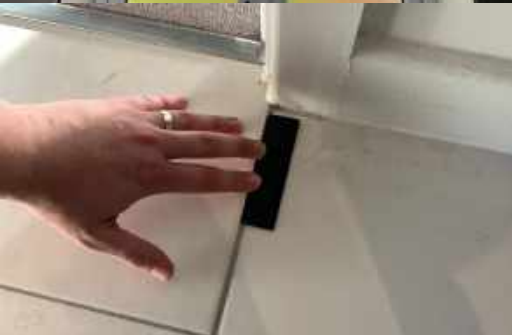
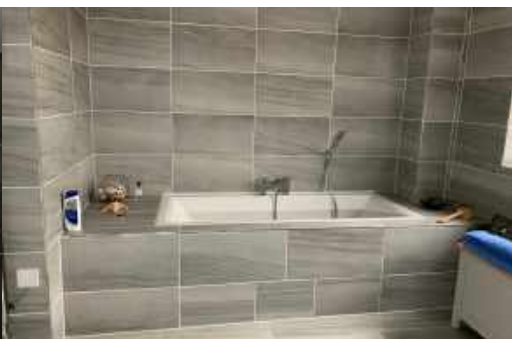
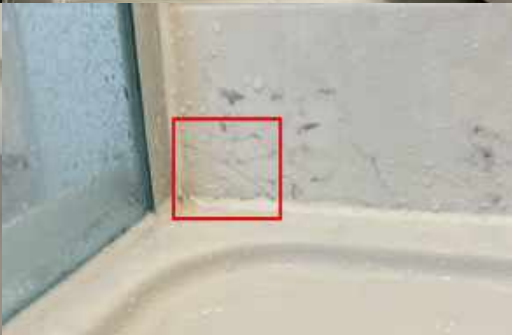
Generally, tiles are more susceptible to cracking in upstairs rooms due to movement from settlement. The most important area to monitor is in the shower area to prevent water ingress.

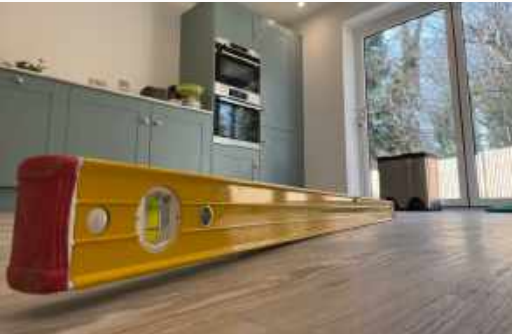
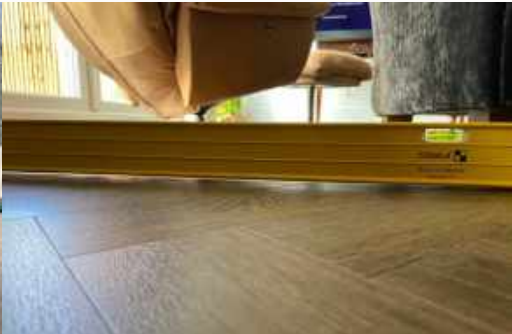
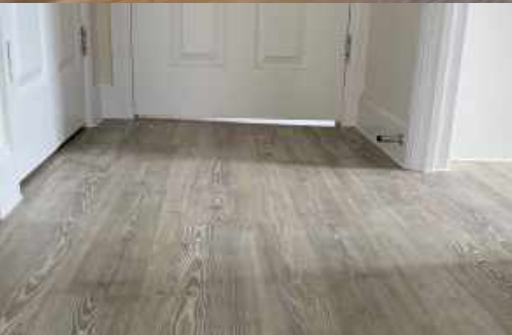
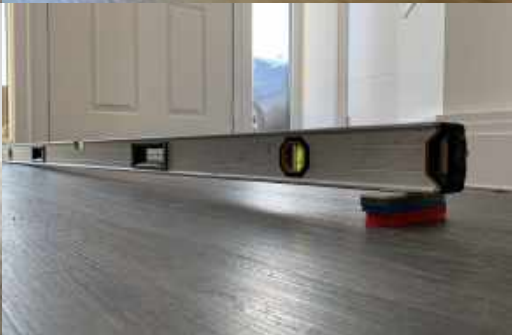
Un-level floors can often be noticeable by eye due to skirting and door gaps as shown in pic 3. It is often the reason for doors catching on carpets. To check whether out of tolerance involves looking at the bubble in the centre of the spirit level: where it is not reasonably level, use spacers at one end to raise it until the bubble is central to understand how far out it is out as shown in pic 4. The NHBC states that floors should be either:

- level within a 3mm deviation per 1m for floors up to 6m across (measured at the furthest points across the full width of the floor)
- a maximum of 20mm out of level for floors over 6m across

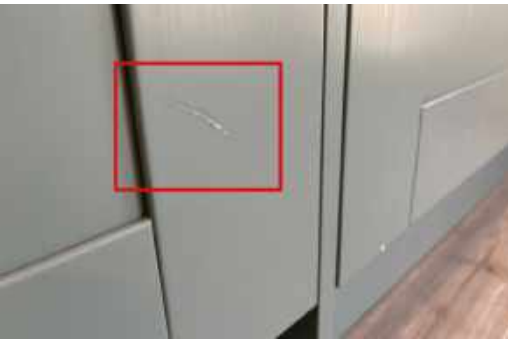
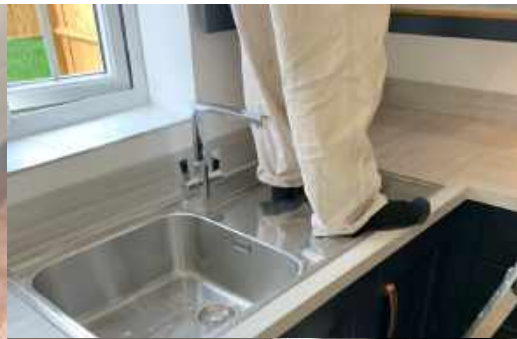
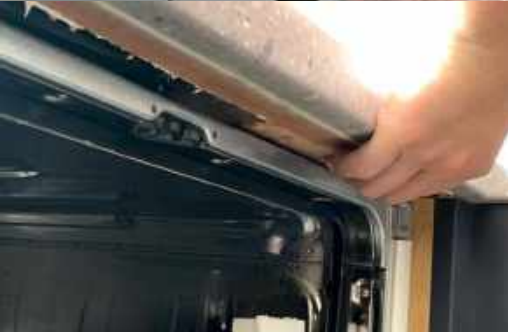
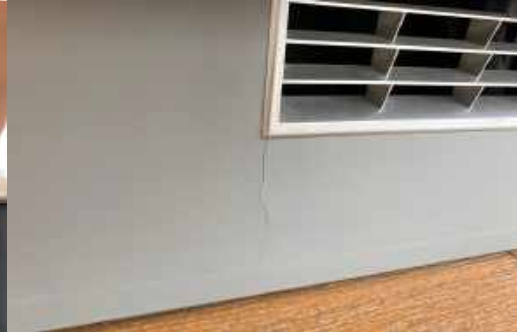
Check units are level, free from damage (pic 1), the doors and handles are level and don't foul opening/closing. Also use a level or stand back to check that wall units are installed level.

Sinks and hobs should be covered for protection but are commonly scratched by trades carrying out work (see picture 2). Check the worktop is not damaged and there is a neat join. If it is a laminate worktop, check that there is moisture barrier above the dishwasher (pic 3 shows a missing section).

If you have an integrated fridge freezer, there should be a vent installed to the plinth underneath. The 4th picture shows what this looks like, where the plinth has been damaged.

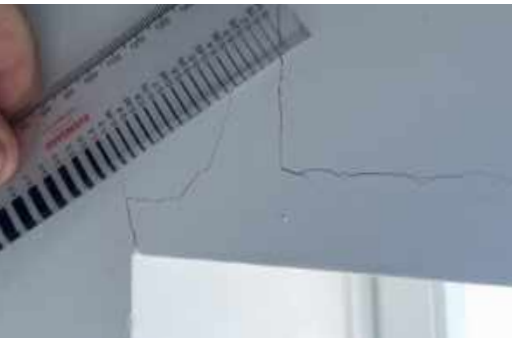
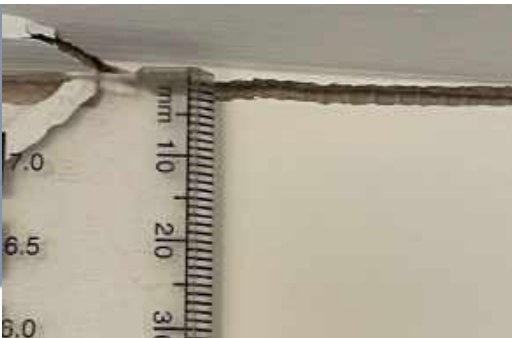
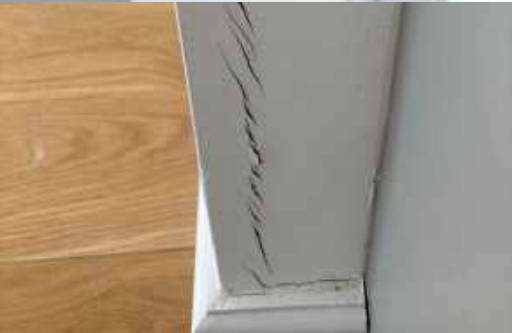
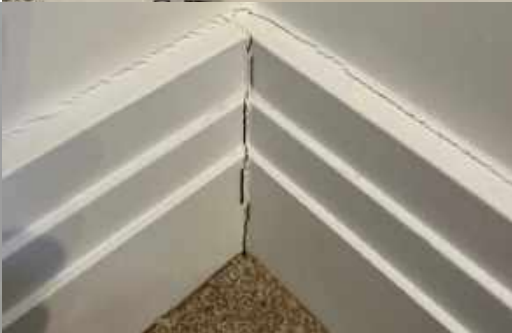
The first photo shows a typical shrinkage crack around an opening. As mentioned previously, most developers are only willing to repair cracks that are 3mm thick or more.

The cause of this is the construction materials drying out. As 'wet' construction materials (plaster etc) contain a lot of water, it usually takes several months for the shrinkage cracks to occur depending on the time of year. Allowing for ventilation (trickle vents) in the property can help this drying out period. Classic shrinkage cracks run along the top of walls rather than at openings, at a constant width no less than 2mm (see picture 2).

You may also find cracks at corners of internal walls along the line of the angle beads as shown in the 3rd image, or at joins of architraves and skirting boards (pic 4) which is normally a simple decorative repair.

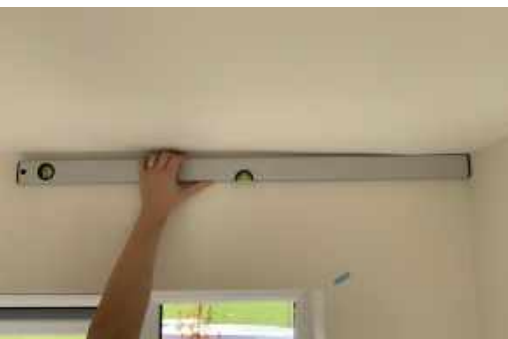
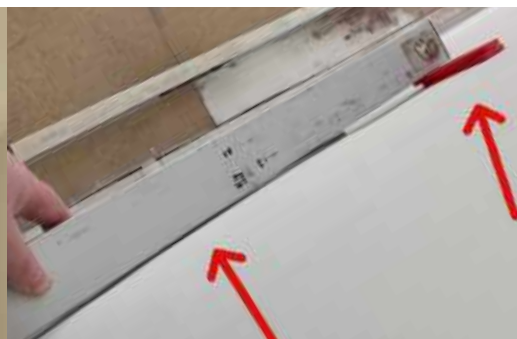
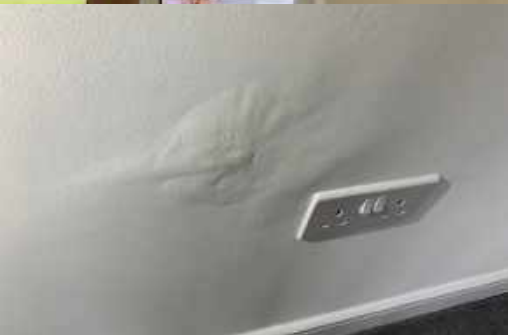
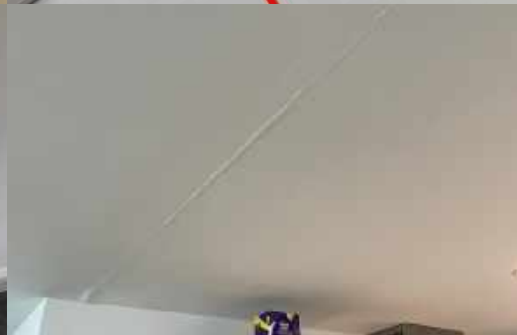
Nail pops will likely appear over time as the house settles and you walk over floorboards. They are small penny sized bumps where the screw 'pops' out slightly. Pic 3 shows blown plasterboard which is simply where the plasterboard is damaged. It is common around sockets where the hole hasn't been cut correctly and gets forced into place.

Scrim tape is what is used between plasterboards to prevent cracks forming. If you have long straight hairline cracks to walls or ceilings (pic 4), it is possible scrim was not installed. Also when installed, the scrim tape is often visible particularly in corners.

Pictures 1 and 2 are examples showing when ceilings are not flat or level or walls are not straight. We use a straight edge to determine this similar to the process when checking flooring. See overleaf for the NHBC tolerances.

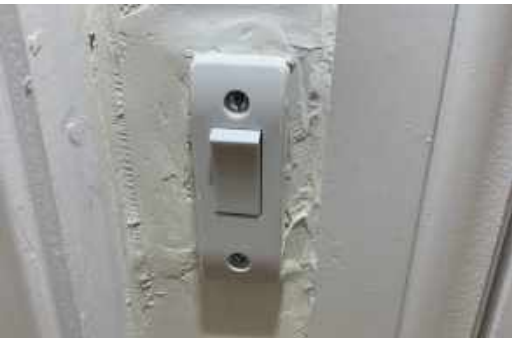
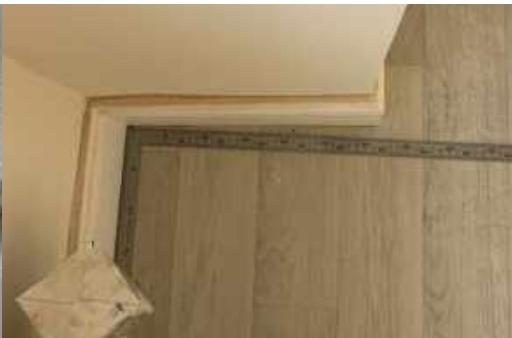
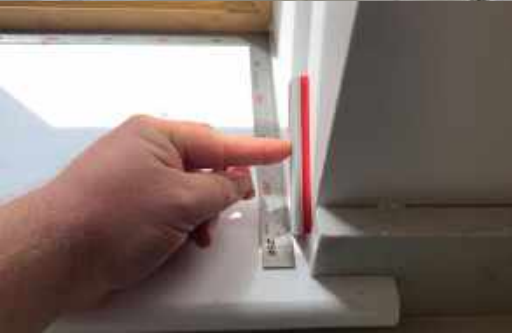
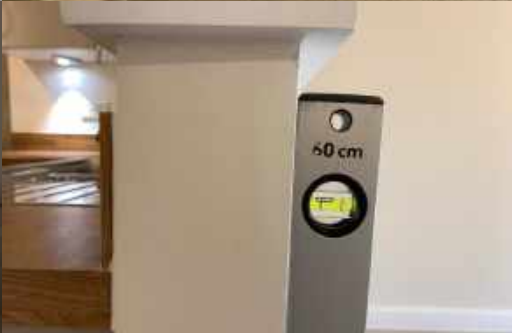
The NHBC requirement checking the finish of walls is to inspect from a distance of 2m and view in natural light (i.e not to use a torch). However for rooms such as bathrooms that often have no windows, we recommend turning the lights off and using a torch particularly to check the ceilings.

Overall when considering whether to raise paint snags, we recommend first asking yourself whether a painter will make it better or possibly worse, as sometimes a small drip is less noticeable than a freshly painted patch to rectify it.
