SNAG LIST

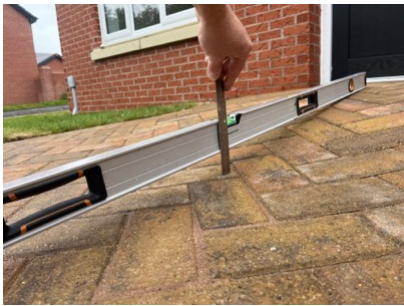
1

The approach is neither an acceptable ramp nor stepped approach which is in breach of building regulations part M
The approach is not flat and is an excessively steep gradient which as shown with a 2m level with equal offsets revealing a 50mm deviation off flatness

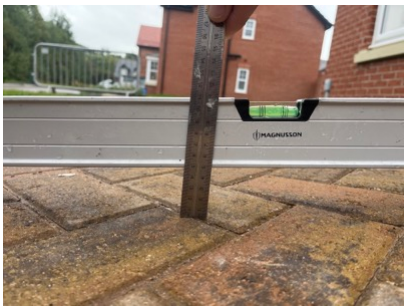
2

As above, close up showing steep gradient

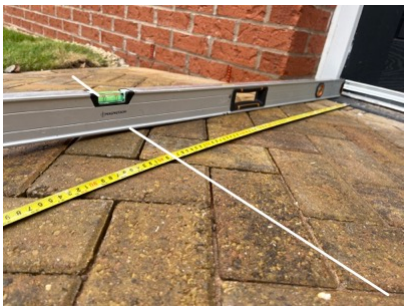
3

Also the "landing" next to the door should be level at 1200mm depth and this is short of 800mm

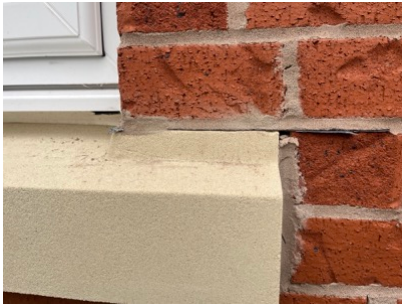
5

Untidy finish to mortar and membrane is visible with no weep vent

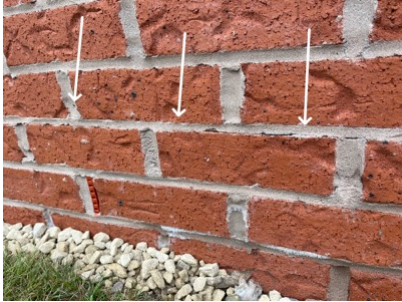
6

Double DPC doesn't have weep vents
This makes the weep vents redundant underneath depending on how far the higher DPC goes across

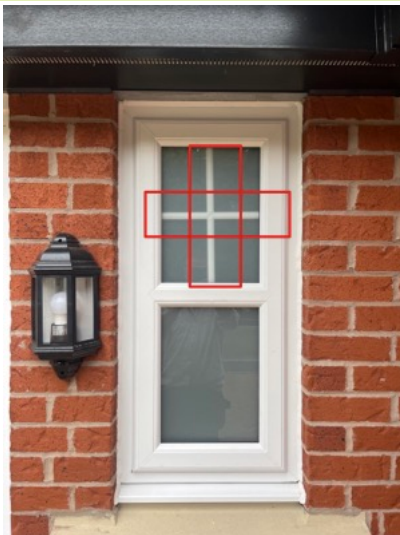
11

External Front
Assigned To Glazing
Glazing bars aren't aligned level / straight
Noticeable by eye

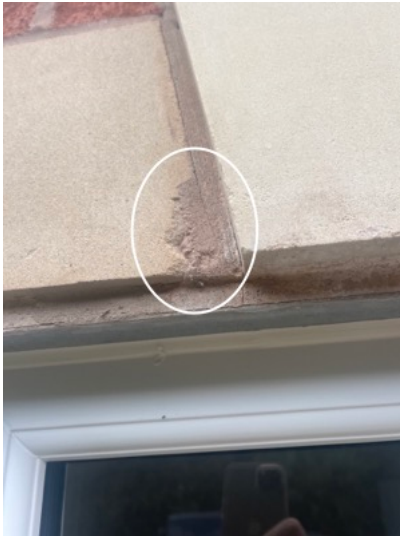
13

Cast stone decorative lintel damaged and covered by mortar

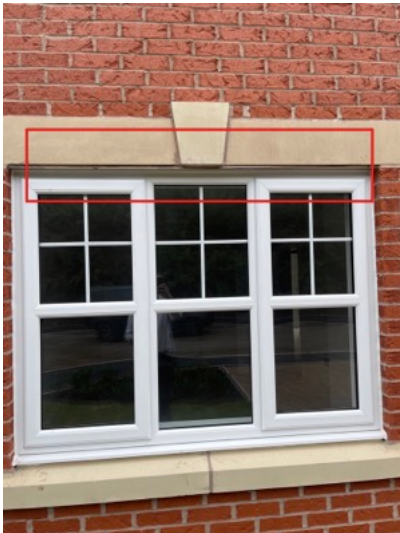
14

Noticeable difference in window vs lintel level

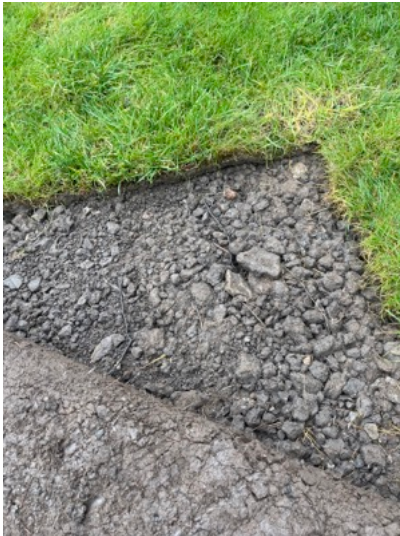
16

Assigned To Landscaping
Stones underneath turf

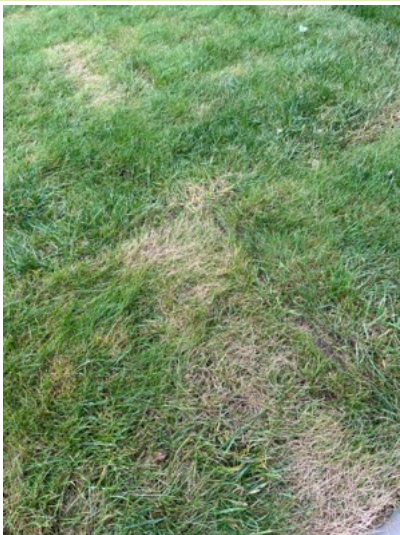
17

Assigned To
As above - this is causing the turf to die

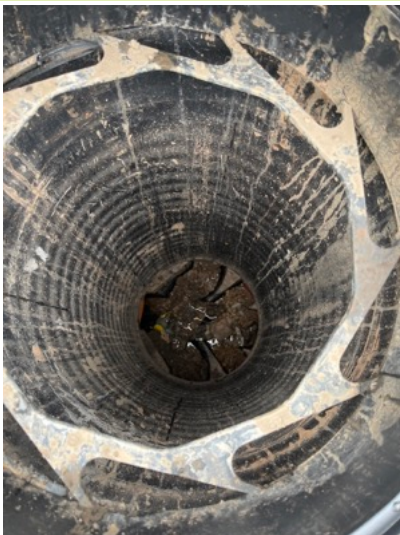
20

External Front
Assigned To Groundwork
Inspection chamber is blocked

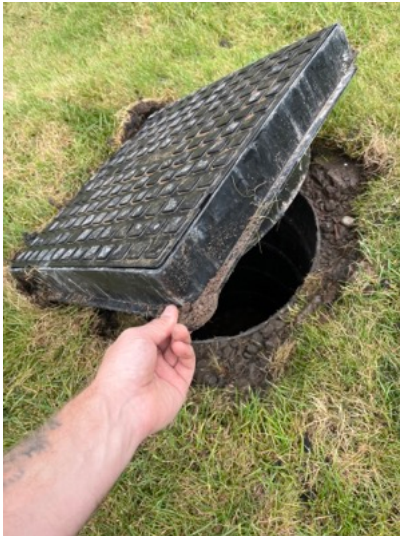
22

Assigned To Groundworks
Inspection chamber not secured - you shouldn't be able to lift it like this - and is blocked

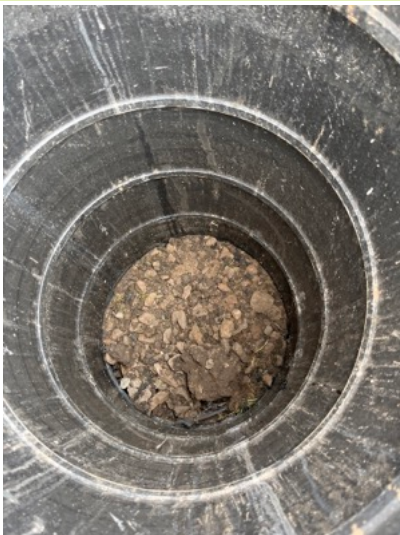
23

Assigned To
Blocked chamber - needs removal, rodding and cctv check once done

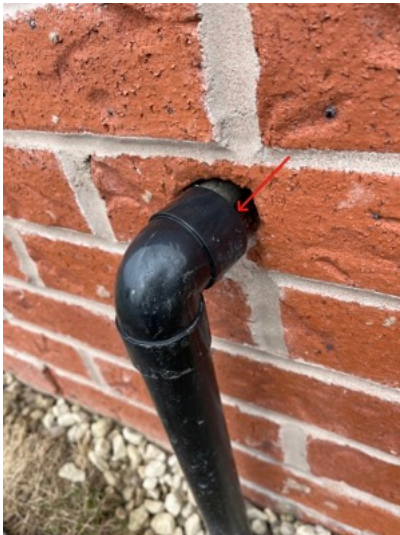
26

Condensate pipe not sealed

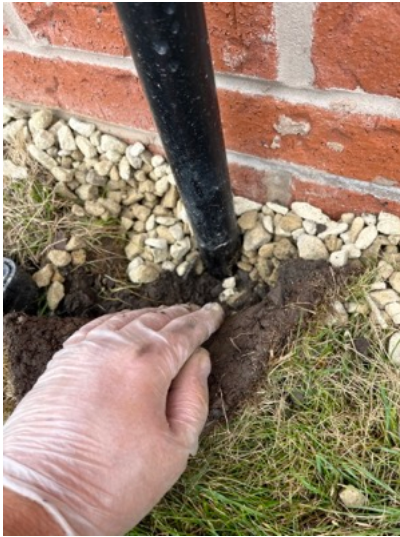
27

The pipe terminates into the ground rather than connection to drain or soakaway

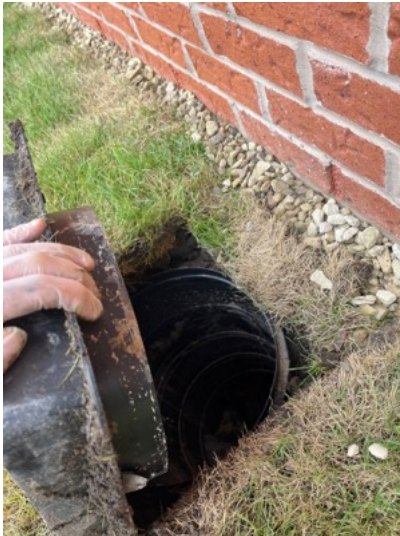
28

Drain cover isn't secure - and is blocked

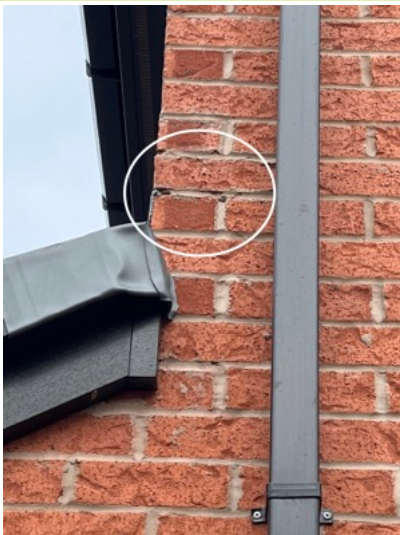
29

Missing weep at end of flashing (cavity tray)

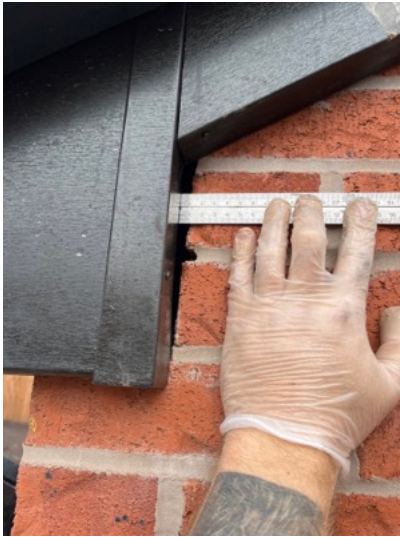
30

Gap next to box end 10mm +. This is out of tolerance and needs mastic seal to prevent pest entry

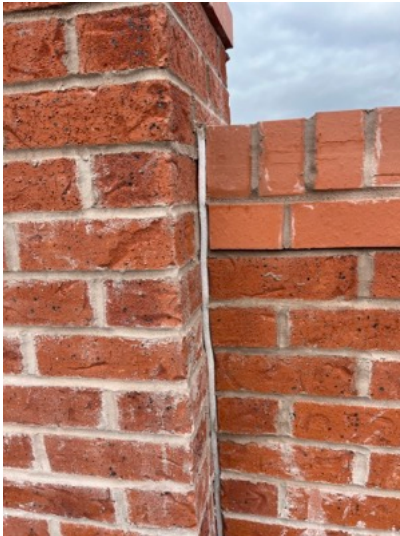
31

Expansion joint not sealed

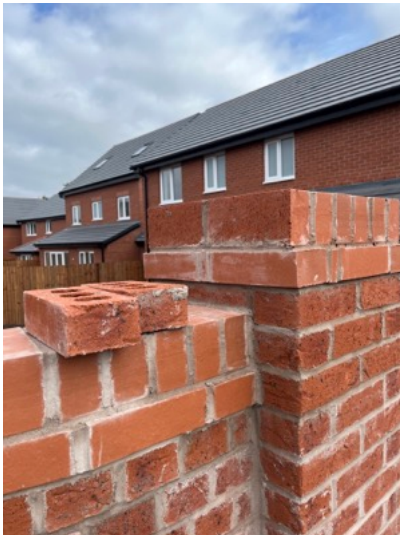
32

Bricks have been left ontop of wall

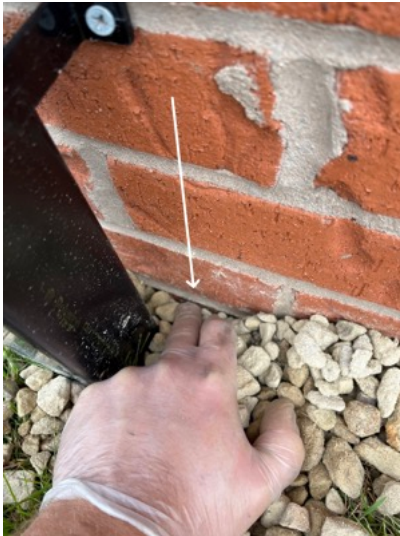
34

DPC below ground level - this should be 150mm above

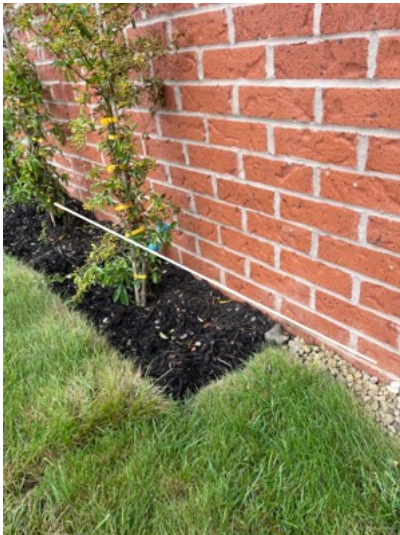
35

As above: all the ground levels need reducing down

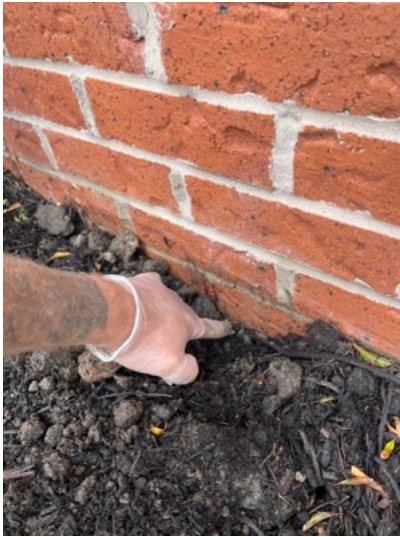
36

As above, the ground is bridging the DPC

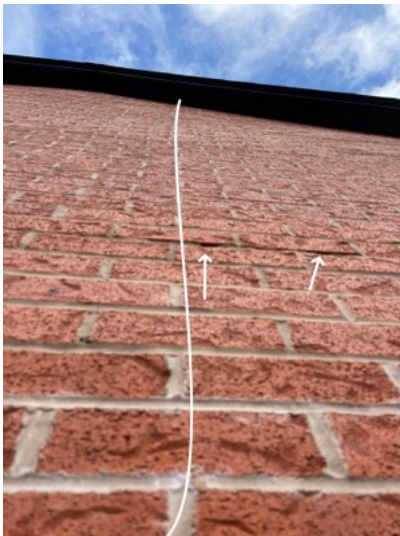
38

Brickwork perps aren't aligned to gable wall which is a sign of poor workmanship as well as being out of tolerance
Arrows pointing to repointing required
The brickwork doesn't appear plumb in areas

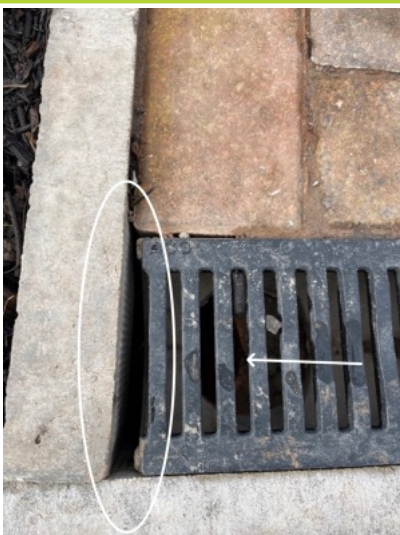
39

Gap to Aco

Drain gulley not aligned

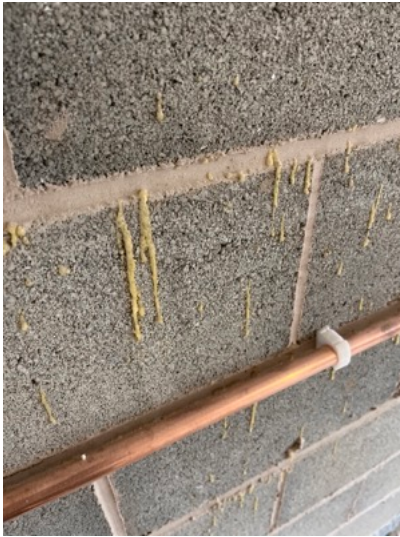
49

Garage
Assigned To
Foam shots all over walls

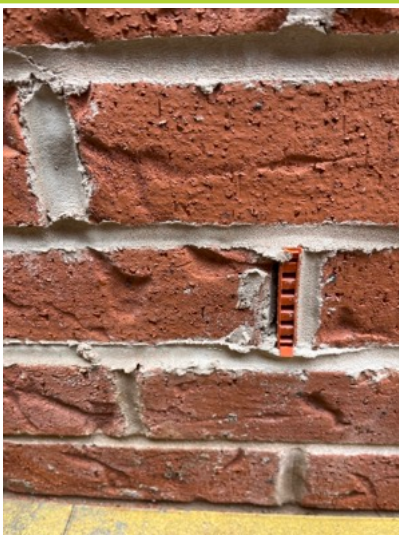
62

External Rhs

The finish of the mortar is rough generally,
there has been a lack of good
workmanship with the brickwork /
pointing

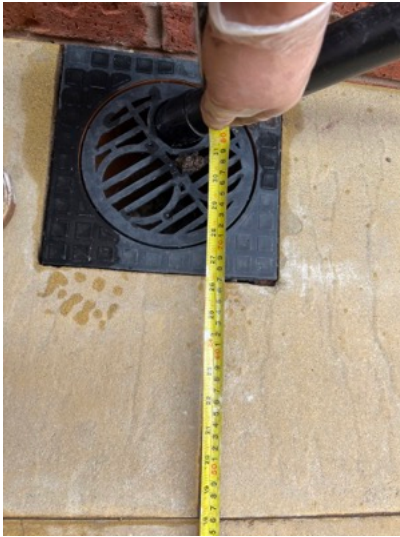
63

External Rhs

The path width is hindered by pipes

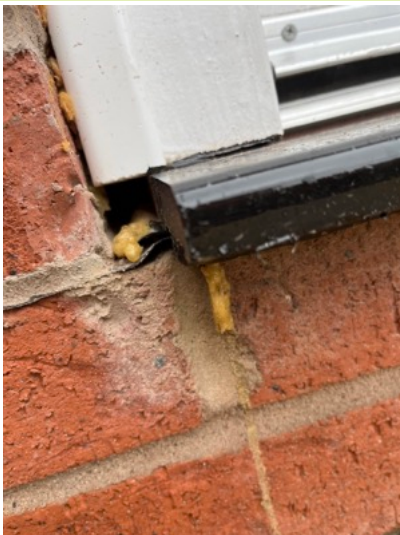
65

● External Rear

Back door has been poorly fitted
There are gaps, visible foam and no seal to the door frame

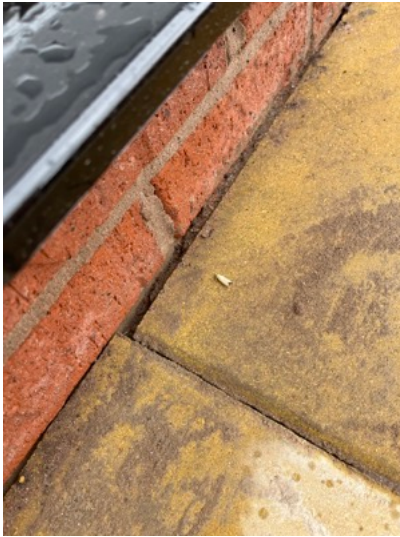
66

External Rear

Flagstones at Back door are not aligned

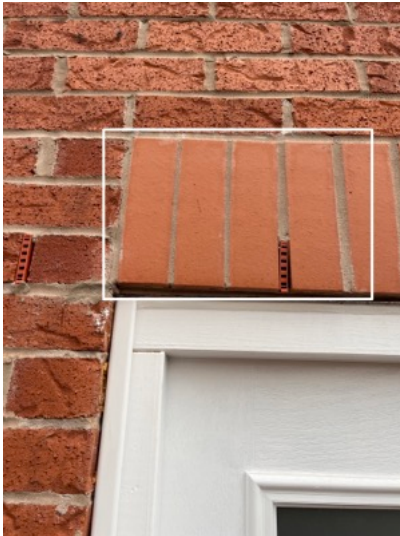
67

External Rear

Soldier bricks aren't straight

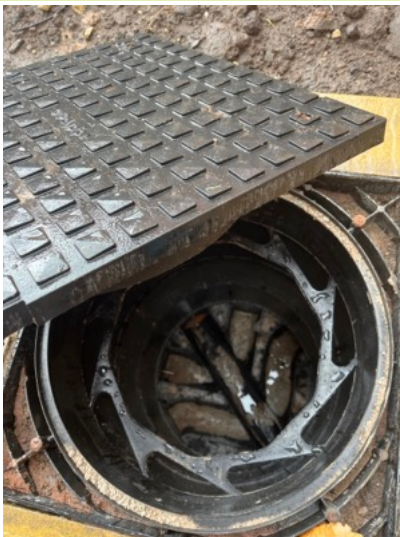
68

● External

No fixings make chamber is insecure to walk over. Also blocked

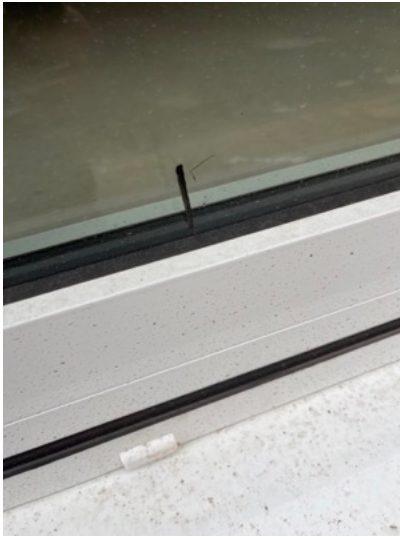
72

External Rear
Assigned To Glazing
Tidy finish to bi folds

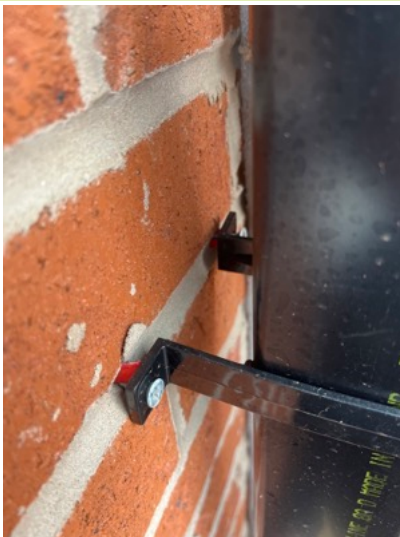
74

External Rear
Assigned To Roofer
Rwdp fixings not secure

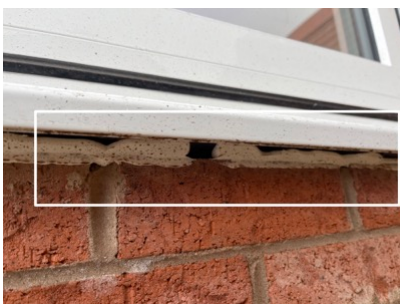
75

External Rear
Assigned To Mastic
Mastic seal gaps

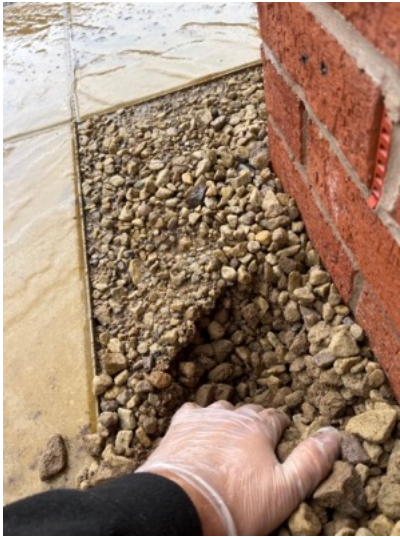
76

External Rear

No weed membrane laid under stones

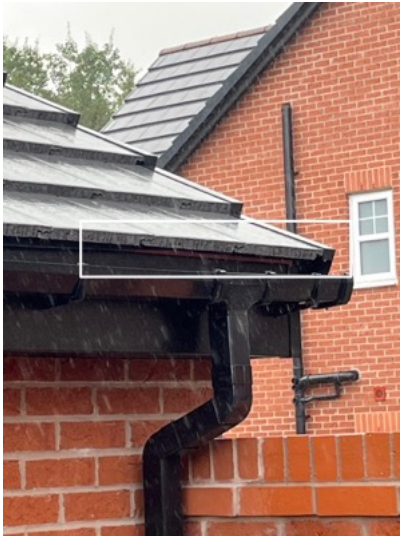
77

External Rear

The underlay is not dressed into the gutter

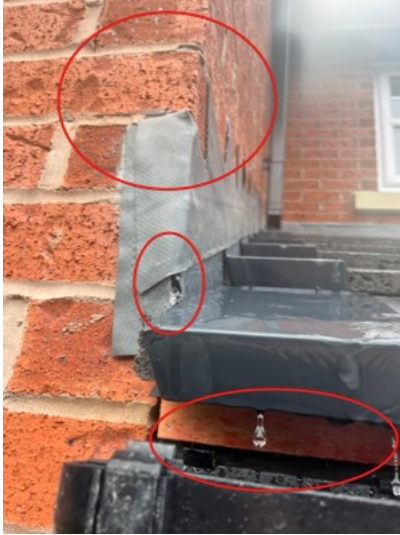
79

External Front

There is a missing weep vent at base of the stepped flashing
The flashing is ripped
The under lay is not dressed into the gutter

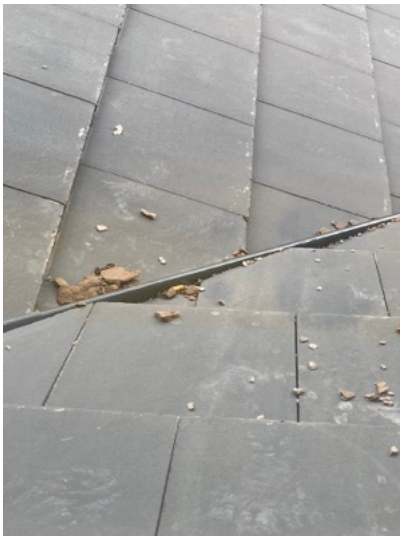
81

External Front

Excessive amount of debris on the roof - see valley at front garage

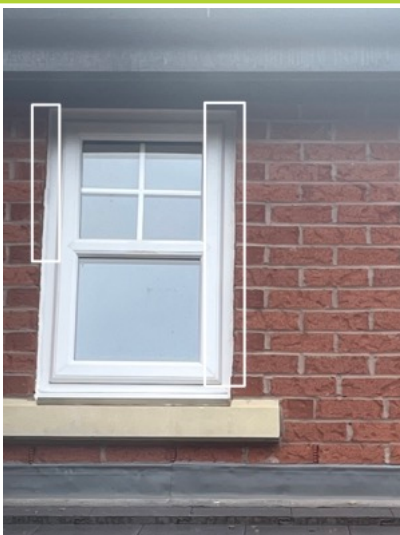
82

External Front

Window reveals are not square / plumb
Out of 4mm tolerance (by eye)

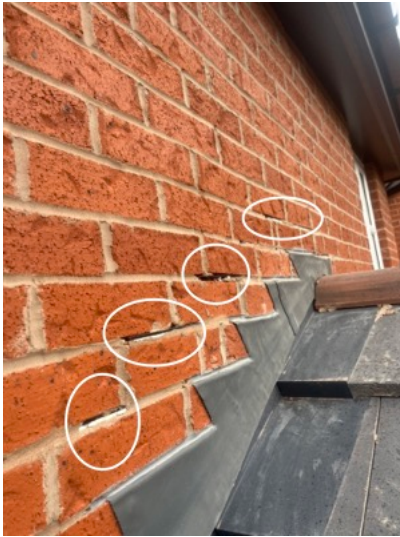
86

External Front

The cavity tray and flashing aren't aligned

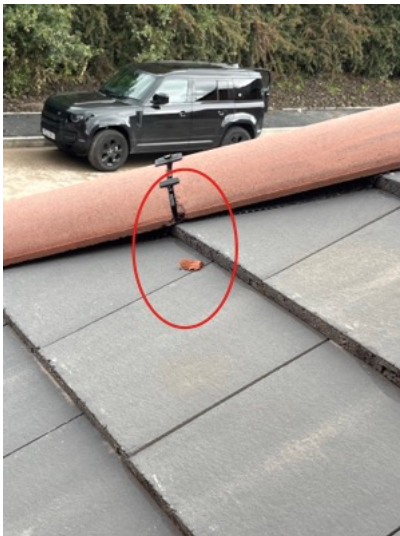
88

External Front

Hip / ridge tiles chipped

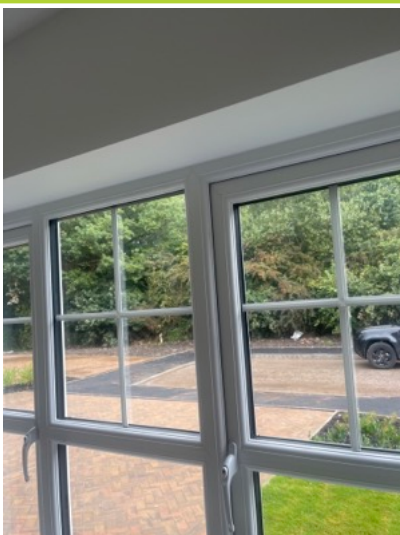
89

Generally

There are no trickle vents which suggests a passive system, in which case the set up is wrong. See part F of Building Regulations

If the builder are assuming this is a continuous extract ventilation system, it should be providing it to all habitable rooms.

The total number of vents in habitable rooms and kitchen should be at least 5. In the house there were just fans to the bathrooms and utility and Kitchen.

With this in mind I believe the property should have trickle vents installed to the windows throughout. The property is experiencing mould to rooms which is not common if there are trickle vents (as it is only common to materials drying out in rooms with a lack of ventilation eg cupboards)

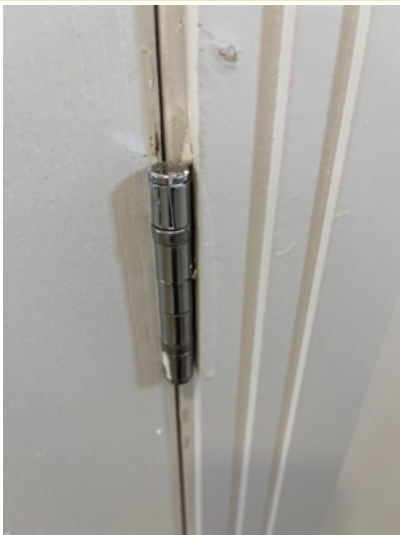
106

Entrance

Rough finish around WC door
It is not part of our survey to highlight paintwork - however it was noticed the quality was poor throughout. The following are only examples to show various paint defects out of tolerance
A painter should visit and repaint areas throughout

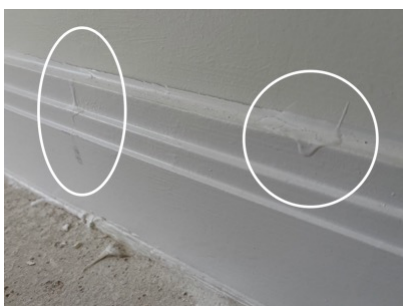
108

Paintwork
Assigned To
Rough finish to the skirting
Example shown here is in lounge

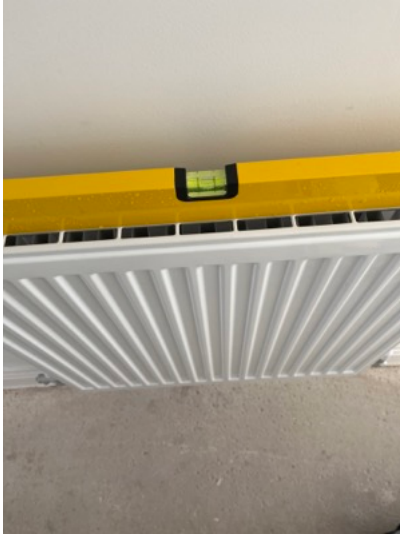
115

Hallway

Rad isn't level

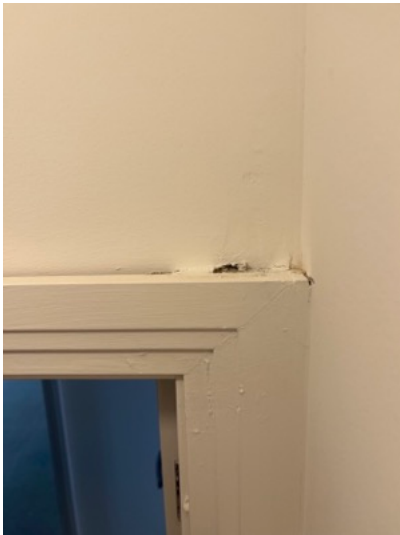
117

Cupboard

Rough finish around Cupboard door

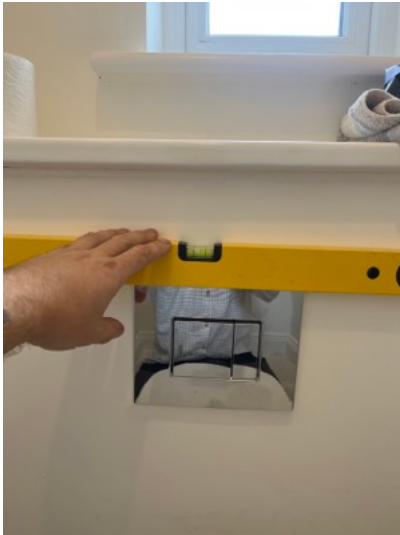
118

WC

Assigned To Plumber
Flush not level

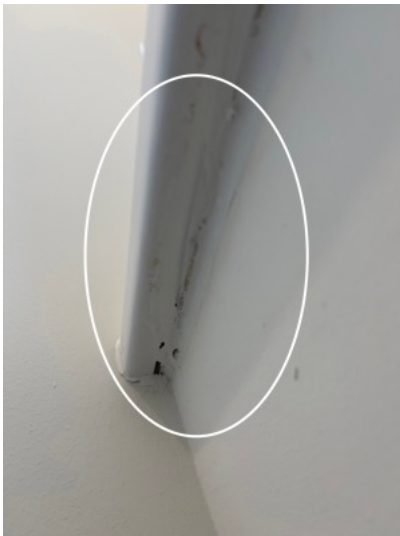
119

Wc

Assigned To Mastic
Rough finish under sink

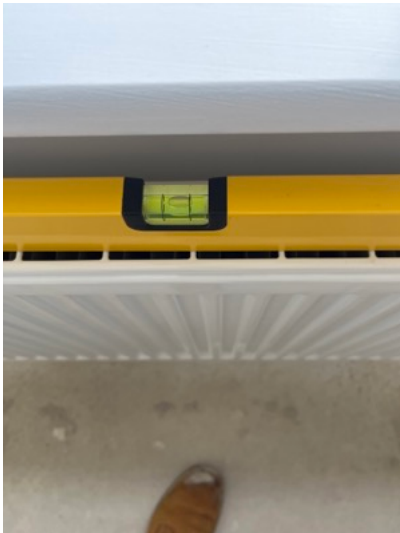
123

Lounge
Assigned To Plumber
Rad isn't level

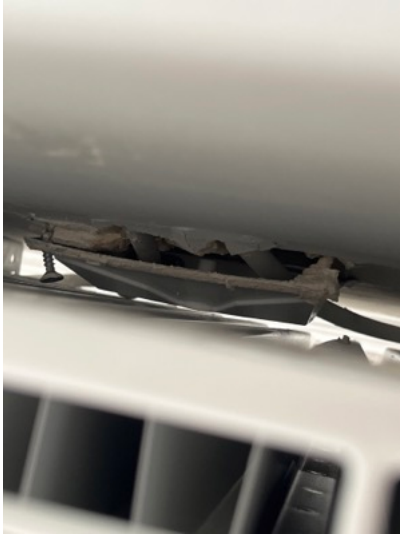
124

Lounge

The cable tidy isn't fixed to the wall

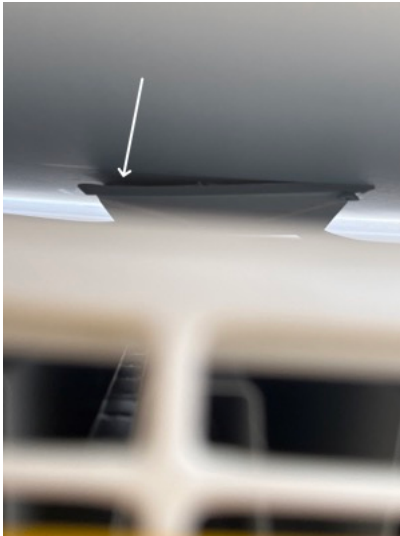
125

Throughout

There are more that need attention so plumber to take rads off and affix throughout

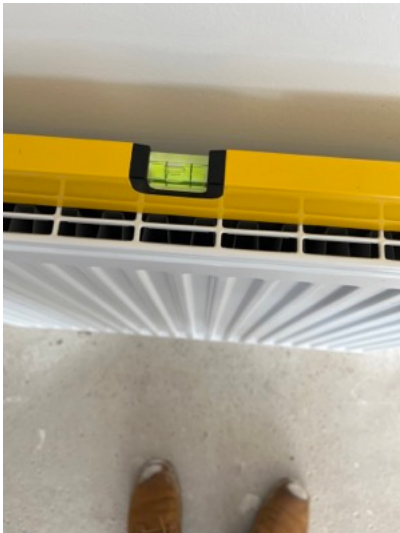
126

Kitchen Diner

Rad next to entry door isn't level

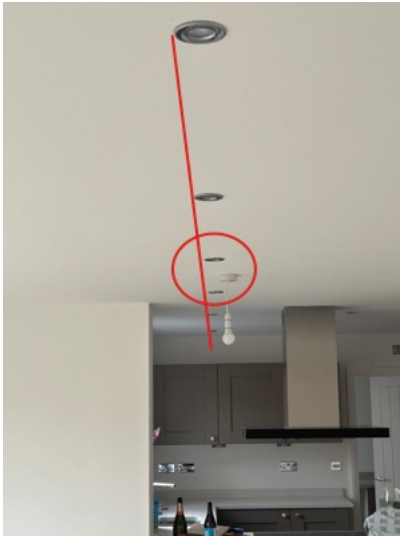
127

Kitchen Diner

Spotlights aren't installed in line

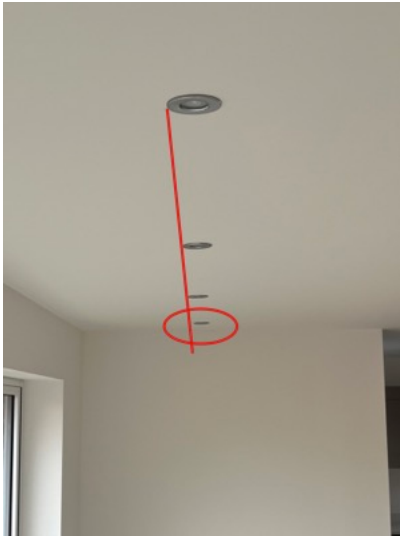
128

Kitchen Diner

Spot not aligned

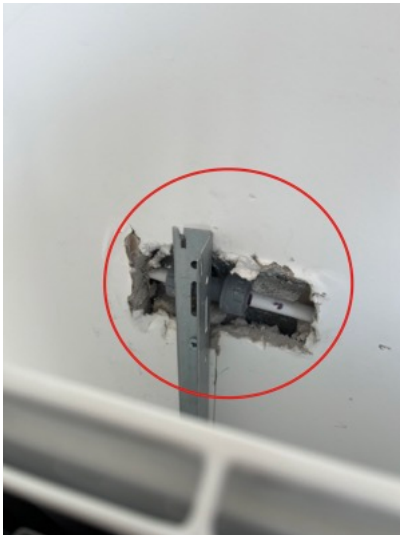
129

● Kitchen Diner

Plumber has cut patch to repair pipe
(assumption is they screwed into the pipe
and caused a leak as there is a straight
connector)

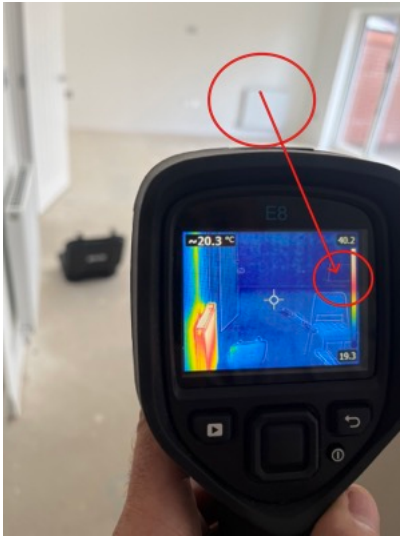
130

Kitchen Diner

As above, the rad is not coming on

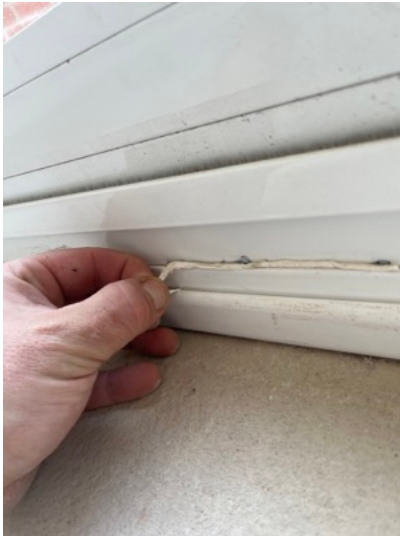
131

Kitchen Diner

Bi fold seal / general finish is poor

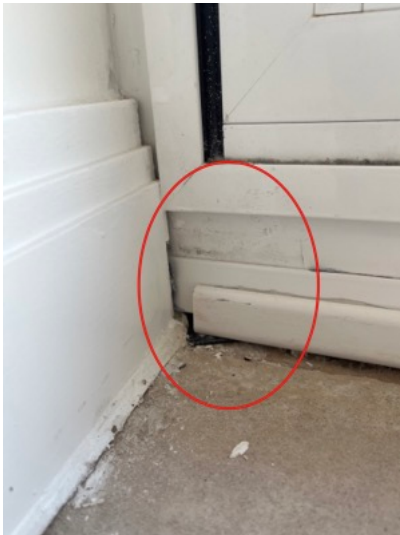
132

Kitchen Diner

Trim is short

Gaps around the frame

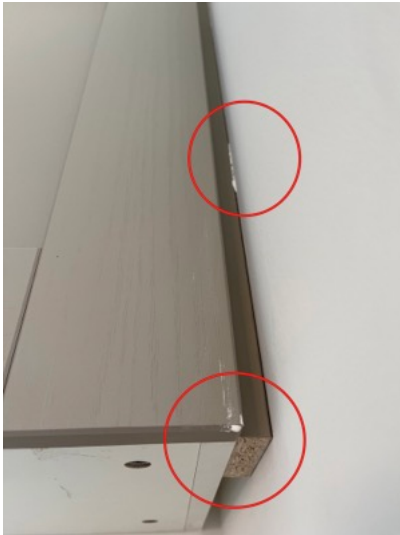
136

Kitchen

Assigned To
End panel poor finish.

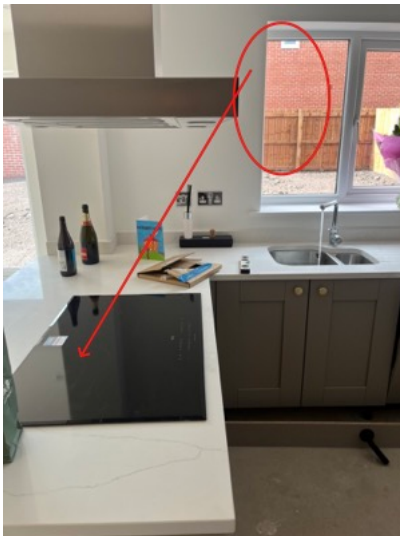
137

● Kitchen

The position of the hood needs moving
It's impractical where it is, projecting to
the point of not being able to see the hob
stood over it

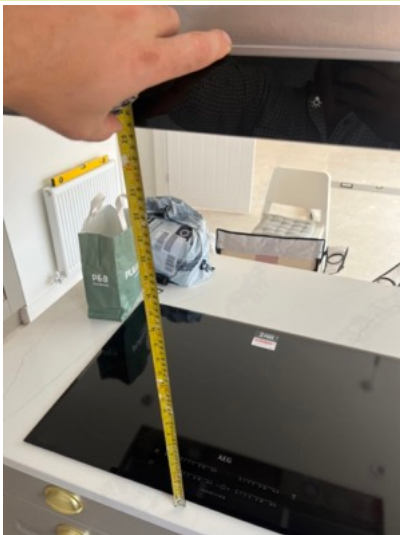
138

Kitchen

Assigned To
It is also below the building regulations
part F height

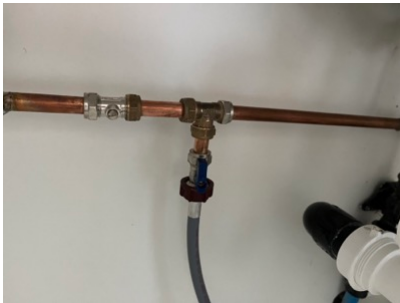
140

Kitchen

There is no double check valve to stop waste water from appliances entering clean water supply

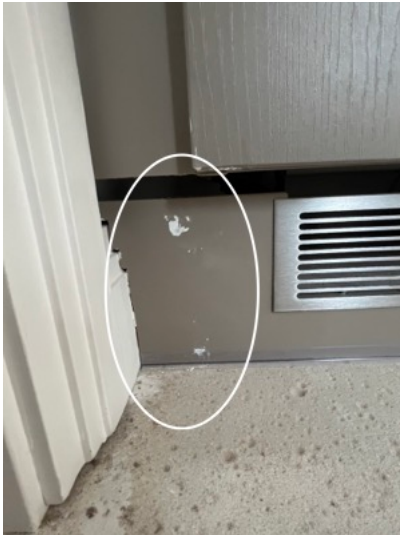
146

Kitchen

Clean up units and plinth from paint splashes

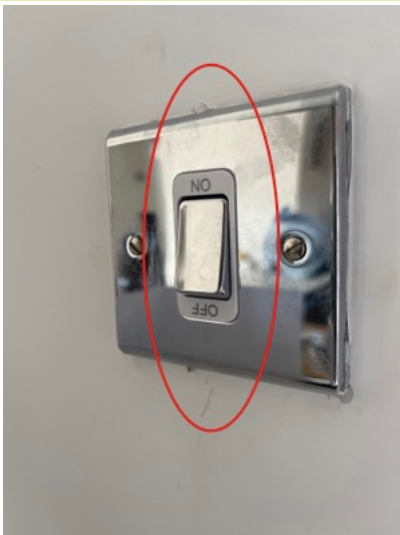
148

Kitchen

Switch upside down

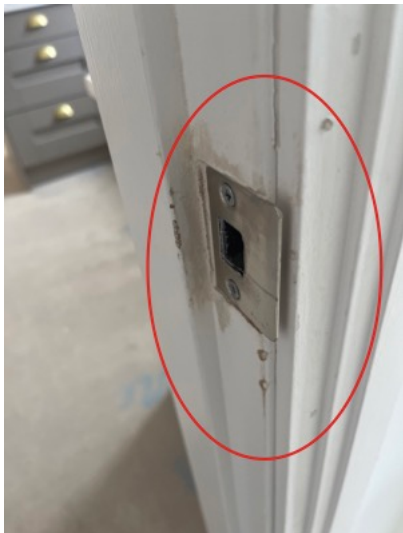
149

Utility

Frame in poor condition.

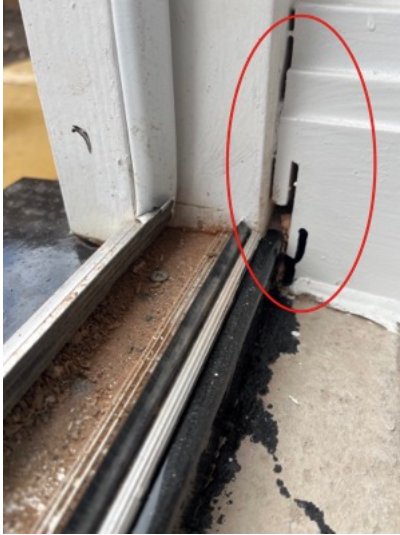
152

Utility

Replace skirting at reveal

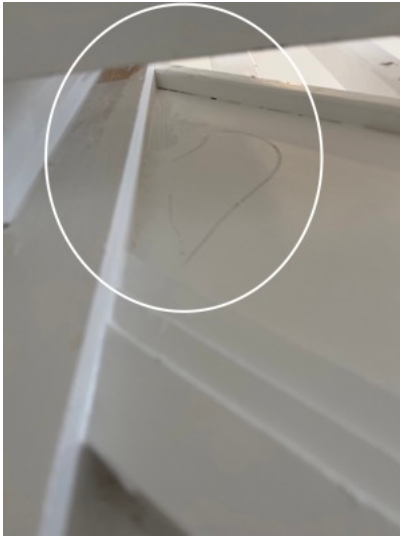
162

Staircase
Assigned To Painter
Rough finish

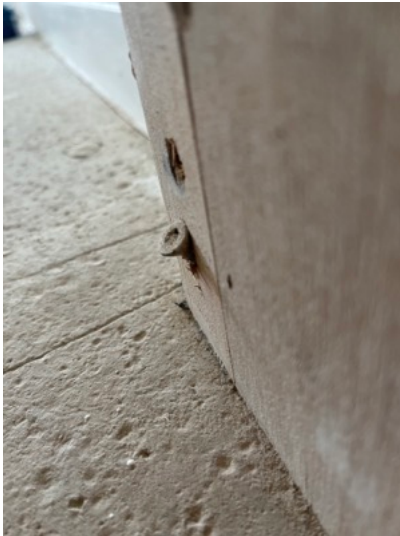
163

Staircase
Assigned To Joiner
Generally it is a poor finish
Screws should not protrude and it
generally has not been handed over
suitable to be carpeted

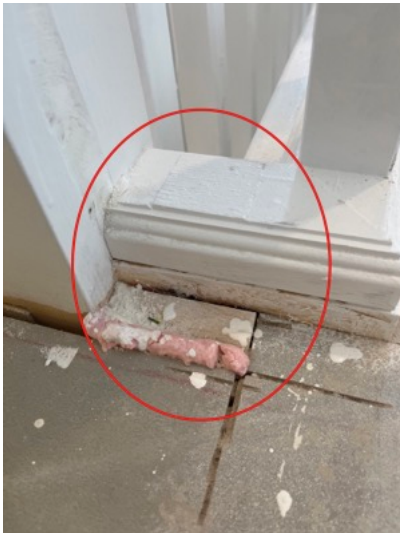
164

Staircase
Assigned To Joiner
Another example of rough handover of
staircase

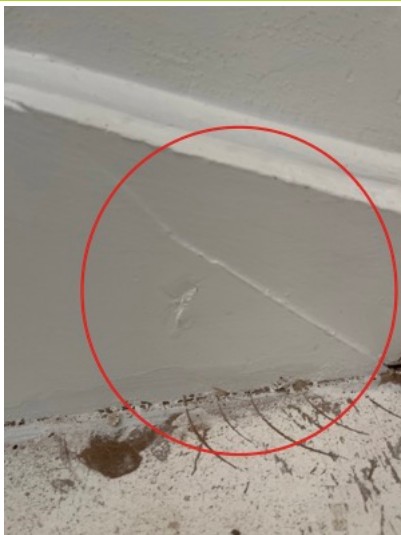
169

Finish of the Stringer is poor all the way up

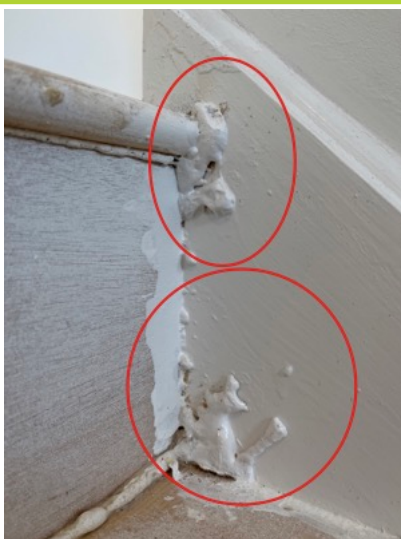
170

The painter has painted over foam rather than making good first

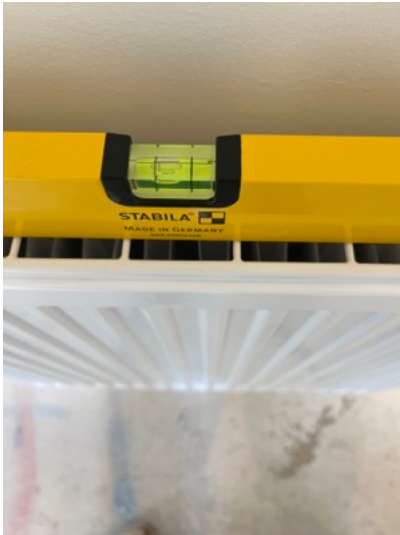
172

Landing
Assigned To Plumber
The radiator is not level

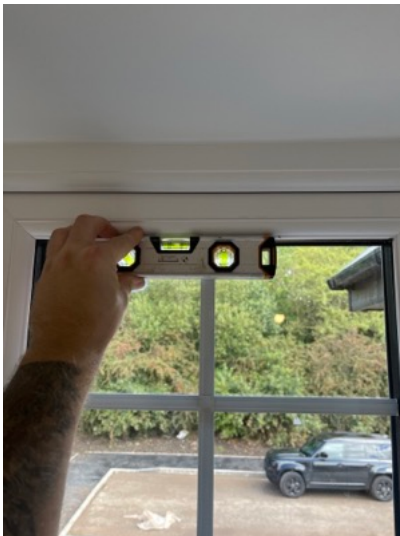
173

Assigned To Glazing
Landing window not level

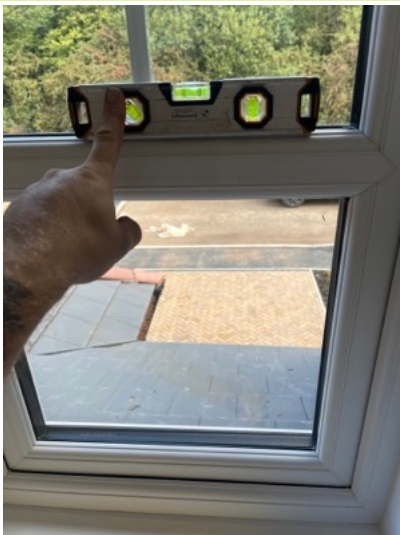
174

Assigned To Glazing
As above, mullion also showing not level

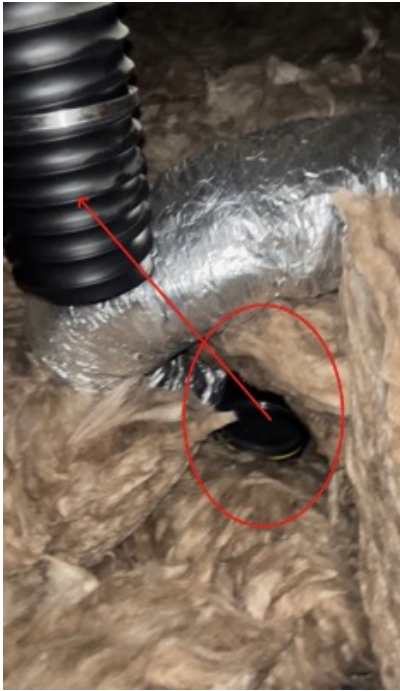
175

The soil stacks haven't been connected. It was buried under insulation after I noticed there was a vent unused and no visible AAV

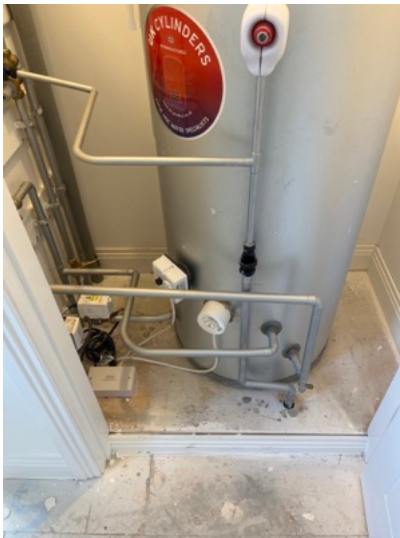
176

There should be lagging to all the hot pipework within 1 m distance of the cylinder tank
There is also no shelving opportunity in here

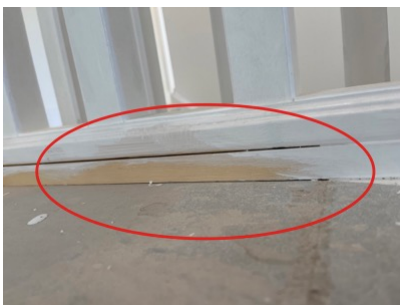
177

Painter has not put any coat on the base rail

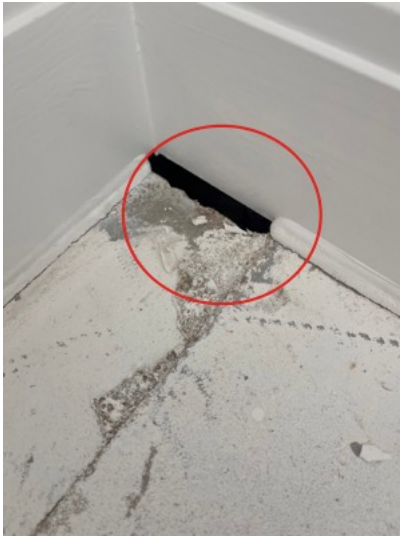
178

Large gap in corner - I was able to see the blockwork, which is a concern not limited to stability, but also thermal efficiency

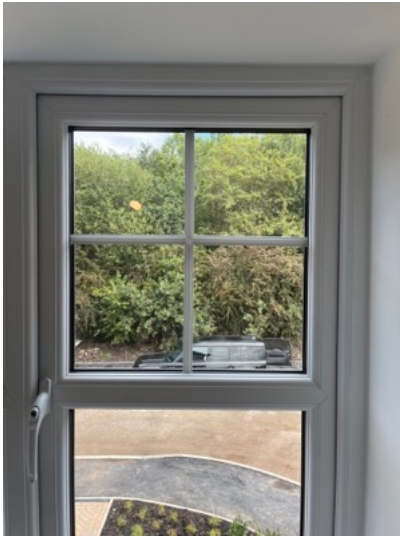
179

Glazing bars aren't level or straight

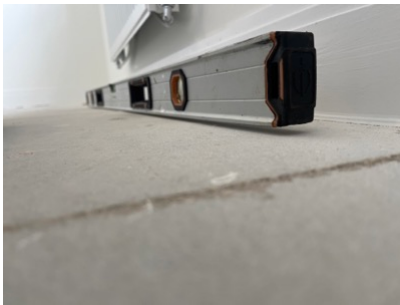
180

This photo was taken in bedroom 2 showing the floorboards not being flat
This was the case in most bedrooms in areas

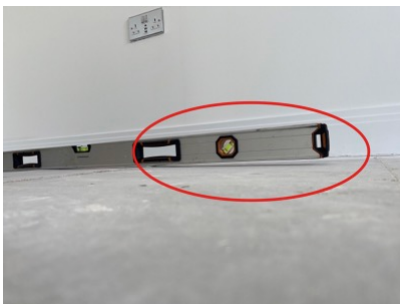
181

Example - showing deviation out of NHBC
- this is in the master bedroom

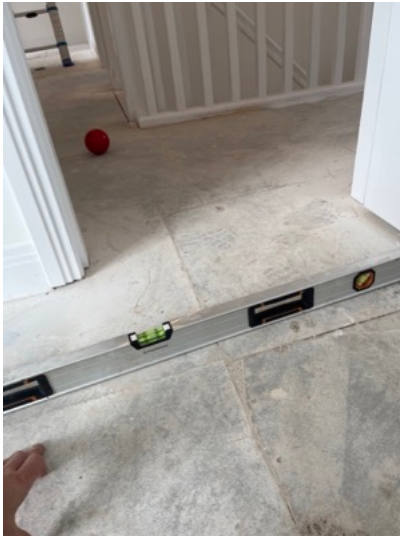
182

Another example in Master where the boards weren't flat or level

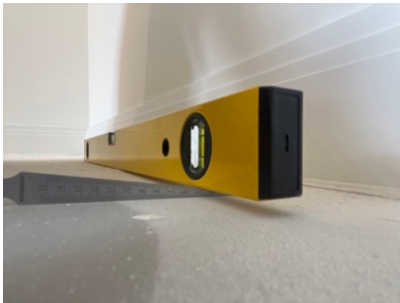
183

Another example in bed 4 showing floorboards not flat by 6mm

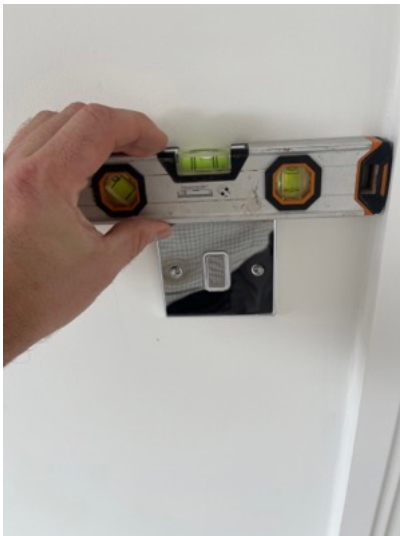
184

Switch isn't level

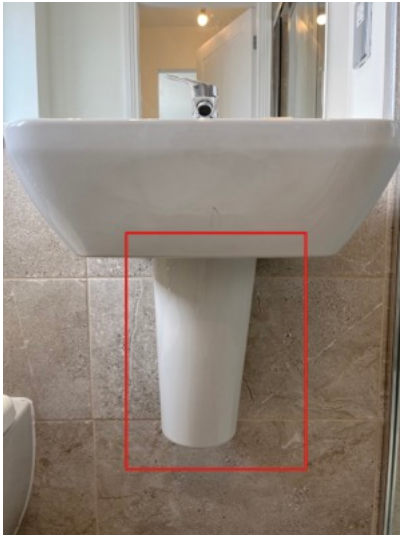
189

Master En-suite
Assigned To Plumber
Pedestal isn't straight

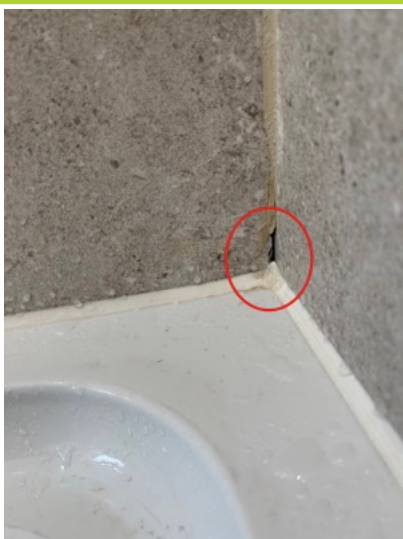
193

Another example

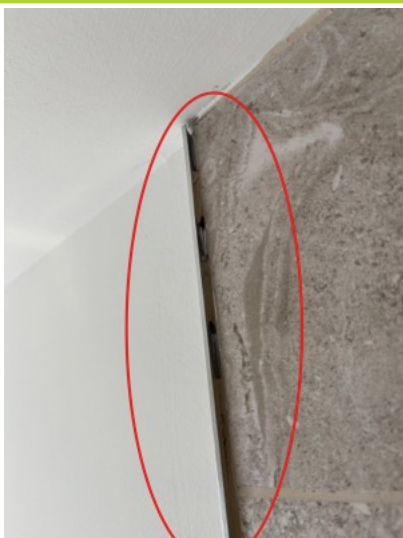
194

Tiling gap

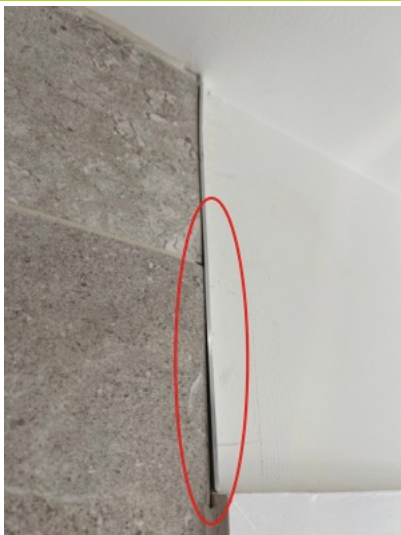
195

Also next to door the trim is loose

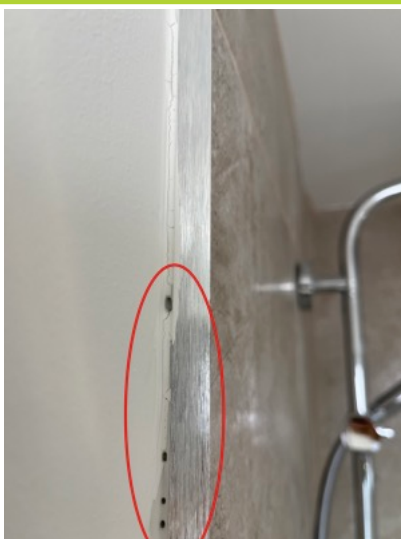
196

Poor finish at edge

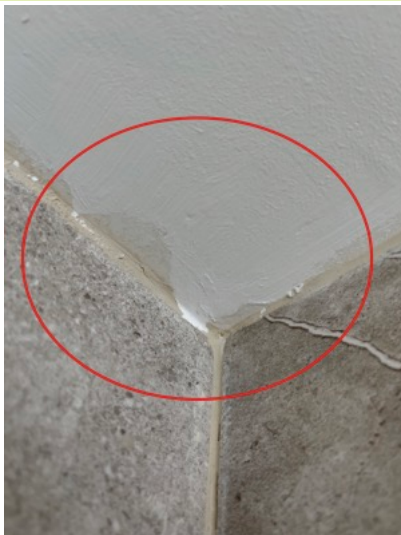
197

Poor decoration to ceiling

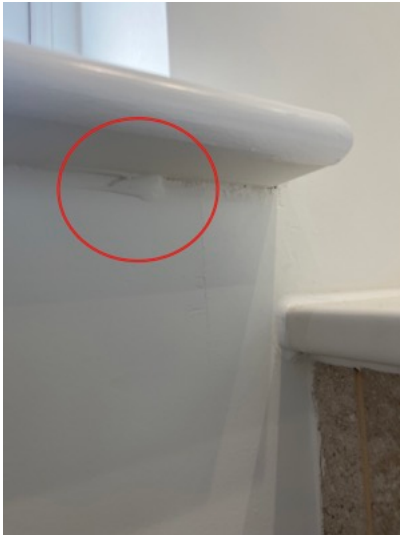
198

Under window board is a rough finish

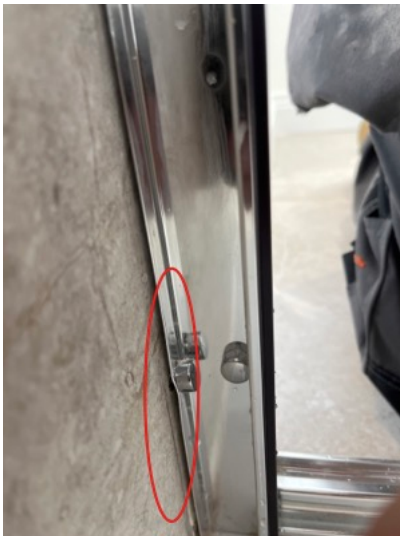
199

Shower frame not flush

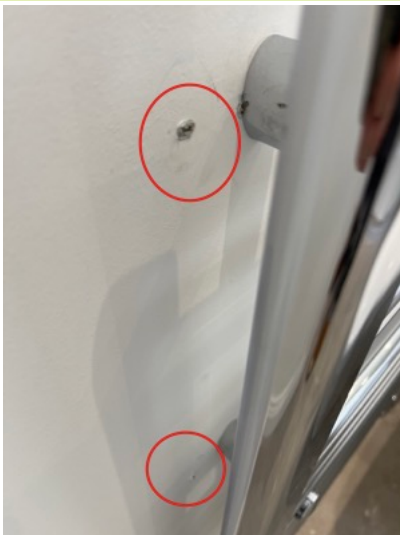
200

Rawl plugs still in place

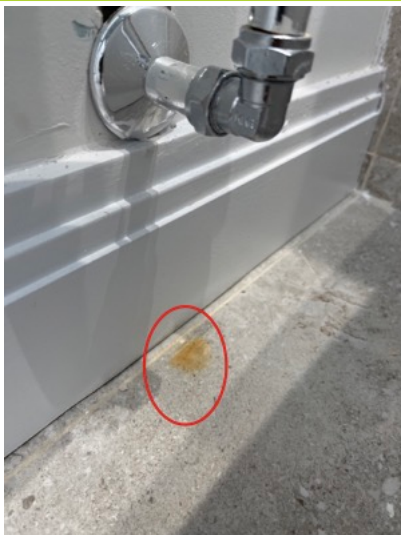
201

Sign of slow leak / old but stained and needs making good

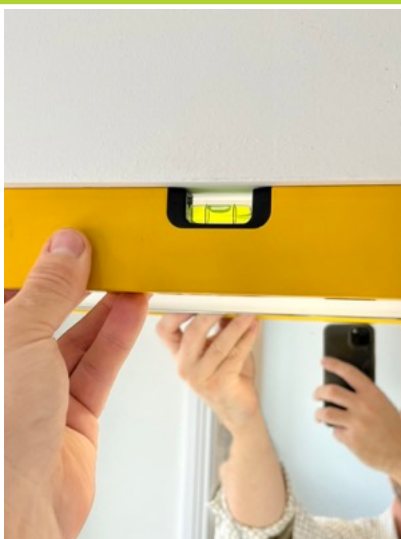
202

The bulkhead isn't level
It's noticeable by eye

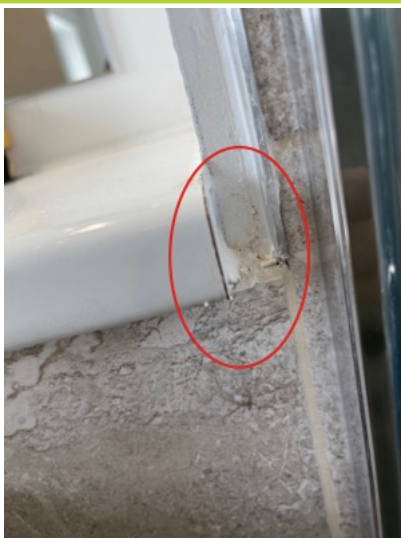
203

Rough finish edge of shelf

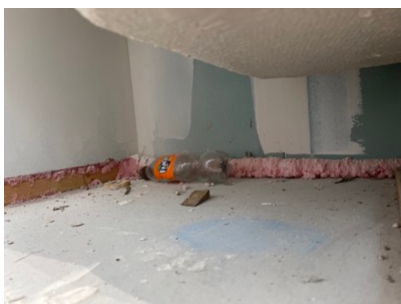
204

Several bottles to remove under bath
Also, it is good practice to leave the
customer spare tiles under the bath

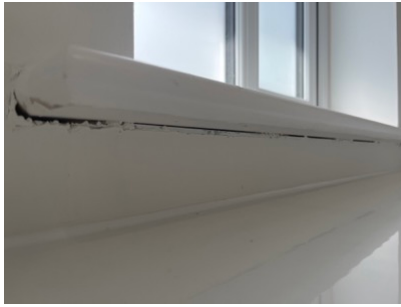
205

Seal gap under window board

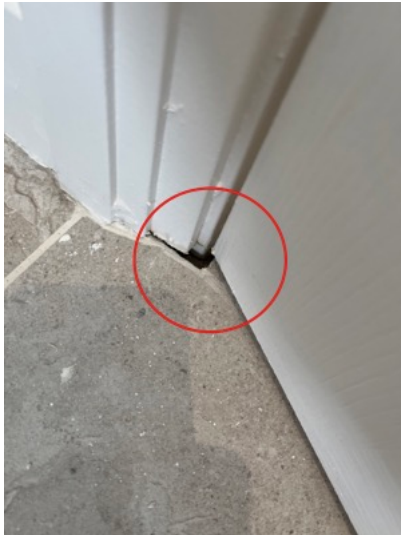
206

Gap next to door

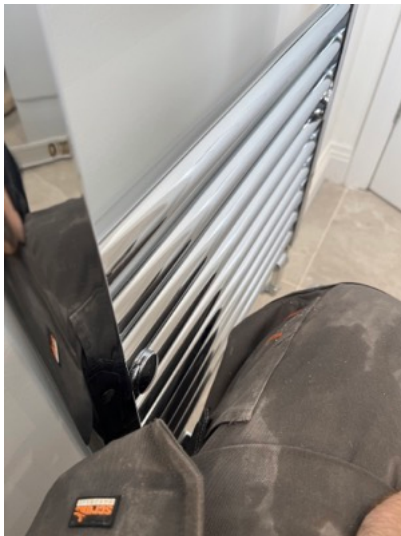
207

Rad too close to toilet

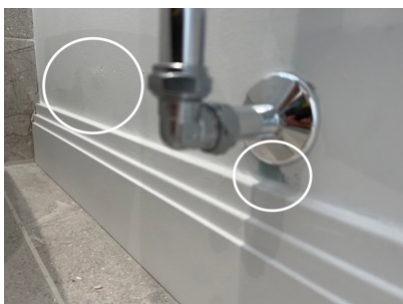
212

Bathroom
Assigned To Painter
Decoration needs improvement

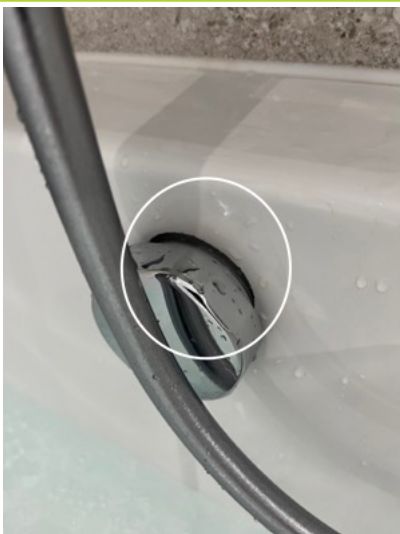
216

Gap to the overflow
The water from the shower is leaking through

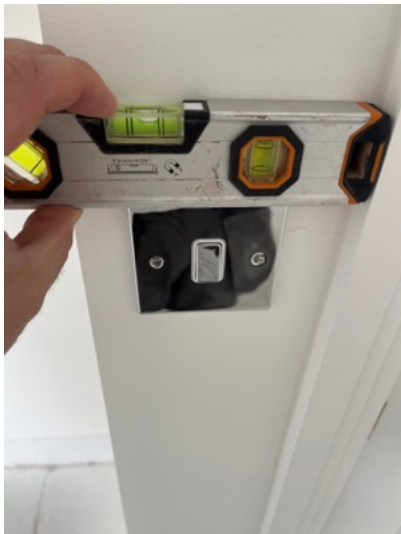
219

Switch isn't level
