SNAG LIST

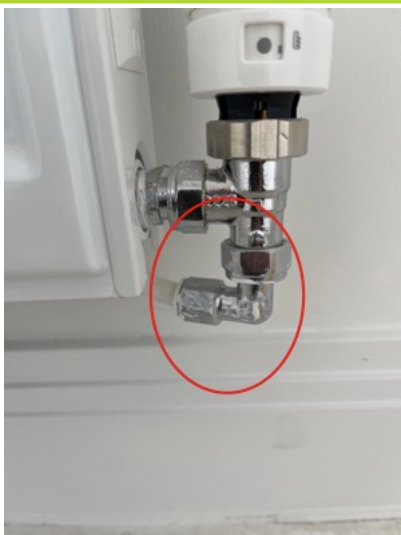
220

Clean paint from radiator fixings

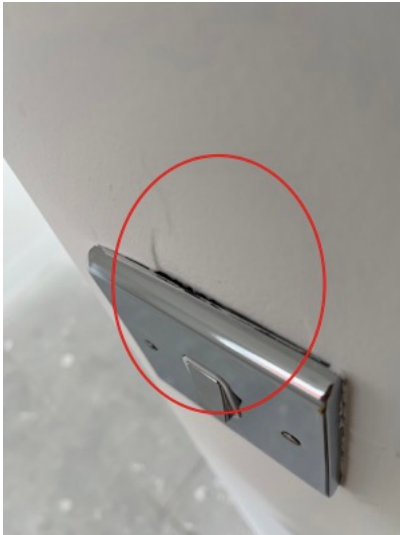
221

Bed 5
Assigned To Plasterer
Poor finish around switch

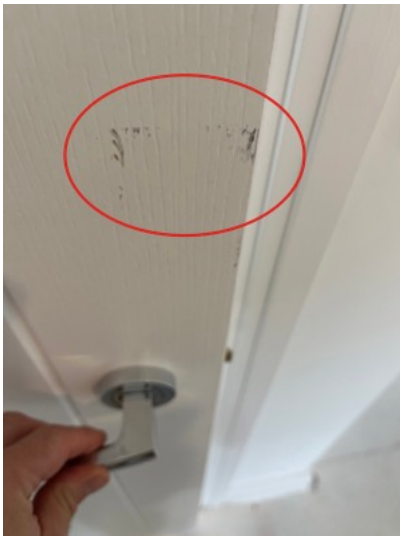
222

Bed 4
Assigned To Painter
Door tarnished

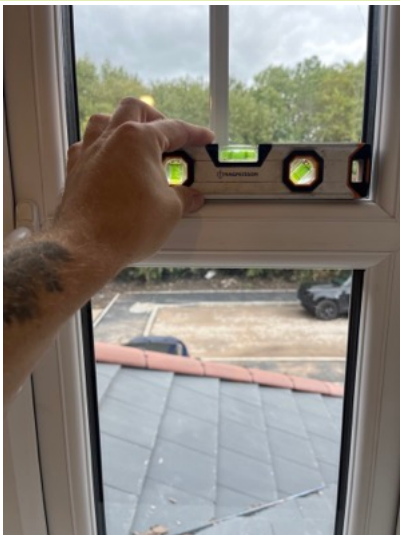
223

Bed 3
Assigned To Glazing
Window isn't level
